# Service Bulletin

Bulletin No.: PIP4989B

**Subject:** BAS+ (HYBRID) eAssist Drive Motor Generator Belt Broken Noisy Worn Or Misaligned

**Models:** 2012 Buick LaCrosse eAssist  
2012 Buick Regal eAssist  
2013 Chevrolet Malibu Eco eAssist  
All with RPO HP6

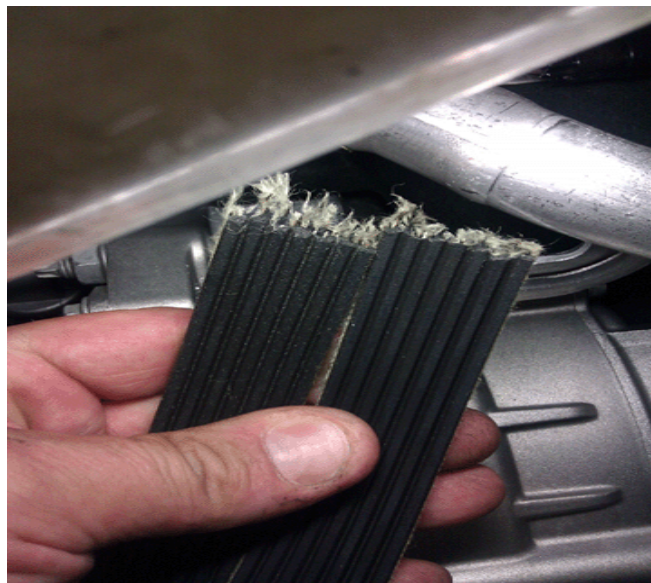
1. Inspect the underhood area for any damage (engine, CV boots, etc.) that may have been induced when the belt broke.
  2. Inspect the Drive Belt and note whether it looks like the belt just snapped cleanly, if it is shredded or worn due to misalignment, incorrect tension, or damaged due to contamination from any fluids. Take a digital photo of the broken belt ends and note the belt date code. The code is four numbers followed by "MX" printed in red lettering as shown below.

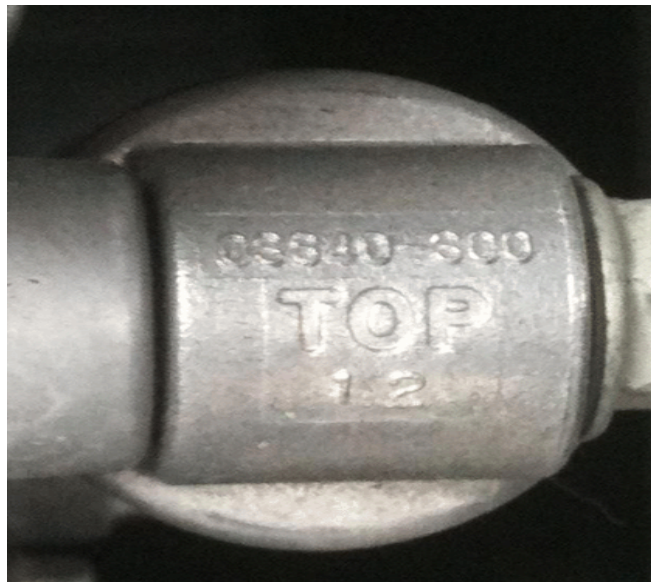
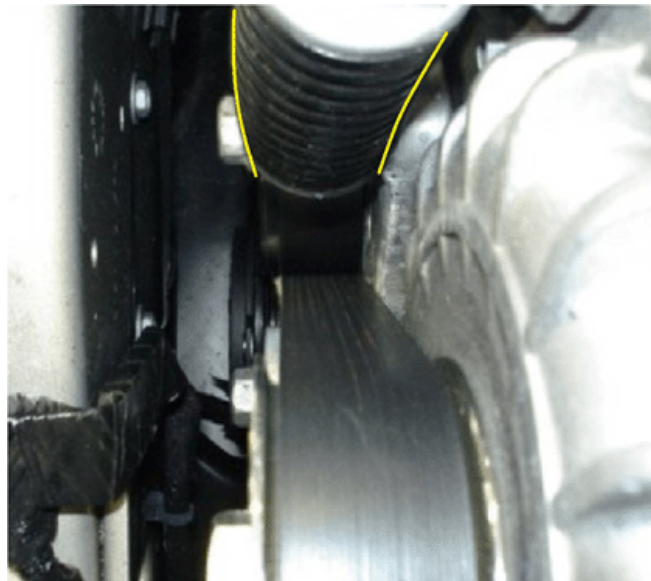
3. If a Laser Belt Alignment Tool (EN-49228 or equivalent) is available, use it to check for proper pulley alignment.
4. Inspect the drive belt tensioner strut assembly to ensure that it is installed correctly - "TOP" is stamped on the upper rounded end of the tensioner strut housing as shown below. If it is installed upside down or if the upper and lower retaining bolts have been reversed during previous repairs, it could cause an alignment concern as shown below. It is not necessary to remove the Tensioner Bolts from the Bracket or remove the spring from the Tensioner. The Upper bolt of the Tensioner is longer than the lower bolt.

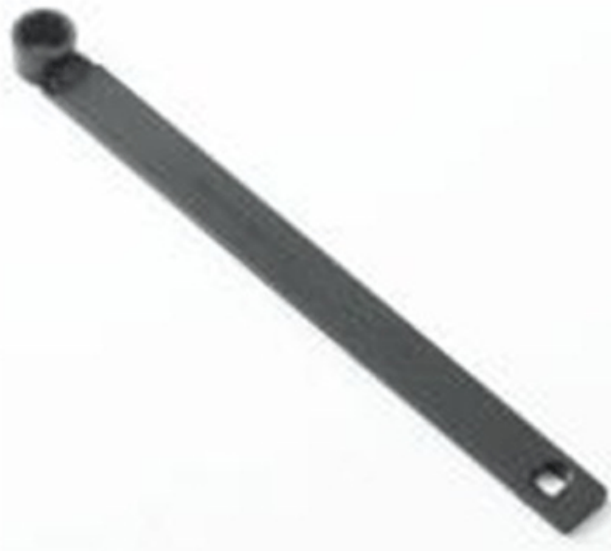
2748752

**Important:** When checking the Center Pivot Bolt torque, it is necessary to use the Torque Wrench Adapter J-45025 when performing this repair. Without this tool, the torque specification in SI will be inaccurate. Achieving the correct torque specification is critical or the bolt may loosen, resulting in premature wear or breakage. The specification in SI is considering that the tech has the Torque Wrench Adapter installed on a 3/8 drive Torque Wrench while they are both kept in a straight line with each other.

6. Check the tensioner pivot bolt torque by marking the head of the tensioner pivot bolt with a marker (See call-out 3 in photo below), torquing it to 42 Nm (31 lb/ft) with the J-45025 / EN-45025 torque tool, and noting the mark again. Please take a digital photo if several degrees of movement (90 Degrees, etc.) are noted.
