Service Bulletin

Bulletin No.: PIP4989C

Subject: BAS+ (HYBRID) eAssist Drive Motor Generator Belt Broken Noisy Worn Or Misaligned

Models: 2012 - 2013 Buick LaCrosse and Regal eAssist
2013 Chevrolet Malibu Eco eAssist
All with RPO HP6

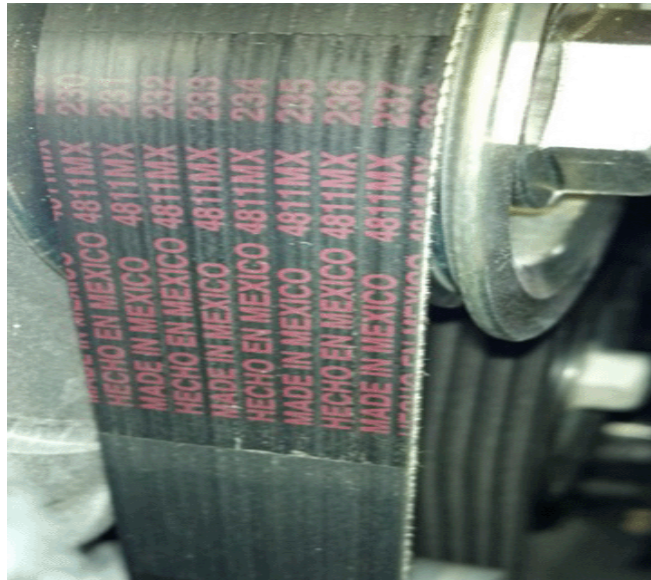
2756515

1. Inspect the under hood area for any damage (engine, CV boots, etc.) that may have been induced when the belt had broken.
2. Inspect the Drive Belt and note whether it looks like the belt just snapped cleanly, if it is shredded or worn due to misalignment, incorrect tension, or damaged due to contamination from any fluids. Take a digital photo of the broken belt ends and note the belt date code. The code is four numbers followed by "MX" printed in red lettering as shown below.

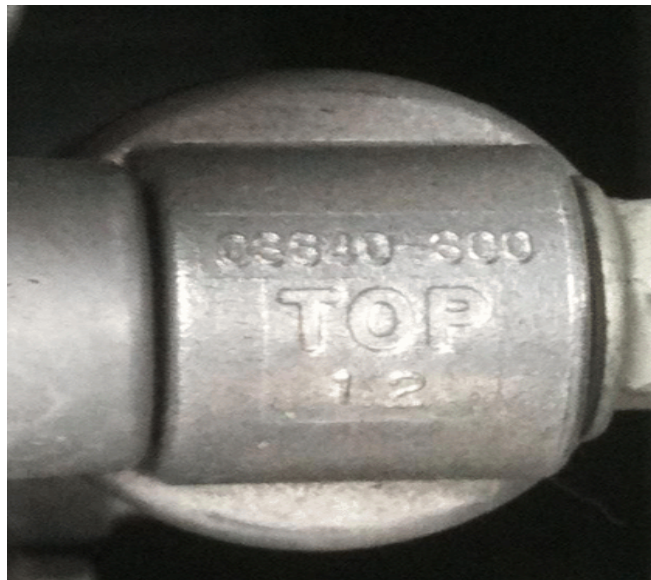
2748756

3. If a Laser Belt Alignment Tool (EN-49228 or equivalent) is available, use it to check for proper pulley alignment.
4. Inspect the drive belt Tensioner strut assembly to ensure that it is installed correctly - "TOP" is stamped on the upper rounded end of the tensioner strut housing as shown below. If it is installed upside down or if the upper and lower retaining bolts have been reversed during previous repairs, it could cause an alignment concern as shown below. It is not necessary to remove the tensioner bolts from the bracket or remove the spring from the tensioner. The upper bolt of the tensioner is longer than the lower bolt.

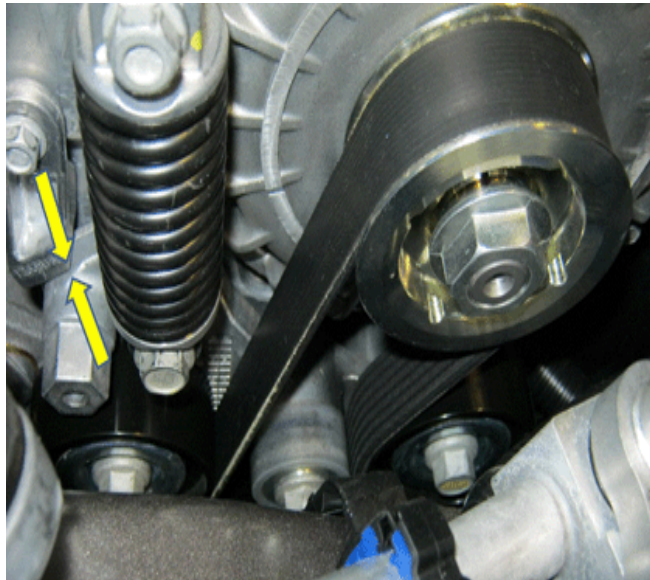
2748754

5. Check for clearance/gap between tensioner stop and the tensioner assembly.
 - Loosen M6 tensioner stop bolt. Using a 19mm socket, rotate the hex feature beneath the strut counter-clockwise to extend the strut. Tighten M6 tensioner stop bolt and confirm you now have clearance/gap between tensioner stop and the tensioner asm.
 - Check and note if the tensioner stop is in place and the bolt is tight.
 - Remove the top tensioner bolt (requires 1st removing stop, then compressing strut, then removing bolt (if present)).
 - Verify that the tensioner assembly rotates about center pivot, but that the pivot or bolt is not loose. The tensioner should be able to move back and forth smoothly with only a small amount of force.

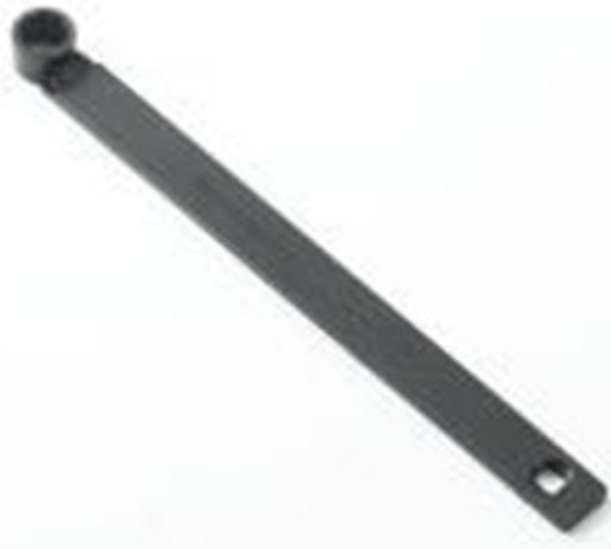
2748752

When checking the center pivot bolt torque, it is necessary to use the Torque Wrench Adapter J-45025 when performing this repair. Without this tool, the torque specification in SI will be inaccurate. Achieving the correct torque specification is critical or the bolt may loosen, resulting in premature wear or breakage. The specification in SI is considering that the tech has the Torque Wrench Adapter installed on a 3/8 drive Torque Wrench while they are both kept in a straight line with each other.
