**SB-10045160-4021**

**Title:** Horizontal Aftertreatment Mounting Bolt Torque

**Applies To:** ProStar, TranStar, WorkStar equipped with MF 11/13 engines

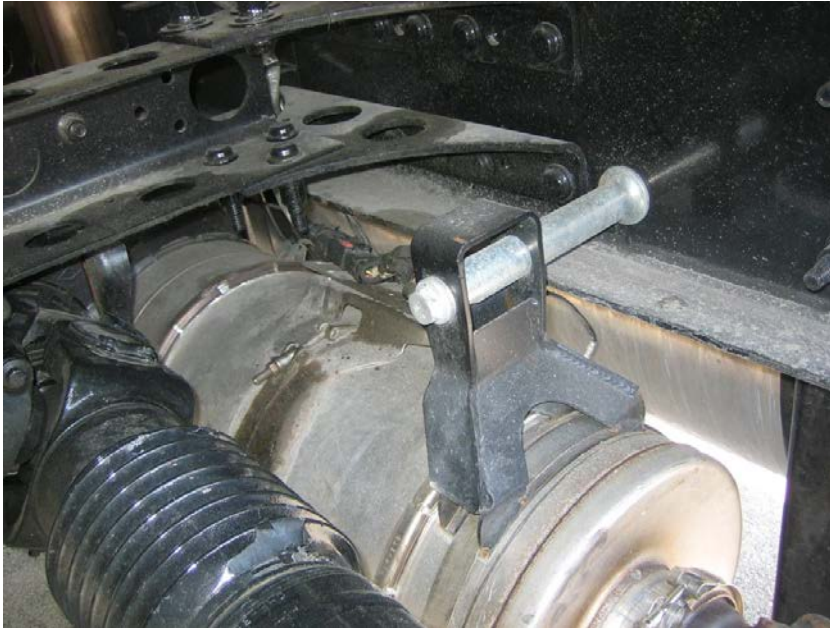
Horizontal Aftertreatment Support Rod Bolt loose or backed out of Aftertreatment Support Hanger Rod.

1. Inspect for Support Rod Bolt to be loose or backed out of Support Rod
2. If loose inspect bolt for wear and replace if necessary

Torque Support Rod Bolt to 88-108 NM / 65-80 Ft. Lbs.
