**SB-10045160-7827**

**Title:** Horizontal Aftertreatment Mounting Bolt Torque**Applies To:** ProStar, TranStar, WorkStar equipped with MF 11/13 engines**DESCRIPTION****Horizontal Aftertreatment Mounting bolt loose****SYMPTOMS**

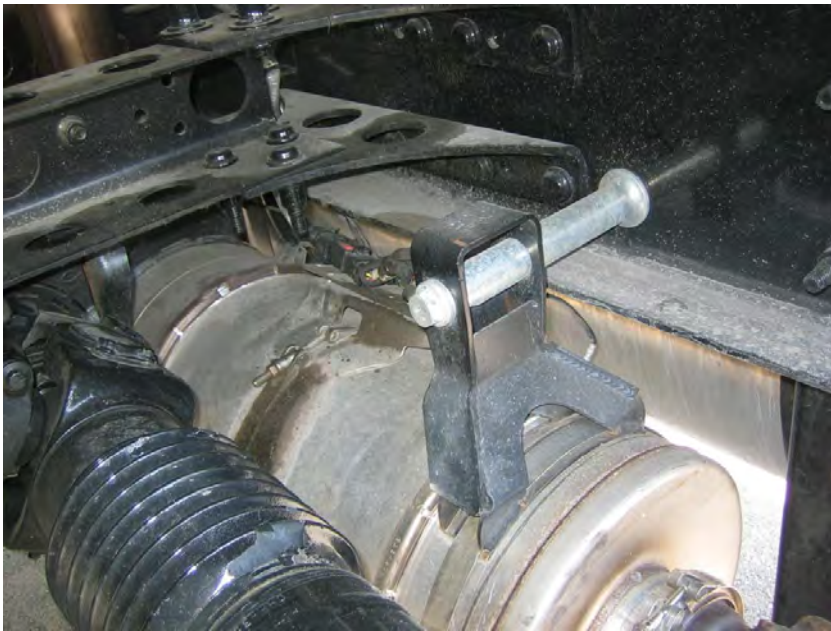
Horizontal Aftertreatment Support Rod Bolt loose or backed out of Aftertreatment Support Hanger Rod.

1. Inspect for Support Rod Bolt to be loose or backed out of Support Rod
2. If loose inspect bolt for wear and replace if necessary

Torque Support Rod Bolt to 88-108 NM / 65-80 Ft. Lbs.
