SB-10045181-6238

Title: Bendix Wingman fault.ACB display with SPN 886 FMI 7. ABS DTC 55. Sensor Alignment tool and instructions

ACB display with SPN 886 FMI 7. ABS DTC 55.

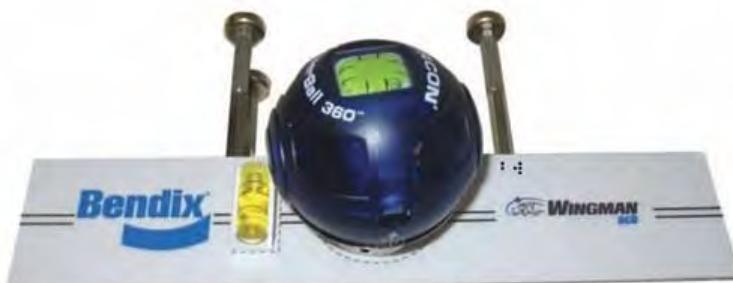
Part #	Description	Qty.
K065284	ACB Alignment tool (Bendix)	1

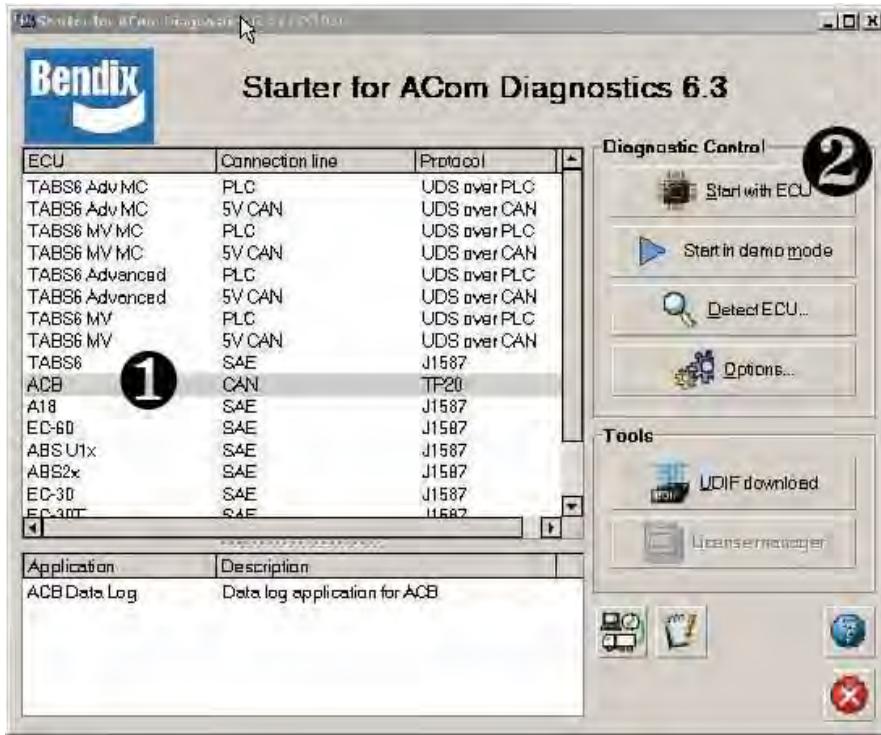
If the system generates a Diagnostic Trouble Code, where a lamp or icon is illuminated on the instrument cluster, then ACom Diagnostics software – version 6.3 or later – is required. **Select "ACB" from the starter screen** (1), then "Start with ECU" (2) . Click "DTC" to show the diagnostic trouble codes.
