SI B18 05 12
Exhaust SystemsJuly 2012
Technical Service

Voluntary Emissions Recall Campaign 11E-A03: Check and/or Replace Emissions Monitoring Components

NEW E70 and E90 with the M57Y engine produced from April 2009 to September 2010

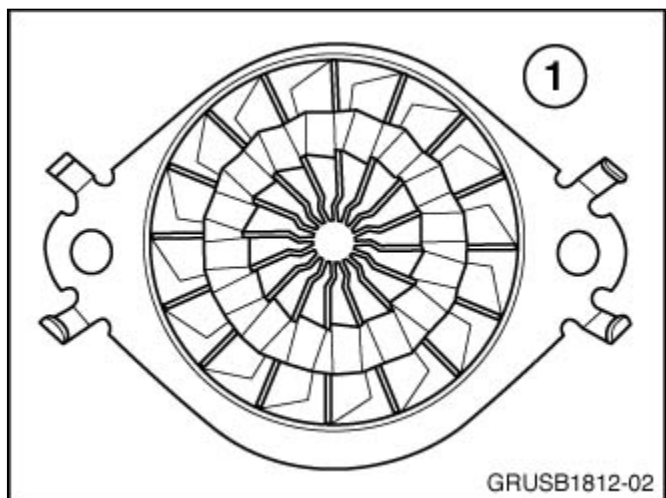
The original style mixer has a multiple fin arrangement (1). This mixer will need to be replaced with P/N 18 30 8 513 445 (E70) or P/N 18 30 8 512 438 (E90).

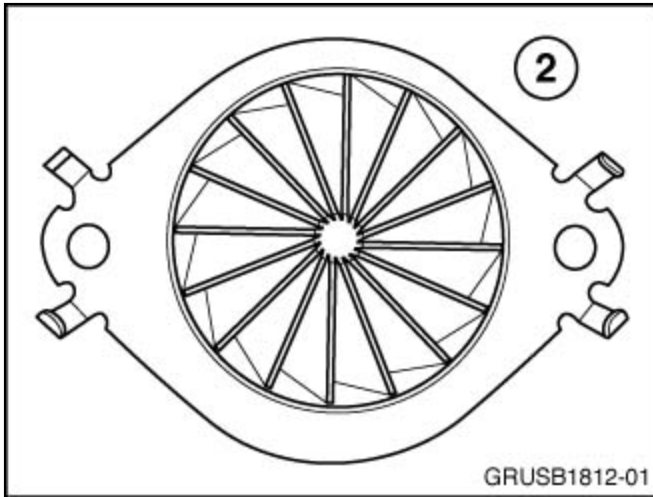
If the updated mixer has already been installed, it will have one set of fins (2). No replacement is necessary. Reinstall

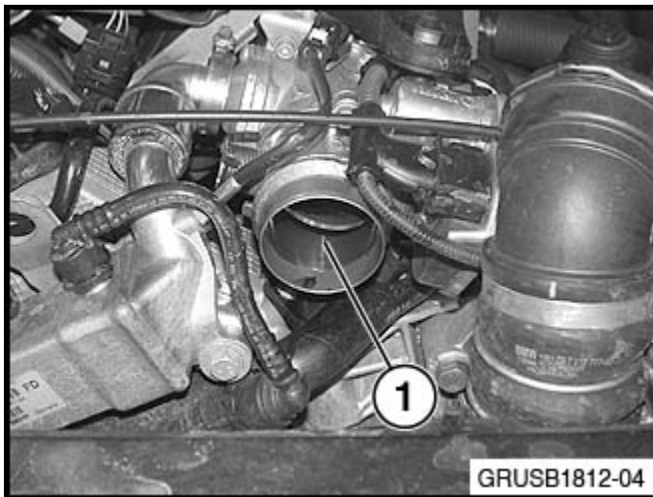
Remove the charge air pipe at the throttle housing (ignition off). Using a flashlight, look through the throttle (1) and inspect the EGR valve.

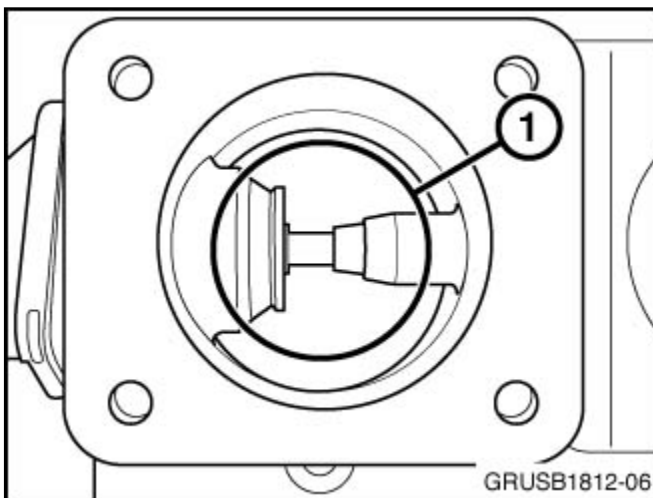
The updated EGR valve (P/N 11 71 8 517 217 or P/N 11 71 8 512 526) has the valve and seat directly in the airstream of the throttle (1). If this valve is installed, no further action is needed. Reinstall the charge air pipe.

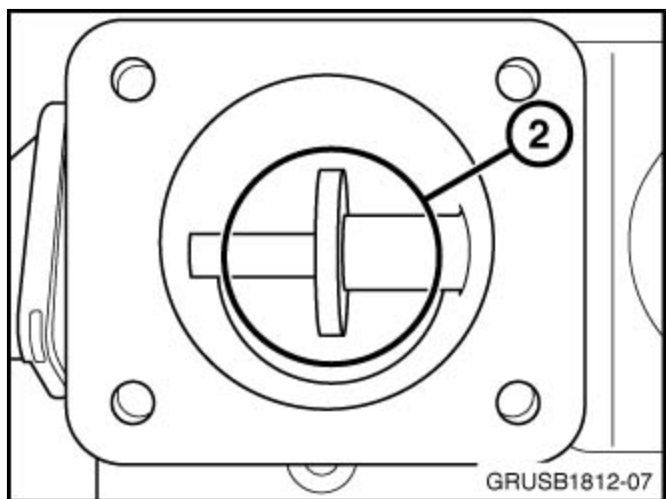
The original EGR valve has a diffuser in the airstream flow from the throttle (2). The valve for EGR actuation is seated further into the EGR airstream. Replace this valve with P/N 11 71 8 512 526 (Repair Instruction 11 71 501).

The DDE will also need to be programmed as part of the Recall. If the EGR valve is replaced, the DDE will need to be programmed after the new EGR valve is installed. This new software package contains the necessary software to adapt to the new EGR valve strategy.
