SERVICE CAMPAIGN BULLETIN

NTB12-065a

VOLUNTARY SERVICE CAMPAIGN 2013 ALTIMA METER BACK LIGHT ILLUMINATION

CAMPAIGN ID #: P2537

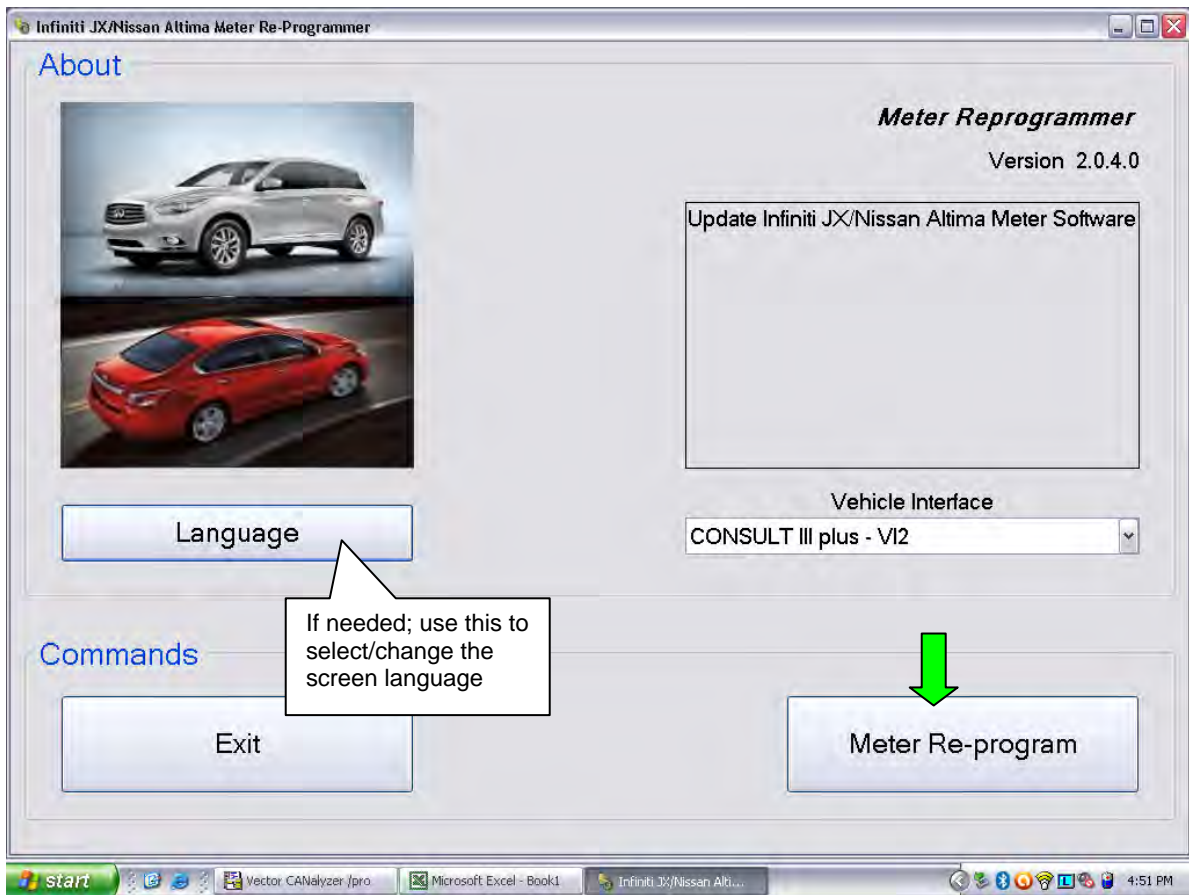
11. When the screen in Figure 1 displays, select **METER Re-program**.

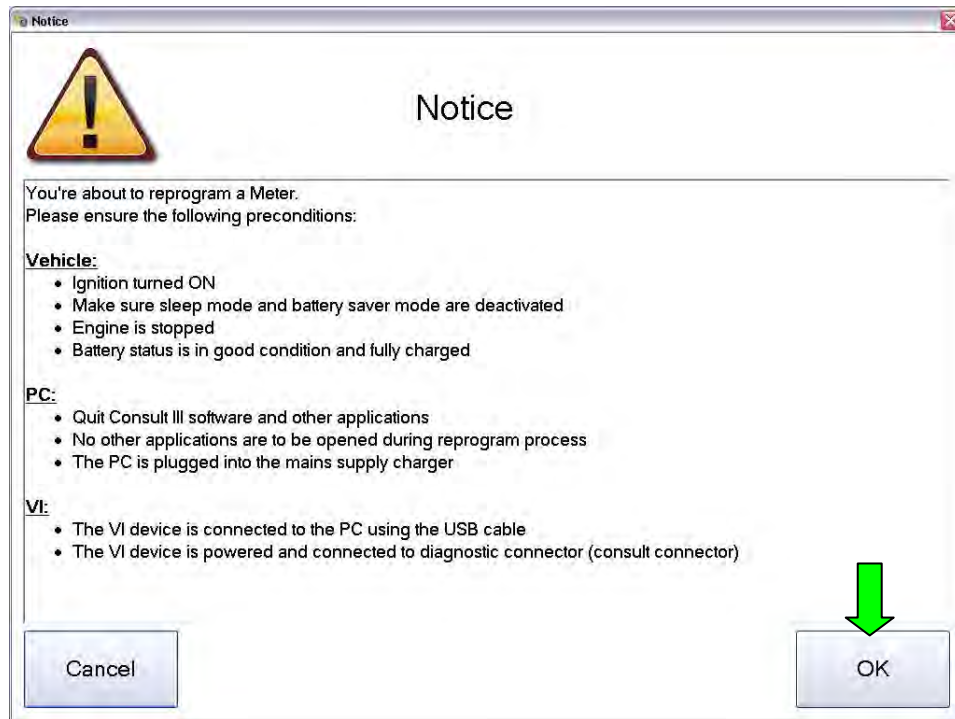
Figure 2

12. Select **OK** – meter reprogramming will start.

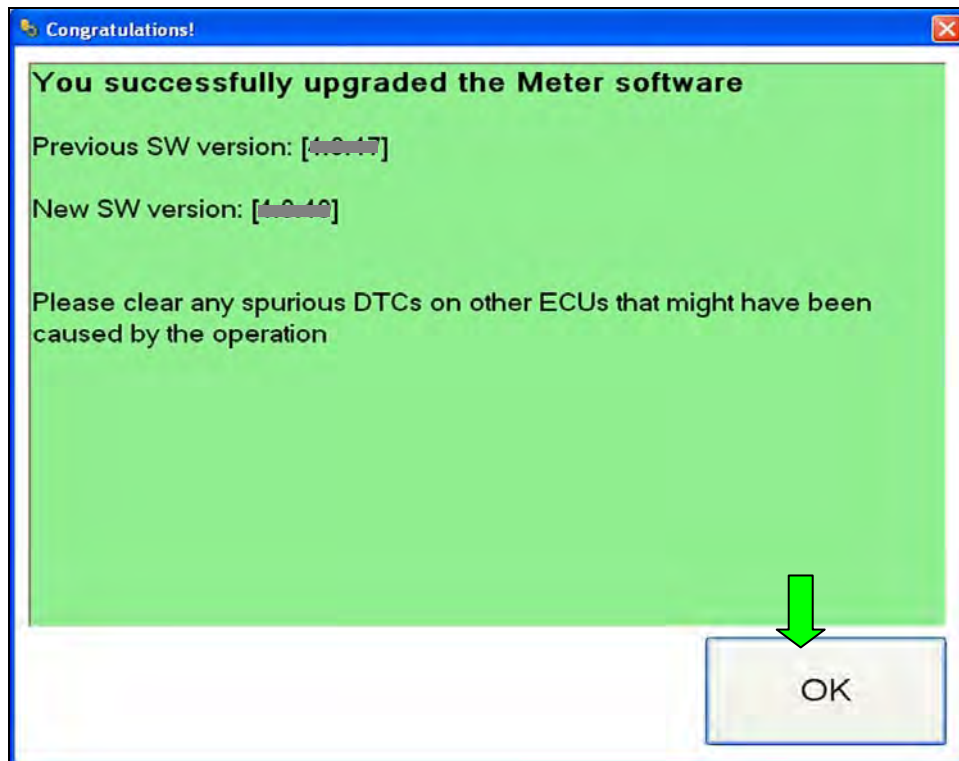
13. The screen in Figure 3 displays when reprogramming is complete – Select **OK**.

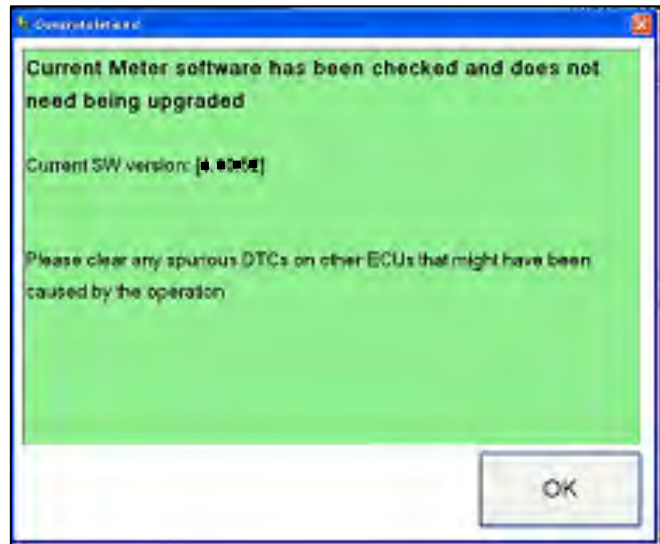
NOTE: If the screen in Figure 4 displays, reprogramming is not needed for this vehicle or it has already been done:

- a. Select OK.
- b. Close the reprogramming tool/software.
- c. Skip to step 16.

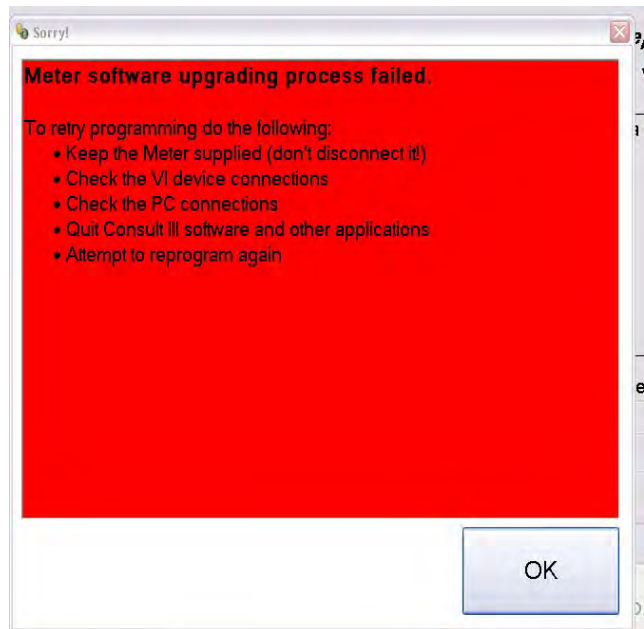
NOTE: If the screen in Figure 5 displays the reprogramming has failed.

- a. Select OK and close the reprogramming tool/software.
- b. Restart the Service Procedure from the beginning. Make sure all steps are completed correctly.

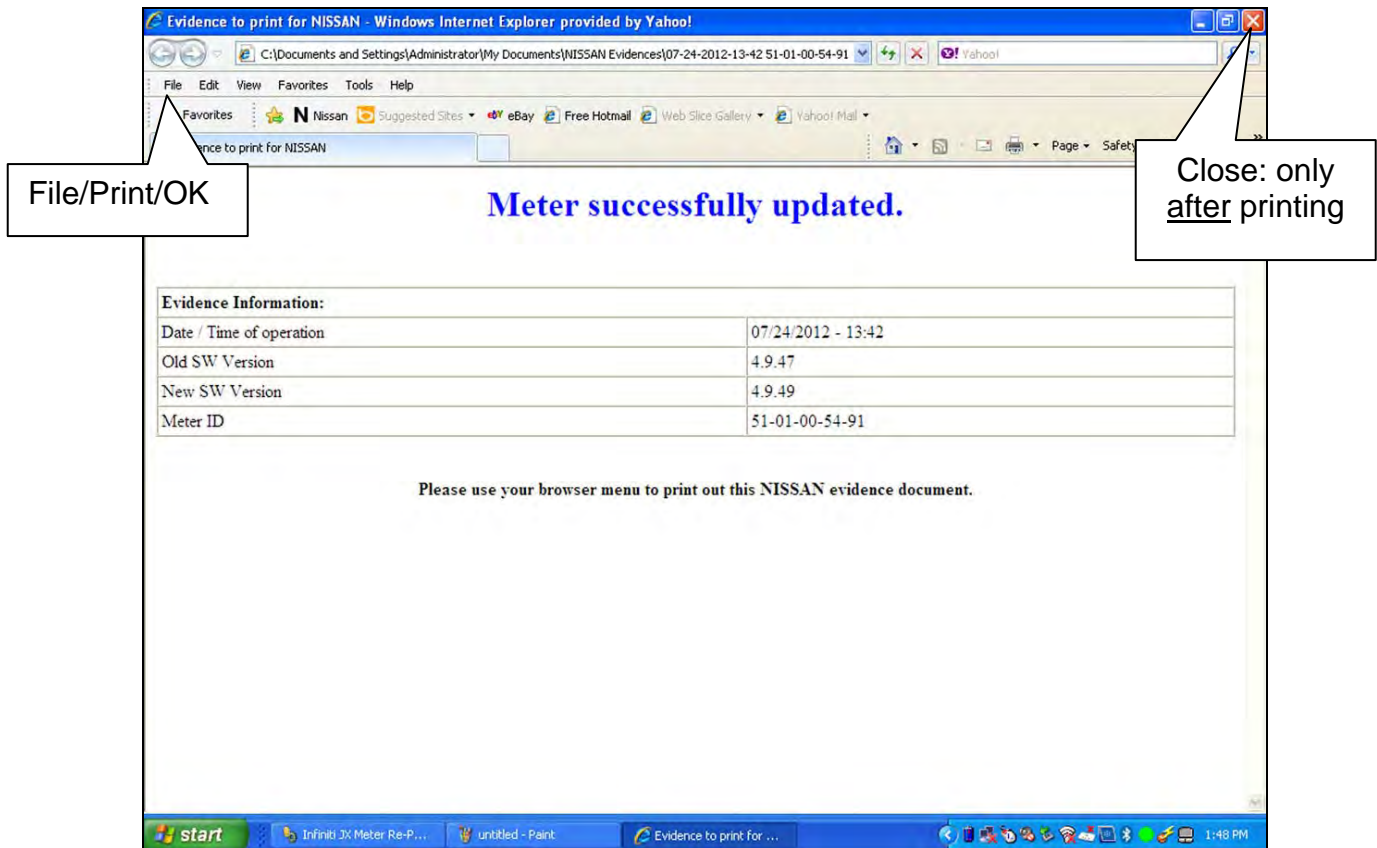
14. For warranty documentation, print a copy of the screen in Figure 6 and attach it to the repair order.
 - To print, use your browser menu – File/Print/OK.
15. After printing, close the L50/L33 Reprogrammer tool/software by selecting the red “X” in upper right corner.
