# SERVICE CAMPAIGN BULLETIN

NTB12-065b

## VOLUNTARY SERVICE CAMPAIGN 2013 ALTIMA METER BACK LIGHT ILLUMINATION

**APPLIED VEHICLE:** 2013 Altima (L33)

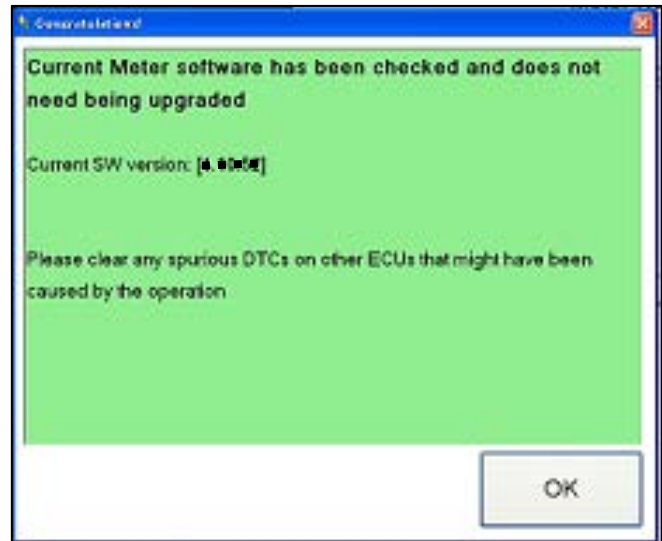
**NOTE:** If the screen in Figure 4 displays, reprogramming is not needed for this vehicle or it has already been done:

- a. Select OK.
- b. Close the reprogramming tool/software.
- c. Skip to step 16.

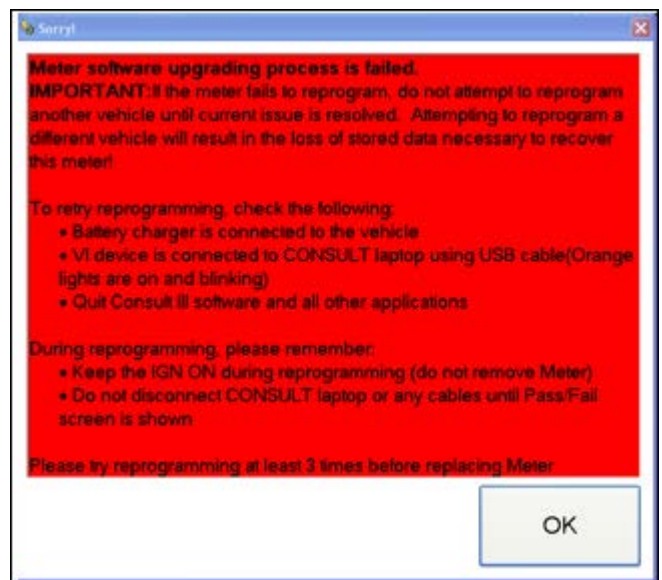
**NOTE:** If the screen in Figure 5 displays:

**IMPORTANT:** If you get the screen in Figure 5 above:

- Make sure to complete all reprogramming attempts on the current vehicle before moving to another vehicle.
- Using the reprogramming tool on another vehicle will erase all data for the current vehicle, and the meter for the current vehicle will not be reprogrammable (recoverable).

**Try reprogramming at least 3 more times.**

- a. Select OK and close the reprogramming tool/software.
- b. Restart this Service Procedure from the beginning.
  - **Make sure all steps are completed correctly.**
  - CONSULT software and all other applications are closed.
  - Plus VI is securely connected to the vehicle and USB cable is connected.
  - Battery charger is connected to the vehicle.
