Service Bulletin

PRELIMINARY INFORMATION

Subject: Hum or Buzz Noise Right Front, Service Brake Assist, ABS or SES MIL

Models: 2012 - 2013 Buick Lacrosse
2012 - 2013 Buick Regal
2014 Chevrolet Impala ECO
2013 Chevrolet Malibu ECO
with eAssist (RPO HP6)

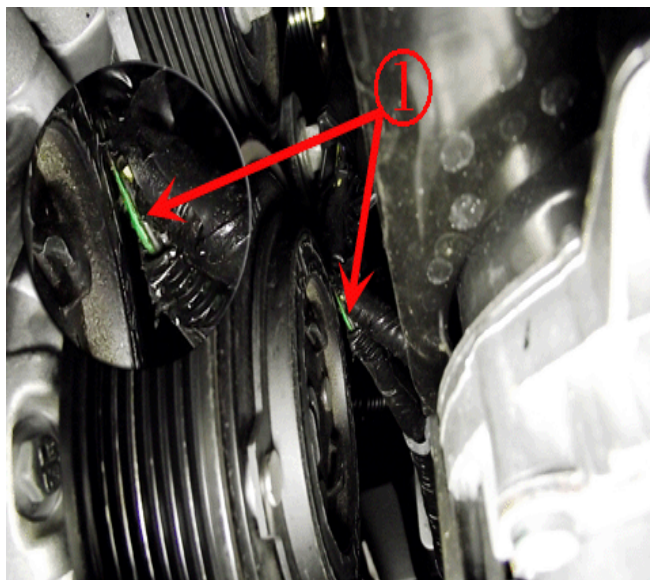
A customer or technician may comment that a buzz or hum noise is heard in the right front at times, possible when turning or driving straight down the road. They may also indicate the ABS MIL, Service Brake Assist Message or SES MIL may be displayed. The following DTCs may be set: C027B, C0040 and P0CBE.

Underhood wiring harness may be contacting the crank pulley, air conditioning compressor pulley or accessory drive belt due to misrouting or not secured properly.

Repair wiring as needed or replace the harness, correct routing and properly secure. Once wiring repairs are complete, confirm proper brake booster vacuum pump operation. The pump can be commanded on using GDS2. Clear all DTCs.
