Service Bulletin

Bulletin No.: PIC5720

Subject: Hum Or Buzz Noise Right Front Service Brake Assist Or ABS MIL

Models: 2012 - 2013 Buick Lacrosse eAssist
 2012 - 2013 Buick Regal eAssist
 2013 Chevrolet Malibu ECO eAssist
 With Hybrid Propulsion (RPO HP6)

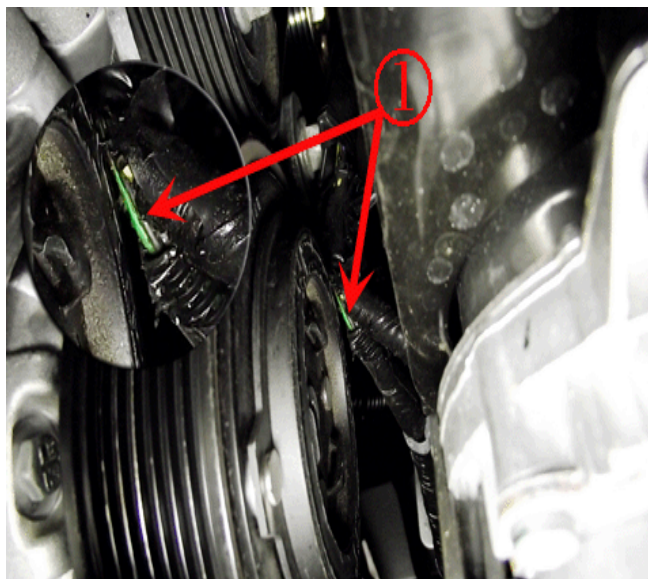
2905462

Concern: Forward lamp harness maybe contacting the crank pulley, air conditioning compressor pulley or accessory drive belt due to misrouting or not secured properly.

Repair wiring as needed or replace the forward lamp harness, correct routing and properly secure. Once wiring repairs are complete confirm proper brake booster vacuum pump operation. The pump can be commanded on using GDS2.
