SI B18 02 12  
Exhaust Systems

March 2013  
Technical Service

**Voluntary Emissions Recall Campaign 11E-A03: Check and/or Replace Emissions Monitoring Components**

E70 and E90 with the M57Y engine produced from January 2008 to September 2009

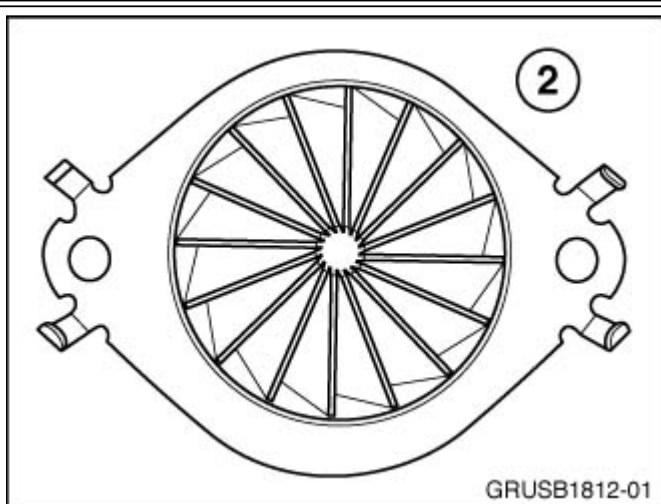
If the updated mixer has already been installed, it will have one set of fins (2). No replacement is necessary. Reinstall the SCR front pipe to the down pipe of the DPF.

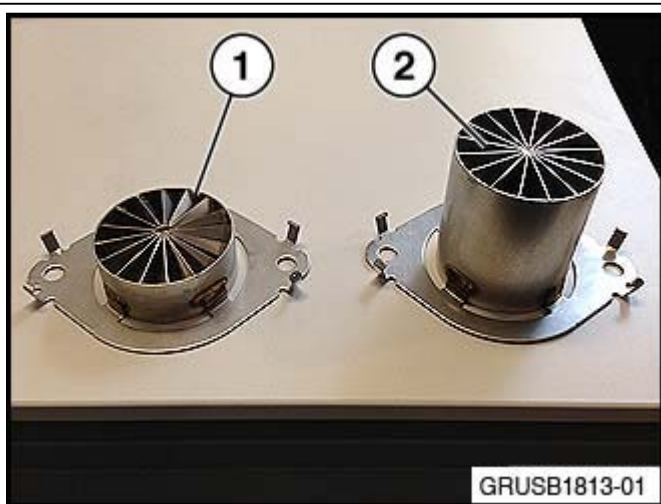
**NEW** The mixer for the E90 (1) is shorter than the E70 mixer (2).

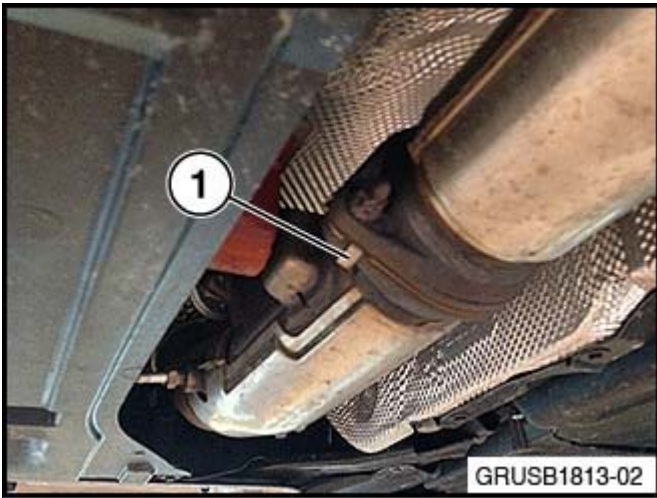
**NEW** The barrel of the E70 mixer points toward the front of the car. This is easily identified by the mixer tabs wrapped around the front pipe flange (1).

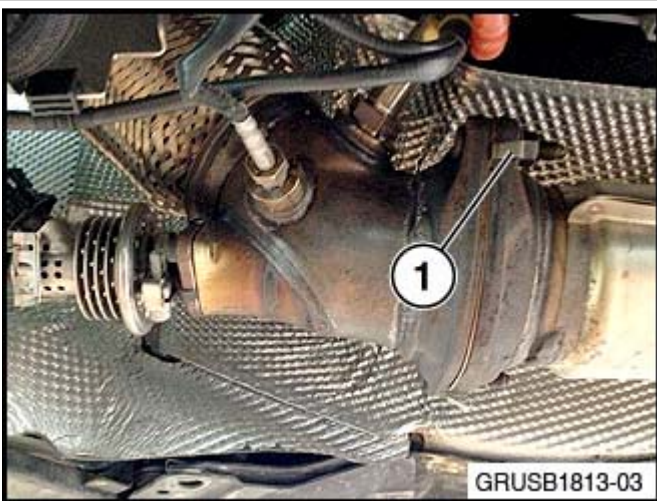
**NEW** The barrel of the E90 mixer points toward the rear of the car. This is identified by the mixer tabs wrapped around the flange on the SCR cat (1).

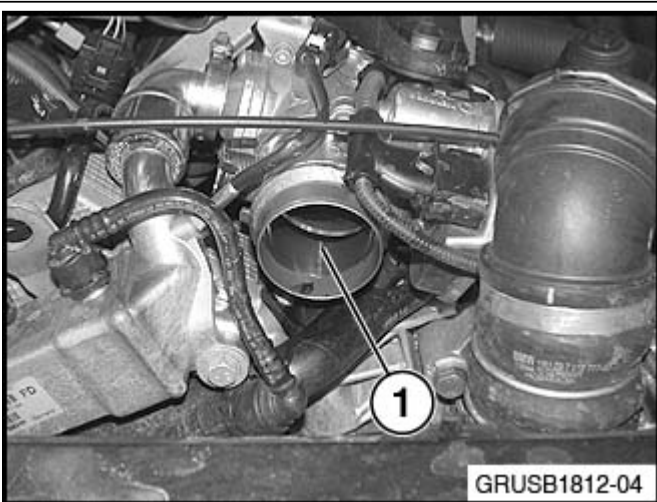
Remove the charge air pipe at the throttle (ignition off). Using a flashlight, look through the throttle (1) and inspect the EGR valve.

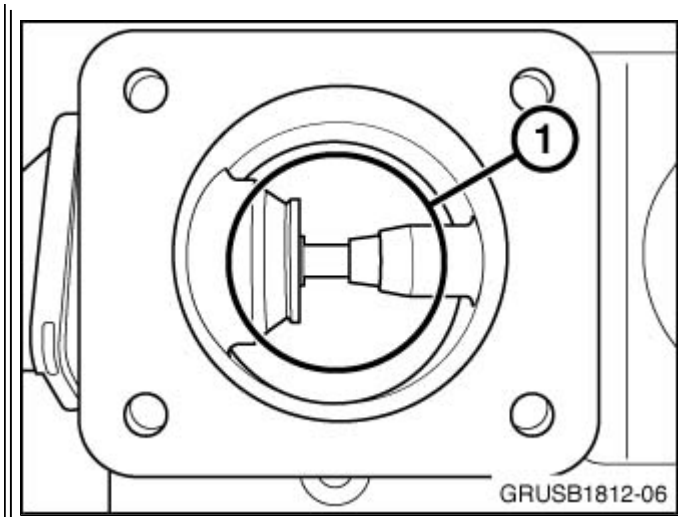
The updated EGR valve (P/N 11 71 8 517 217 or P/N 11 71 8 512 526) has the valve and seat directly in the airstream of the throttle (1). If this valve is installed, no further action is needed. Reinstall the charge air pipe.

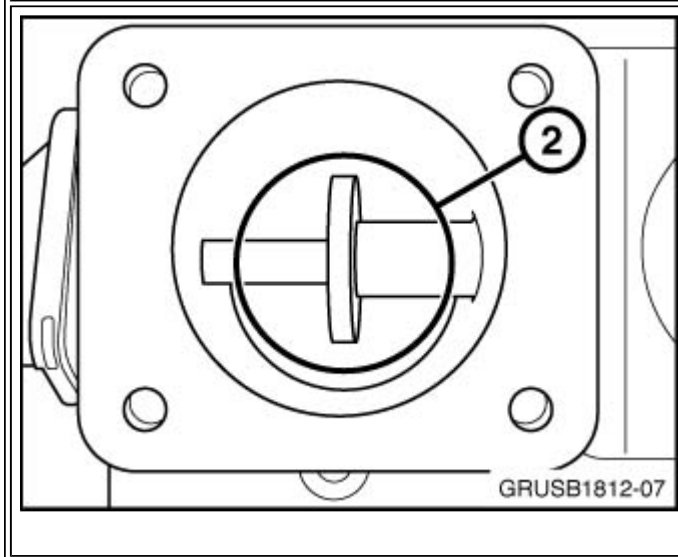
The original EGR valve has a diffuser in the airstream flow from the throttle (2). The valve for EGR actuation is seated further into the EGR airstream. Replace this valve with P/N 11 71 8 512 526 (Repair Instruction 11 71 501).

The DDE will also need to be programmed as part of the Recall. If the EGR valve is replaced, the DDE will need to be programmed after the new EGR valve is installed. This new software package contains the necessary software to adapt to the new EGR valve strategy.
