SI B18 02 12  
Exhaust Systems

**Voluntary Emissions Recall Campaign 11E-A03: Check and/or Replace Emissions Monitoring Components**

E70 and E90 with the M57Y engine produced from January 2008 to September 2009

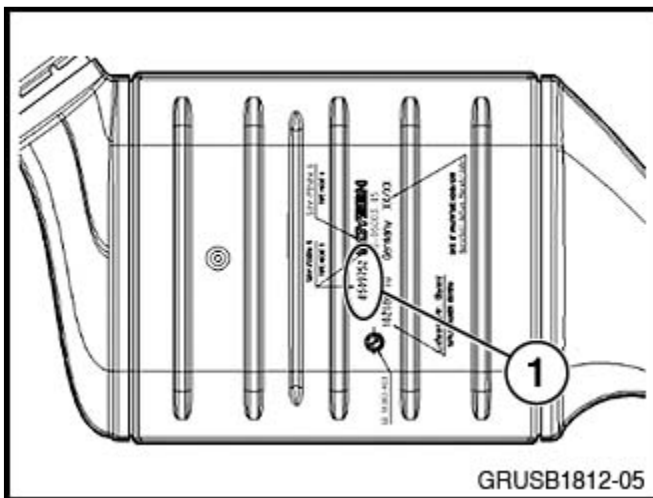
**NEW** Check the part number of the SCR catalyst (1). If the part number is not 18 30 8 509 752/753 (E70) or 18 30 8 509 749/750 (E90), the SCR catalyst will need to be replaced.

Note: If replacement is necessary, also perform the SCR mixer check/replacement at the same time.

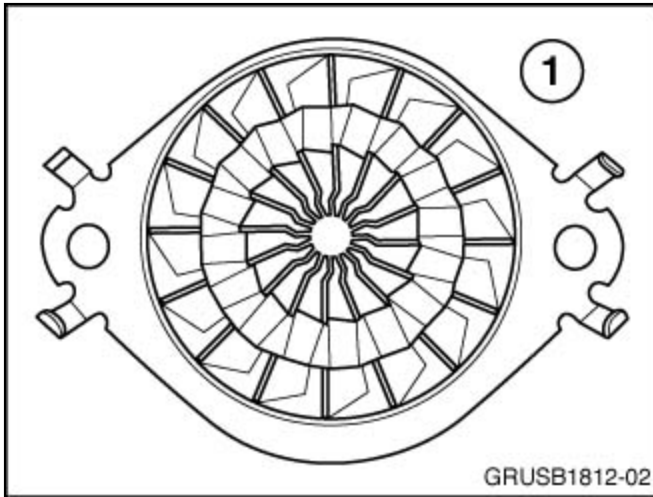
The original style mixer has a multiple

fin arrangement (1). This mixer will need to be replaced with P/N 18 30 8 513 445 (E70) or P/N 18 30 8 512 438 (E90).

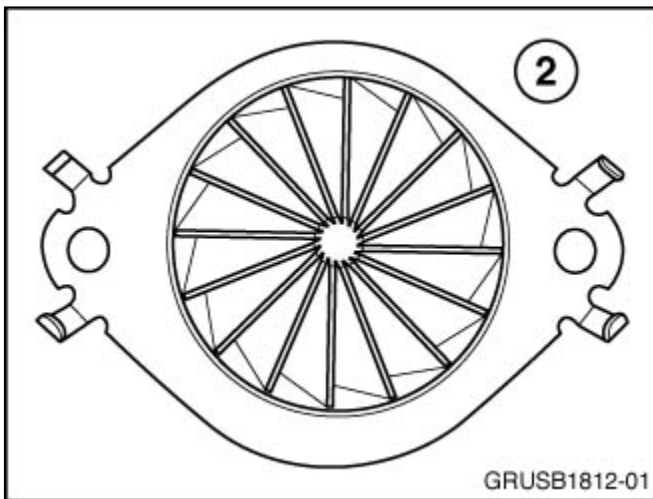
If the updated mixer has already been installed, it will have one set of fins (2). No replacement is necessary. Reinstall the SCR front pipe to the down pipe of the DPF.

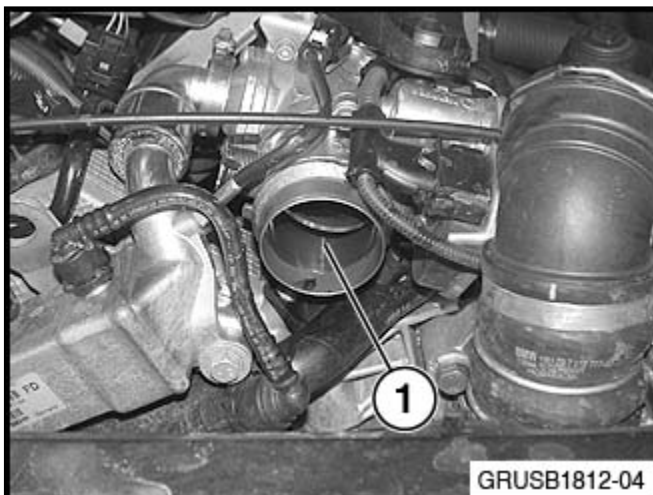
Remove the charge air pipe at the throttle (ignition off). Using a flashlight, look through the throttle (1) and inspect the EGR valve.

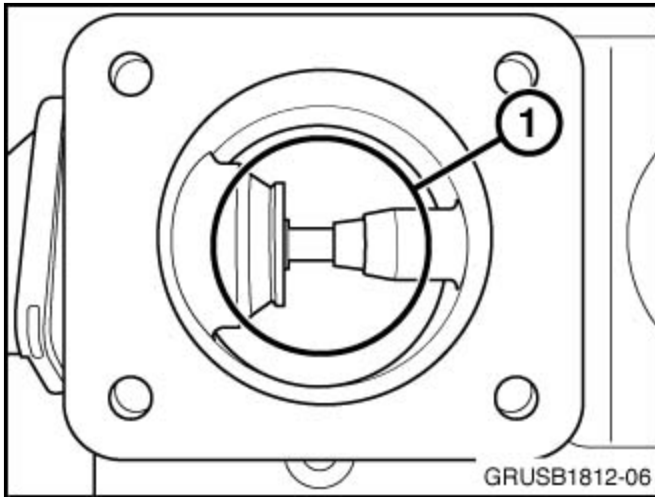
The updated EGR valve (P/N 11 71 8 517 217 or P/N 11 71 8 512 526) has the valve and seat directly in the airstream of the throttle (1). If this valve is installed, no further action is needed. Reinstall the charge air pipe.

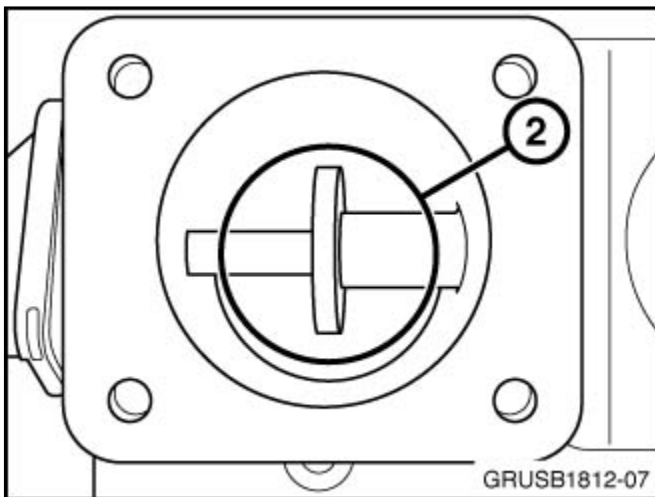
The original EGR valve has a diffuser in the airstream flow from the throttle (2). The valve for EGR actuation is seated further into the EGR airstream. Replace this valve with P/N 11 71 8 512 526 (Repair Instruction 11 71 501).

The DDE will also need to be programmed as part of the Recall. If the EGR valve is replaced, the DDE will need to be programmed after the new EGR valve is installed. This new software package contains the necessary software to adapt to the new EGR valve strategy.

Program the vehicle using ISTA/P 2.46.3 or later.
