# Service Bulletin

**SUBJECT:** Special Coverage Adjustment – Throttle Position Sensor Replacement

**MODELS:** 2008-2010 Cadillac Escalade, Escalade ESV, Escalade EXT  
2008-2009 Chevrolet TrailBlazer  
2008-2010 Chevrolet Avalanche, Express, Silverado, Suburban, Tahoe  
2009-2010 Chevrolet Colorado  
2008-2009 GMC Envoy  
2008-2010 GMC Savana, Sierra, Yukon, Yukon XL  
2009-2010 GMC Canyon  
2008-2009 HUMMER H2  
2008-2010 HUMMER H3  
2009-2010 HUMMER H3T  
Equipped with V8 Engine (LFA, LY2, L20, LMG, LC9, LH6, LMF, LH8, LH9, L76, LS2, LY5, LY6, L92, L96, LZ1, L94, L9H)

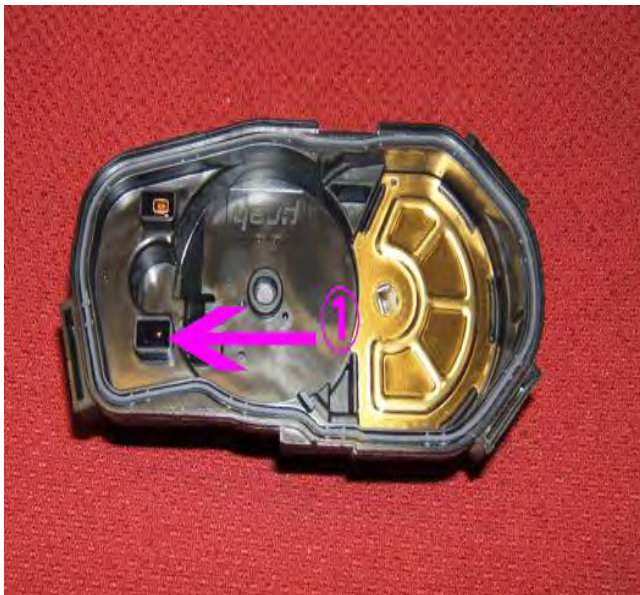
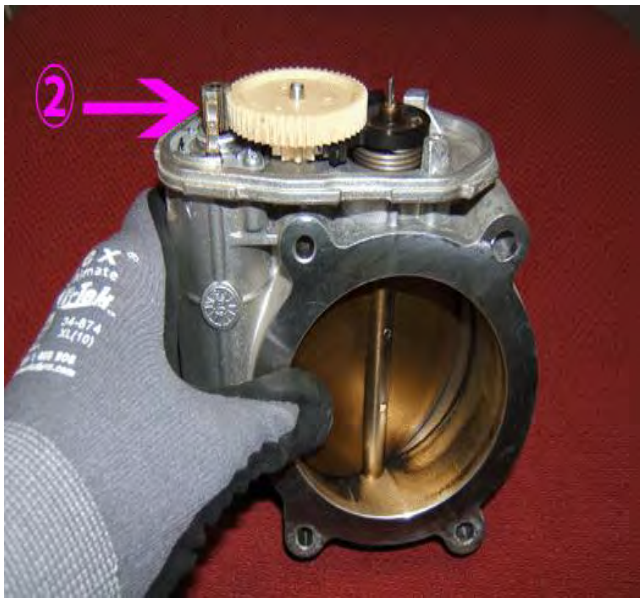
**Note:** If one or both of the TP sensor cover female throttle actuator motor terminals HAVE BEEN retained on the throttle actuator motor male terminals (2), remove and discard those female terminals.

14. Observe the TP sensor cover for missing female throttle actuator motor terminals (1). Verify that the female throttle actuator motor terminals HAVE REMAINED in the TP sensor cover and HAVE NOT been retained on the throttle actuator motor male terminals (2). Discard the old TP sensor cover, gasket and terminals.
15. Remove the new TP sensor cover from the protective shipping wrapper.

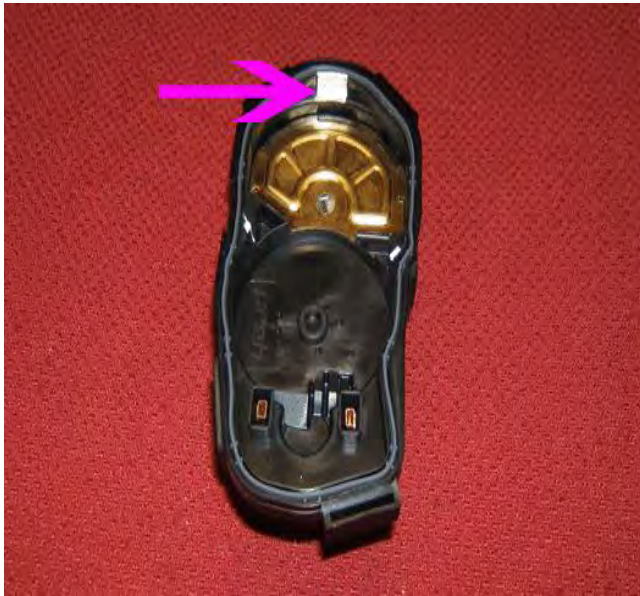
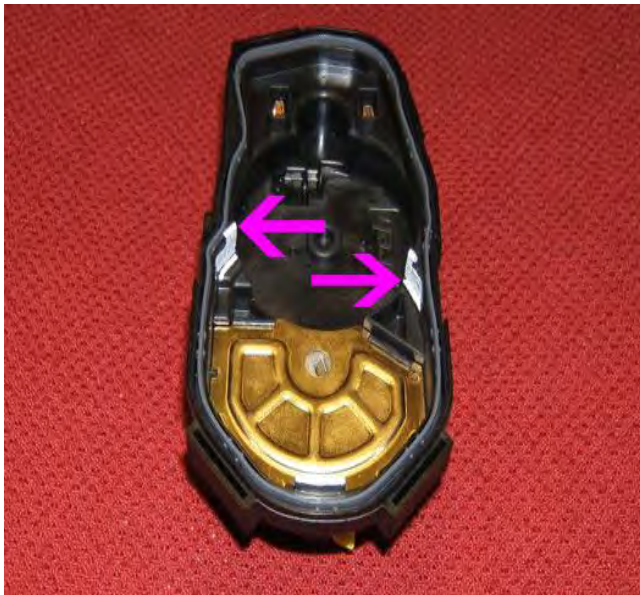
2699007

- 18. Verify that all three of the TP sensor cover alignment tabs are present and are not damaged.
- 19. Grasp and hold the throttle body in the previously hand held upward position. Lightly depress the intermediate gear to verify that it is fully seated and the gears are engaged.
