Integration Relay - Poor Ground

Service Category Power Source/Network

Section Power Distribution

YEAR(S)	MODEL(S)	ADDITIONAL INFORMATION
2012 – 2013	Camry HV	
2012 – 2013	Camry

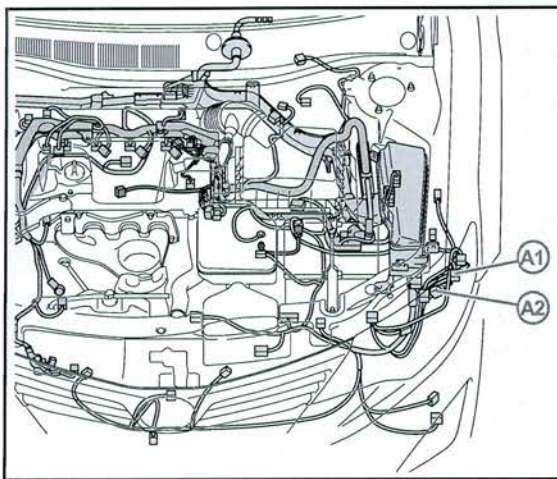
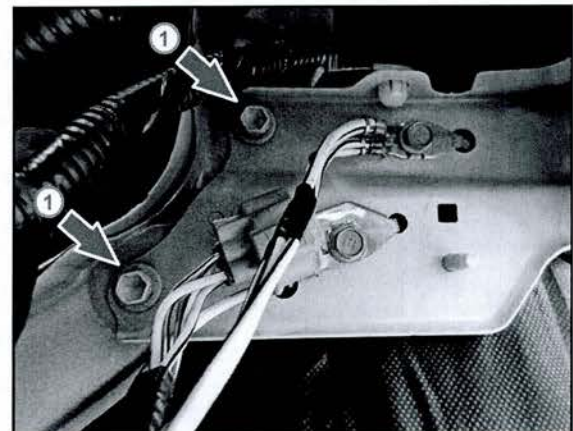
Figure 1.

1. Has the vehicle had body work or the A1/A2 grounds, or apron mounting bolts disconnected?
 - **YES / UNSURE** — Continue to step 2.
 - **NO** — This bulletin does NOT apply. Continue diagnosis using the applicable Repair Manual.

1	Apron Bolts
---	-------------

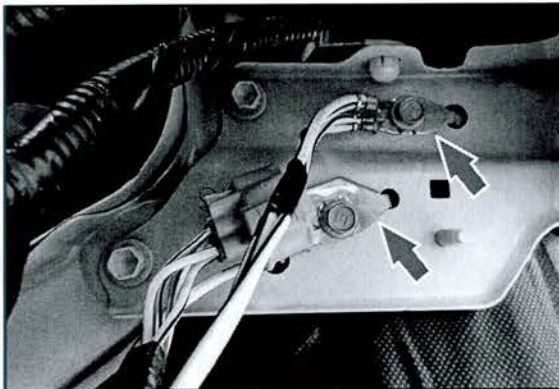
Figure 3.

7. Perform voltage drop test* from the two left fender bracket ground wire eyelet tabs to body ground (see Figure 3).

8. Is voltage drop from each ground location less than 0.2 volts?
 - **YES** — This bulletin does NOT apply. Continue diagnosis using the applicable Repair Manual.
 - **NO** — A voltage drop of 0.2 volts or more from either of the ground locations may indicate poor continuity in the ground circuit. Proceed to step 9.
9. With battery disconnected, remove the left hand fender bracket from the apron for inspection.

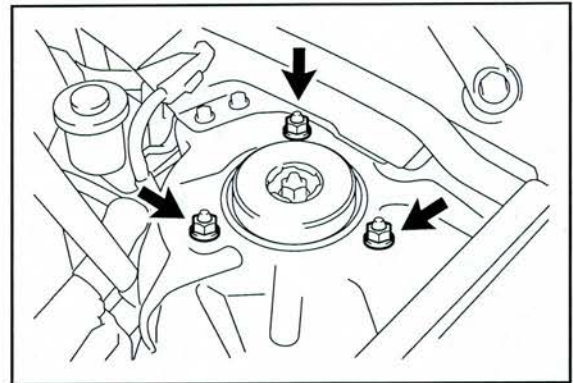
Figure 4.

- A. Use a left front strut tower mounting bolt as a good body ground (see Figure 4).
- B. To perform voltage drop test, connect the negative lead of the DVOM to the strut tower bolt, and the positive lead to the ground wire eyelet tab.

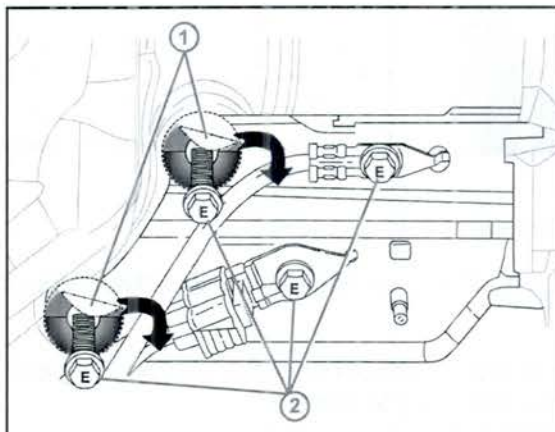
Figure 5.

- Ground bolts are "E" bolts (see Figures 5 and 7).
- Apron bolts should be "E" bolts if left hand fender bracket has been replaced (see Figures 5 and 7).
- The area around the bracket to apron mounting bolt holes (see Figure 6) is free of paint.
- The area around the apron mounting bolt holes do not show masking tape or painted masking tape (see Figures 5 and 6).

1	Confirm Green Masking Tape Is Removed
2	Confirm "E" Bolts Are Installed

- **NO** — Replace the left hand fender bracket.
- **YES** — Remove the tape or paint and continue to step 12.

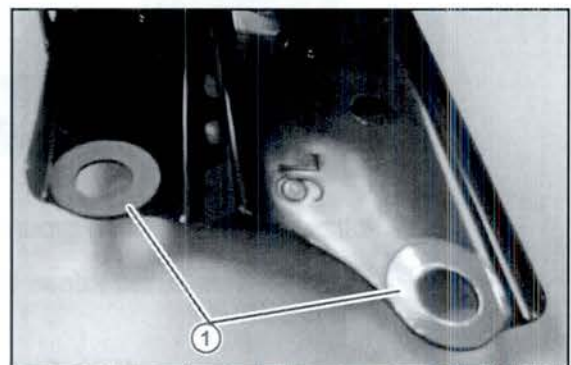
Figure 6.

1	Masking Tape — REMOVE After Painting, NO Paint in This Area
---	---

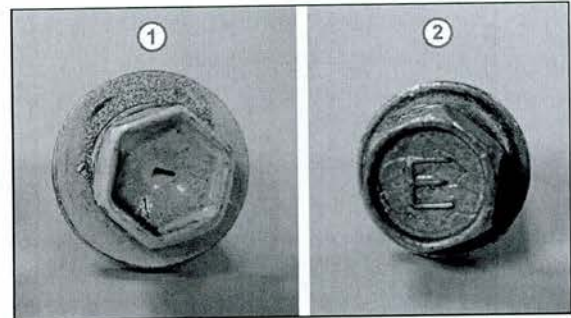
Figure 7.

- It is important that the bracket to apron mounting bolts/washers are free of paint on the front portion of the bracket.
- The new part number bracket comes with instructions that should be followed carefully when replacing.
- The new bracket also comes with green tape around the apron mounting bolts to protect it during the painting phase (see Figures 5 and 6). This green masking tape MUST be removed in order for the bracket to be properly installed on the vehicle.
- The new bracket includes new apron "E" mounting bolts. It is important that the new "E" bolts are used and are torqued properly. See Figure 7 on how to identify new bolts.

1	Old Bolt: DO NOT USE or Reuse These Bolts
2	NEW "E" Bolt

Torque: Ground Bolts:
6.9 – 9.8 N*m (70 – 100 kgf*cm,
5.1 – 7.2 ft*lbf)

Torque: Bracket to Apron Bolts:
3.9 – 8.8 N*m (40 – 90 kgf*cm,
2.8 – 6.5 ft*lbf)

12. Once areas are repaired and secured with new "E" bolts, replace the Engine Room Junction Block Assembly.
