T-SB-0179-12

September 19, 2012

Integration Relay - Poor Ground

YEAR(S)	MODEL(S)	ADDITIONAL INFORMATION
2012	Camry HV	
2012	Camry

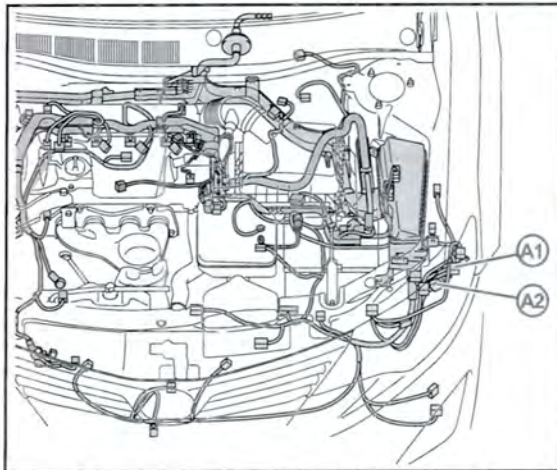
Figure 1.

At NO time should the battery be connected when any ground attachments (A1, A2, apron bolts, or front side panel bracket) are loose.

- Has the vehicle had body work or the A1/A2 grounds, or apron mounting bolts disconnected?
 - YES / UNSURE** — Continue to step 2.
 - NO** — This bulletin does NOT apply. Continue diagnosis using the applicable Repair Manual.

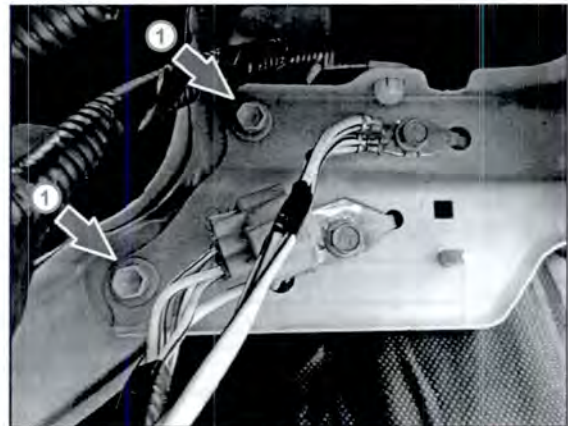
Figure 2.

1 Apron Bolts

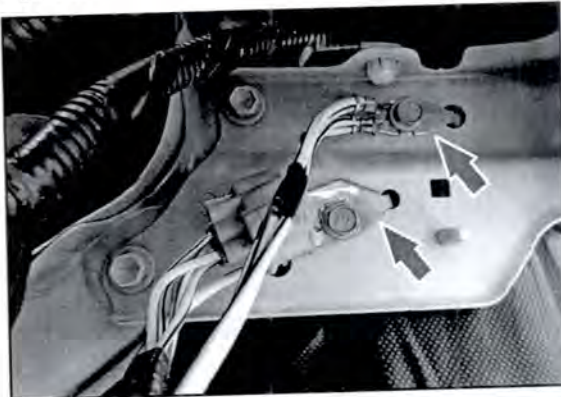
Figure 3.

7. Perform voltage drop test* from the two left fender bracket ground wire eyelet tabs to body ground (see Figure 3).

8. Is voltage drop from each ground location less than 0.2 volts?
 - **YES** — This bulletin does NOT apply. Continue diagnosis using the applicable Repair Manual.
 - **NO** — A voltage drop of 0.2 volts or more from either of the ground locations may indicate poor continuity in the ground circuit. Proceed to step 9.
9. With battery disconnected, remove the left hand fender bracket from the apron for inspection.

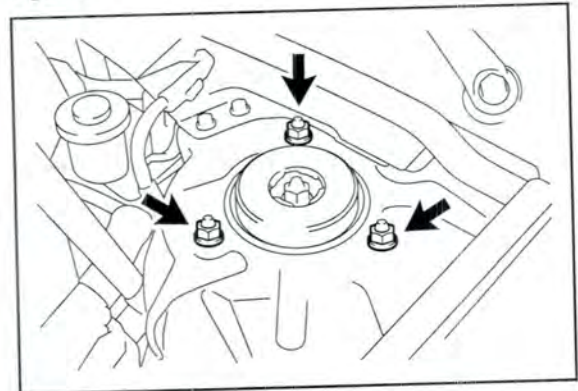
Figure 4.

- A. Use a left front strut tower mounting bolt as a good body ground (see Figure 4).
- B. To perform voltage drop test, connect the negative lead of the DVOM to the strut tower bolt, and the positive lead to the ground wire eyelet tab.

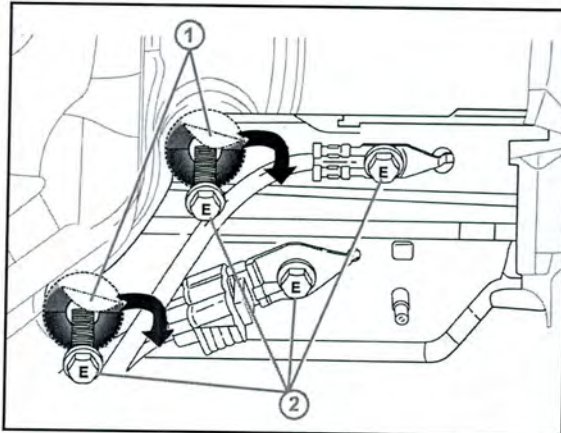
Figure 5.

- Ground bolts are "E" bolts (see Figures 5 and 7).
- Apron bolts should be "E" bolts if left hand fender bracket has been replaced (see Figures 5 and 7).
- The area around the bracket to apron mounting bolt holes (see Figure 6) is free of paint.
- The area around the apron mounting bolt holes do not show masking tape or painted masking tape (see Figures 5 and 6).

1	Confirm Green Masking Tape Is Removed
2	Confirm "E" Bolts Are Installed

- **NO** — Replace the left hand fender bracket.
- **YES** — Remove the tape or paint and continue to step 12.

12. Once areas are repaired and secured with new "E" bolts, replace the Engine Room Junction Block Assembly.

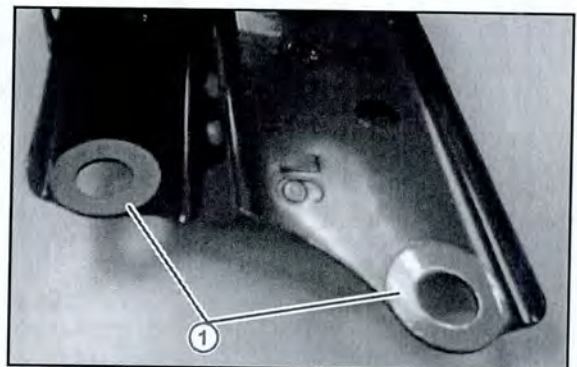
Figure 6.

1	Masking Tape — REMOVE After Painting, NO Paint in This Area
---	---

- It is important that the bracket to apron mounting bolts/washers are free of paint on the front portion of the bracket.
- The new part number bracket comes with instructions that should be followed carefully when replacing.
- The new bracket also comes with green tape around the apron mounting bolts to protect it during the painting phase (see Figures 5 and 6). This green masking tape MUST be removed in order for the bracket to be properly installed on the vehicle.
- The new bracket includes new apron "E" mounting bolts. It is important that the new "E" bolts are used and are torqued properly. See Figure 7 on how to identify new bolts.

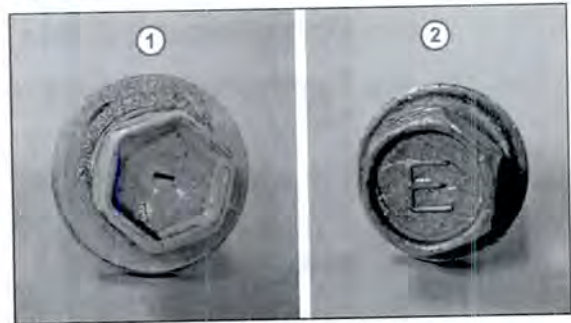
Figure 7.

1	Old Bolt: DO NOT USE or Reuse These Bolts
2	NEW "E" Bolt

Torque: Ground Bolts:
 6.9 – 9.8 N*m (70 – 100 kgf*cm,
 5.1 – 7.2 ft*lbf)

Torque: Bracket to Apron Bolts:
 3.9 – 8.8 N*m (40 – 90 kgf*cm,
 2.8 – 6.5 ft*lbf)
