**SB-10049579-7351**

**Title:** Horton Stratis Fan Hub Diagnostics

**Applies To:** Prostar, LoneStar, TranStar, WorkStar, IBB

Horton VMaster Ultra (Stratis) Viscous Fan Drive Troubleshooting Guide  
 Engine feature code 12THX

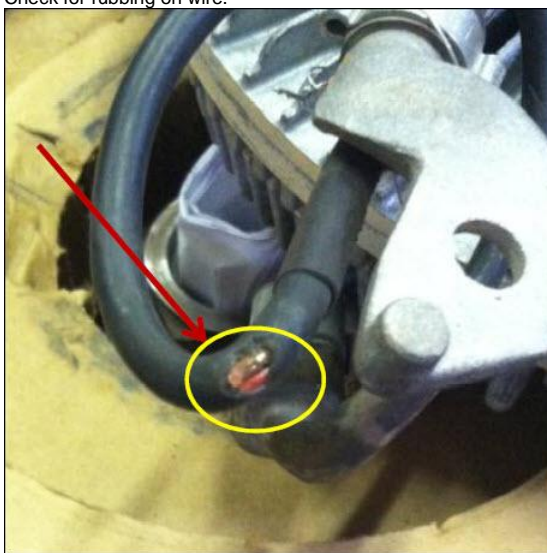
1. Visual Inspection
  - Check for rubbing on wire.

- If rubbing is present and inside wires are visible, but no copper is visible apply heat shrink over the harness.
- If copper can be seen, check to see if it is only one single wire, or multiple wires.
  - If it is one wire, place electrical tape over the wire.
  - Using 4:1 heat shrink will allow the heat shrink tubing to pass over the connector as shown. P/N: ZBJE849565 or equivalent

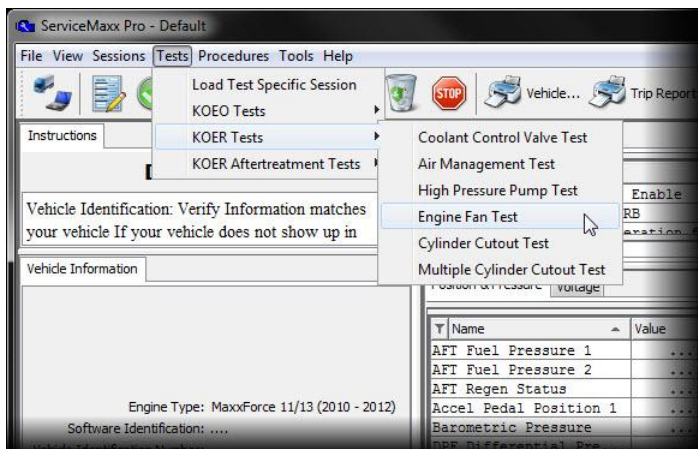
- o Manually apply 12 volts to Pin 3 and Ground to Pin 1, checking fan operation. It should be disengaged. Some surging may be normal depending on the temperature of the fan hub.
- o Bring engine to operating temperature. 175°F-180°F.
- o Connect with ServiceMaxx and perform "Engine Fan Test".
- o The entire test (5 test points) must be recorded and submitted with the warranty claim.
- o If the visual, electrical and functional tests all check OK, the fan hub is not the cause of the customer complaint. Do NOT replace the fan hub.
