SERVICE BULLETIN

Classification: EC12-034a	Reference: NTB13-001a	Date: February 27, 2013
-------------------------------------	---------------------------------	-----------------------------------

2013 SENTRA; ENGINE HAS HESITATION OR STOPS RUNNING AT IDLE OR VERY LOW SPEEDS

APPLIED VEHICLE: 2013 Sentra (B17)

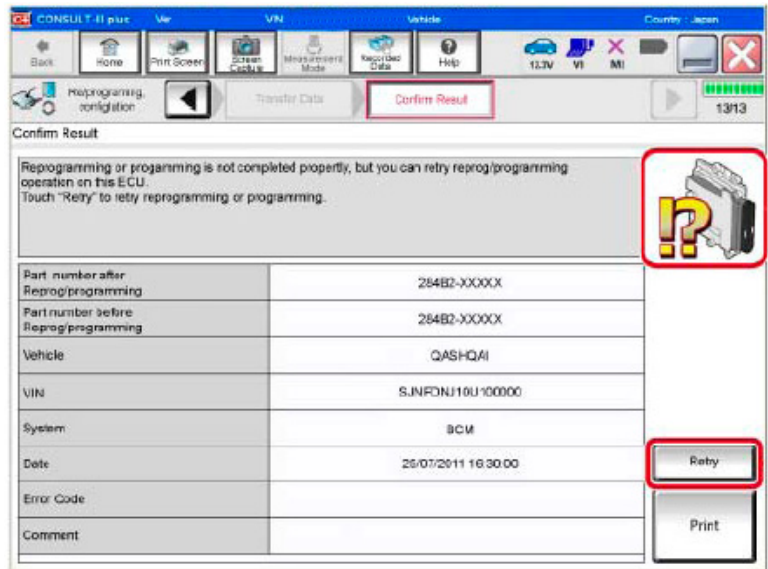
Figure 5

If reprogramming does not complete and the “!?” icon displays as shown in Figure 5:

- Check battery voltage (12.0–15.5 V).
- Ignition is ON, engine OFF.
- External Bluetooth® devices are OFF.
- All electrical loads are OFF.
- **Select retry and follow the on screen instructions.**
- “Retry” may not go through on first attempt and can be selected more than once.

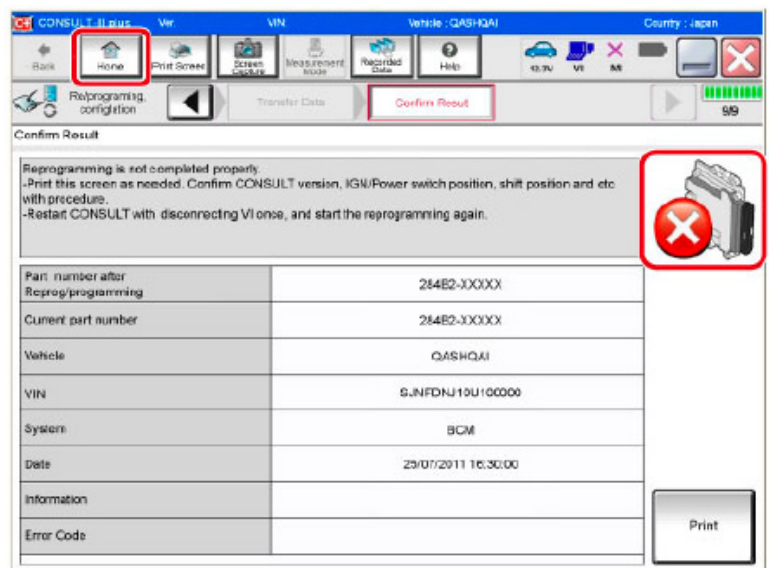
Figure 6

If reprogramming does not complete and the “X” icon displays as shown in Figure 6:

- Check battery voltage (12.0 – 15.5 V).
- CONSULT A/C adapter is plugged in.
- Ignition is ON, engine OFF.
- Transmission is in Park.
- All C-III plus / VI cables are securely connected.
- All C-III plus updates are installed.
- **Select Home, and restart the reprogram procedure from the beginning.**
