GRAND VITARA

Technical Bulletin

Section Title: Restraints
 TSB No. TS 05 01140R

SUBJECT: COUNTER-MEASURE PROCEDURE FOR DTC B1318
MODEL(S): GRAND VITARA (JB424W/JB632W)
YEAR: 2009
VIN BREAKS: JB424W: ~JS3TD042494101207 May 26, 2009
 JB632W: ~JS3TD148494100441 May 28, 2009

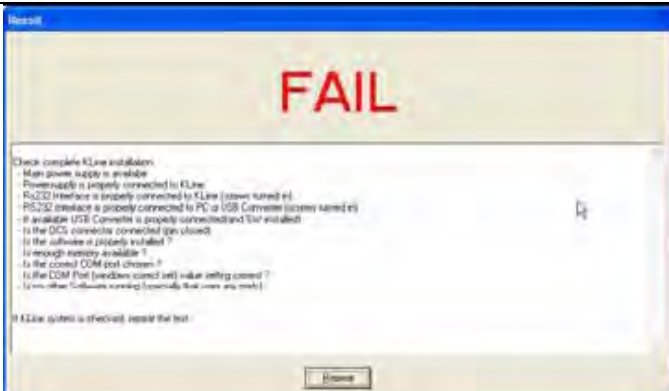
<p>If the “FAIL” window shown to the left has opened, check reprogramming tools, connections, and PC setting by referring to the check list below. Click the “Repeat” button, and retry the reprogramming.</p> <p style="text-align: center;">Note: Reprogramming can be retried twice.</p>

- Main power supply is available and properly connected to K-Line interface cable.
- RS232C Interface cable is properly connected to K-Line cable (screws tightened).
- RS232C Interface cable is properly connected to PC or USB Converter (screws turned in).
- If necessary RS232C - USB Converter is properly connected.
- If necessary USB driver is properly installed.
- OCS connector is properly connected.
- Correct COM port is used.
- No other software is running (specially that uses any port).

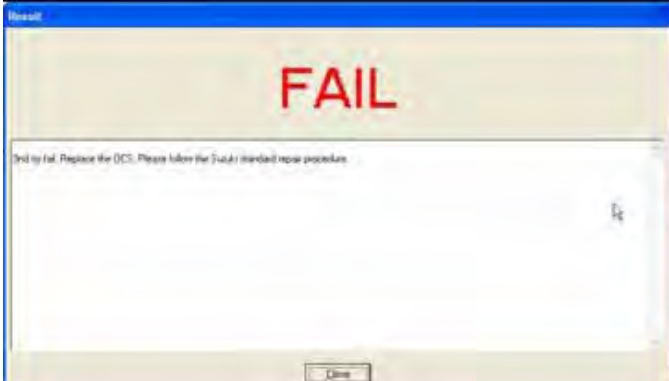
<p>If the “FAIL” window shown to the left has opened, OCS reprogramming is impossible. In most cases the incorrect com port has been set. Recheck the com port settings and make a second attempt to reprogram the OCS. If this “FAIL” screen continues to appear, click the “CLOSE” button and then replace the OCS/Seat Cushion Assembly referring to the service manual.</p>
