Technical Bulletin

Section Title: Restraints
 TSB No. TS 01 02260R2

SUBJECT: COUNTER-MEASURE PROCEDURE FOR DTC B1318
MODEL(S): SX-4 (RW420)
YEAR: ALL MY 2009 (except where VIN breaks indicate production change)
VIN BREAKS: ~JS2YA413396202055 May 27, 2009
 ~JS2YA411596200564 May 27, 2009
 ~JS2YB413496206032 May 26, 2009
 ~JS2YB417096203342 May 27, 2009
 ~JS2YC415896200927 May 26, 2009
 ~JS2YC412696204318 May 27, 2009

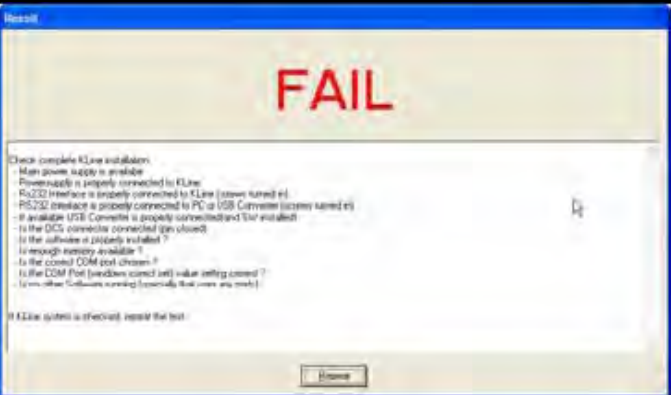
<p>If the “FAIL” window shown to the left has opened, check reprogramming tools, connections, and PC setting by referring to the check list below. Click the “Repeat” button, and retry the reprogramming.</p> <p style="text-align: center;">Note: Reprogramming can be retried twice.</p>

- Main power supply is available and properly connected to K-Line interface cable.
- RS232C Interface cable is properly connected to K-Line cable (screws tightened).
- RS232C Interface cable is properly connected to PC or USB Converter (screws turned in).
- If necessary RS232C - USB Converter is properly connected.
- If necessary USB driver is properly installed.
- OCS connector is properly connected.
- Correct COM port is used.
- No other software is running (specially that uses any port).

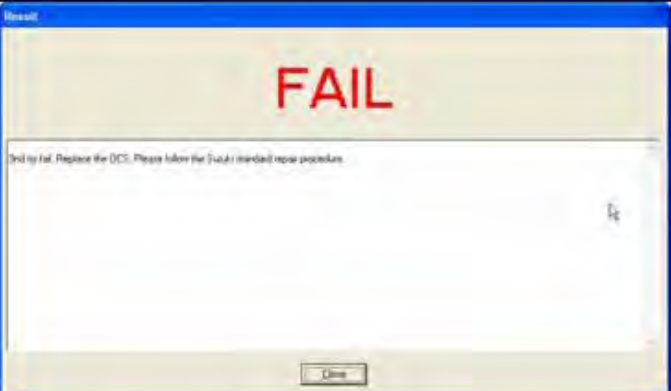
<p>If the “FAIL” window shown to the left has opened, OCS reprogramming is impossible. In most cases the incorrect com port has been set. Recheck the com port settings and make a second attempt to reprogram the OCS. If this “FAIL” screen continues to appear, click the “CLOSE” button and then replace the OCS/Seat Cushion Assembly referring to the service manual.</p>
