SERVICE CAMPAIGN BULLETIN

NTB13-002

VOLUNTARY SERVICE CAMPAIGN 2013 PATHFINDER TCM REPROGRAM

APPLIED VEHICLES: 2013 Pathfinder (R52)

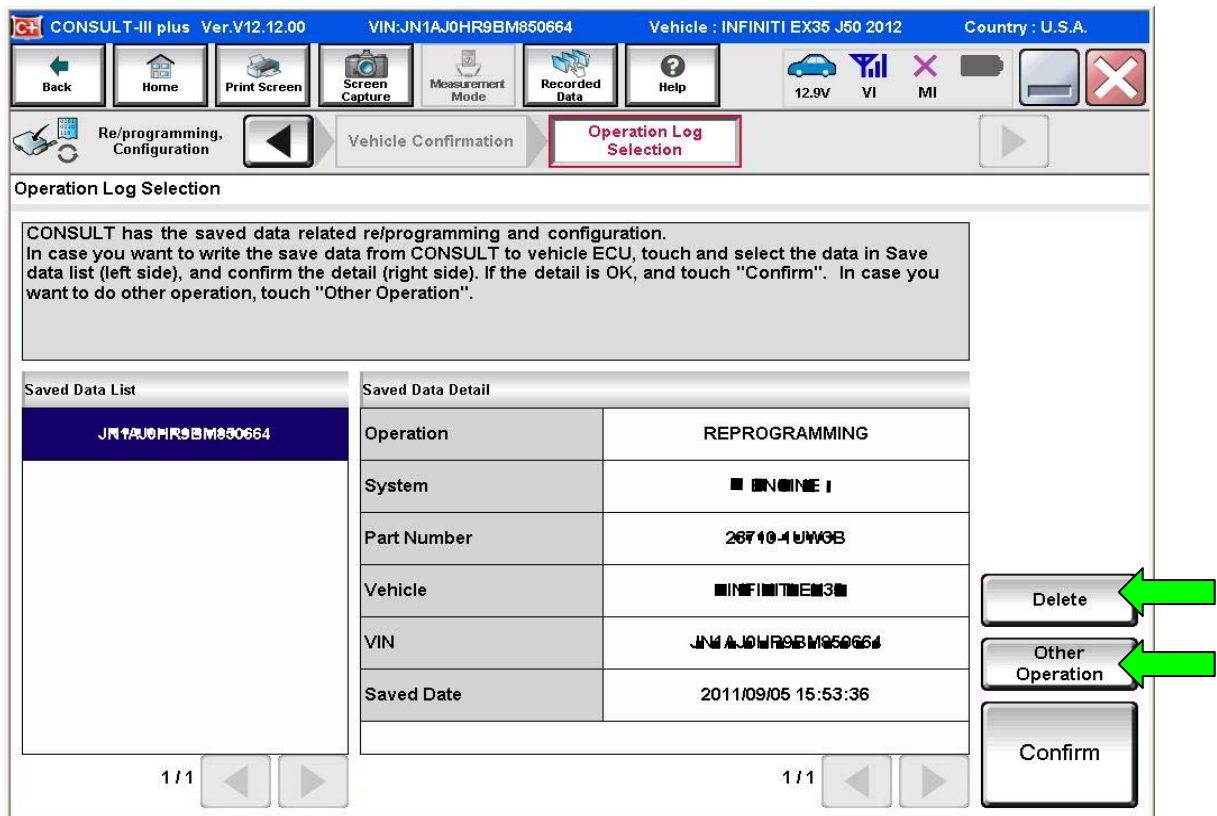
Figure 1A

During the initial “Reprogramming Confirmation” set-up, if you get this screen (Figure 1A):

NOTE: If reprogramming does not complete, this screen can display for reprogramming recovery. Do not select Delete if this screen displays during reprogram recovery.

1. Select **Delete**, then
2. Select **Other Operation**, then
3. Continue with the reprogramming procedure.

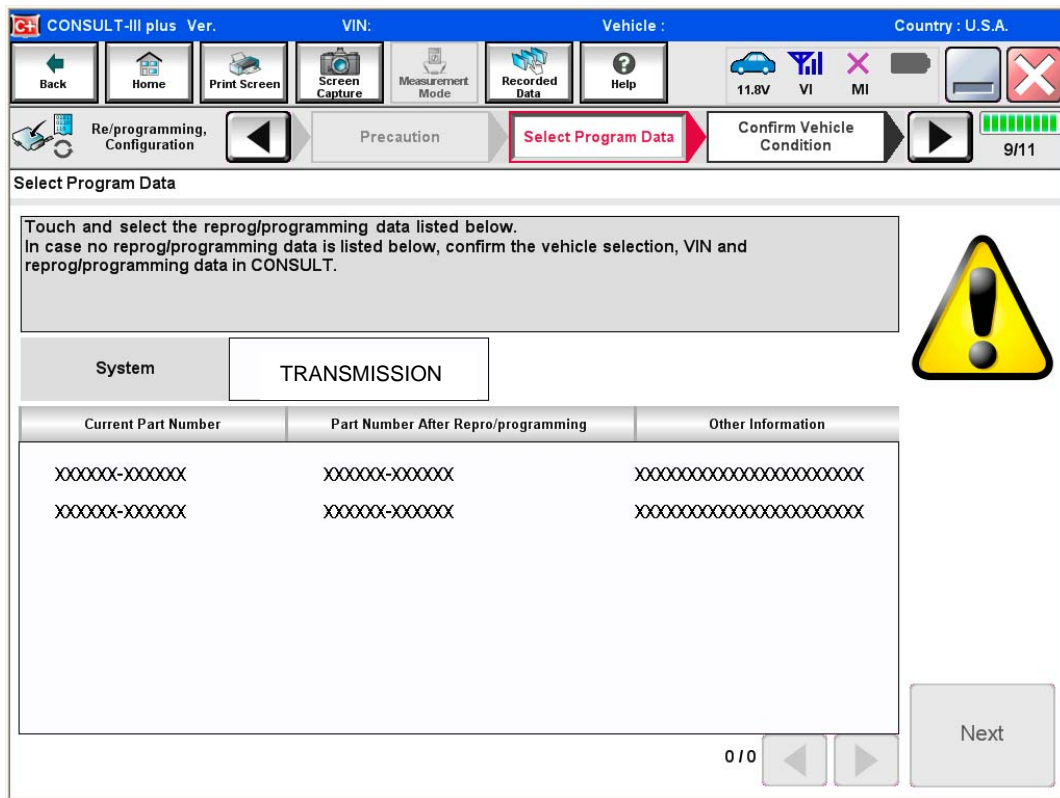
- In some cases, more than one new P/N for reprogramming is available.
 - In that case, the screen in Figure 3 displays.
 - Select and use the reprogramming option that **does not** have the message “Caution! Use ONLY with NTBXX-XXX”.
- If you get this screen and it is blank (no reprogramming listed), it means there is no reprogramming available for this vehicle.
