Rear Axle Nut Washer Installation

Classification	Repair Bulletin - Level II	Section/Group	31 - Suspension	Country/Region	North America
Year	2012	Model	Model S	Version	All

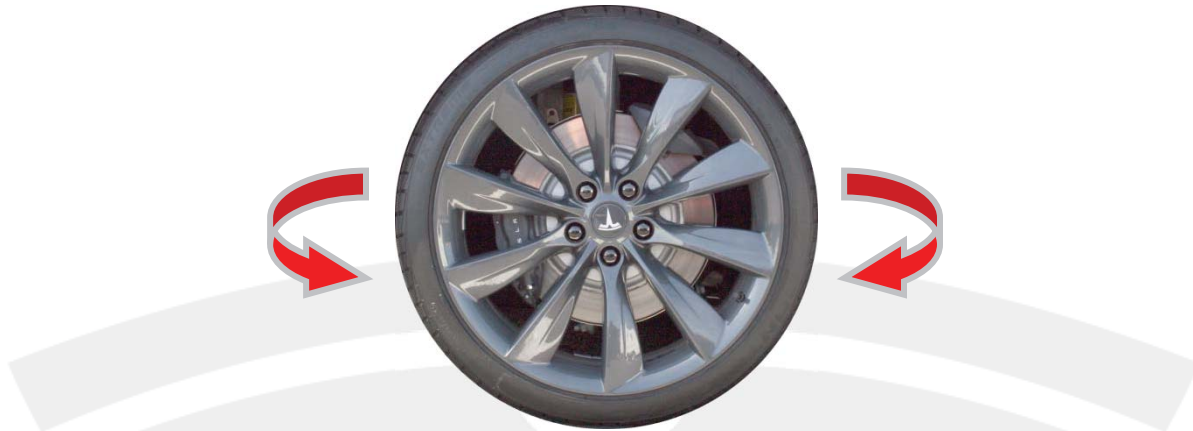
Figure 1

6. Face one of the rear wheels. Grasp the wheel/tire assembly with both hands, at the left and right edges. Check for free play by trying to rock the wheel from side to side (Figure 1).

8. Repeat steps 6 and 7 on the other rear wheel.
9. If no axial play is noted, continue to the Inspecting the Axle Nut section of this document. If axial play is noted, skip to the Replacing Rear Wheel Hub and Bearing Assembly section of this document.

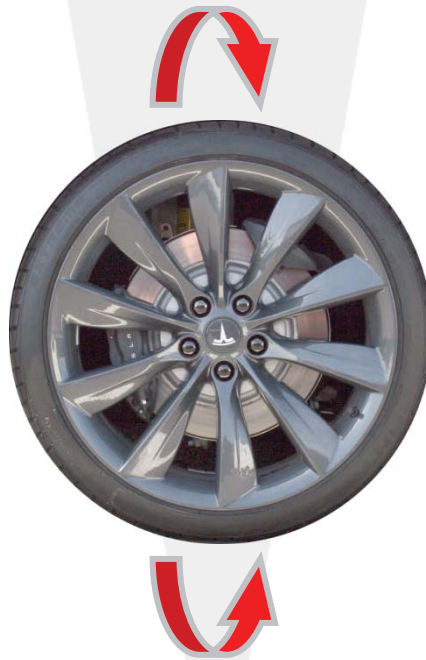
Figure 2

7. Grasp the wheel/tire at the top and bottom. Check for free play by trying to rock the wheel up and down (Figure 2).

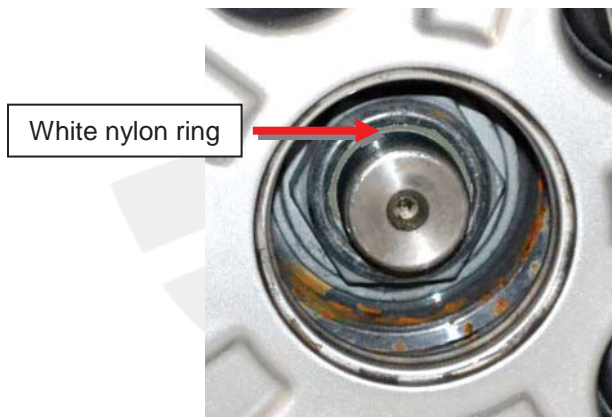
Figure 3 (Old axle nut)

1. Use a small trim tool or other non-marring pry tool to remove the center cap from one of the rear wheels.
2. Inspect the axle nut. If the axle nut has a visible white nylon ring, locking washers and new axle nuts need to be installed (Figure 3). Continue this procedure. If there is no white nylon ring, the nut is up to date and the lock washer is already installed; no further action is required (Figure 4).

1. Shift into Park to engage the parking brake.
2. Remove and discard the left and right rear axle nuts.
3. Install wedge-lock washers (Figure 5) on the left and right axle shaft splines.

4. Install new axle nuts on the left and right rear axle shaft splines. Torque the axle nuts to 245 Nm.
