Service Bulletin

SUBJECT: Service Update for Inventory and Customer Vehicles
Turbo-to-Exhaust Manifold Joint May Relax
Expires with Base Warranty

MODELS: 2013 Cadillac ATS
2013 Chevrolet Malibu
Equipped with 2.0L Engine (LTG)

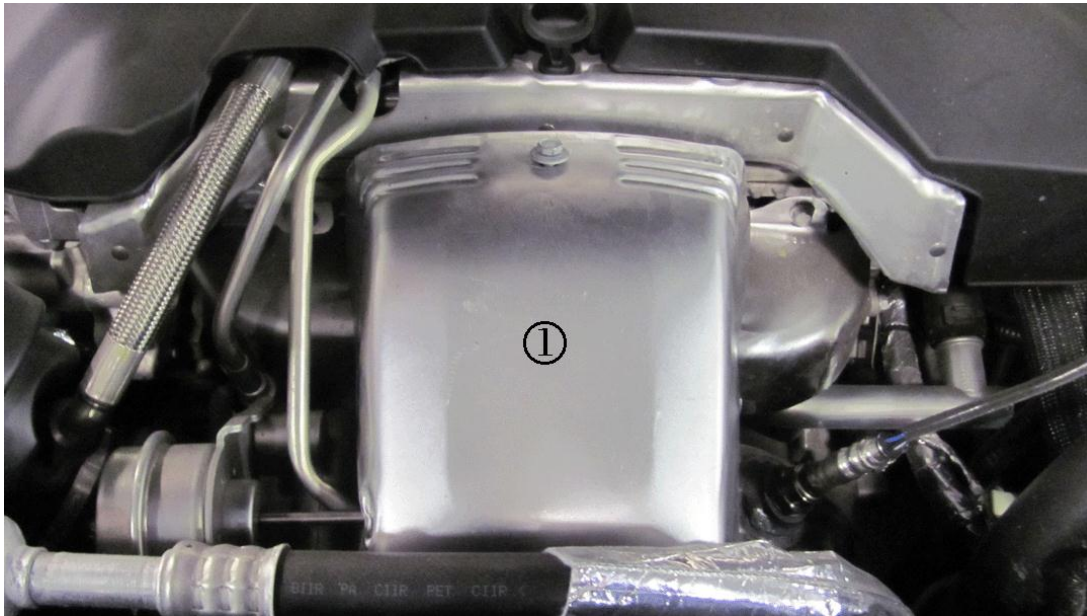
3268362

2. Locate the turbocharger exhaust heat shield (1).

3. Remove the turbocharger exhaust heat shield. Refer to *Exhaust Manifold Heat Shield Replacement (LTG)* in SI.
