# Service Bulletin

**SUBJECT:** Service Update for Inventory and Customer Vehicles  
Turbo-to-Exhaust Manifold Joint May Relax  
Expires with Base Warranty

**MODELS:** 2013 Cadillac ATS  
2013 Chevrolet Malibu  
Equipped with 2.0L Engine (LTG)

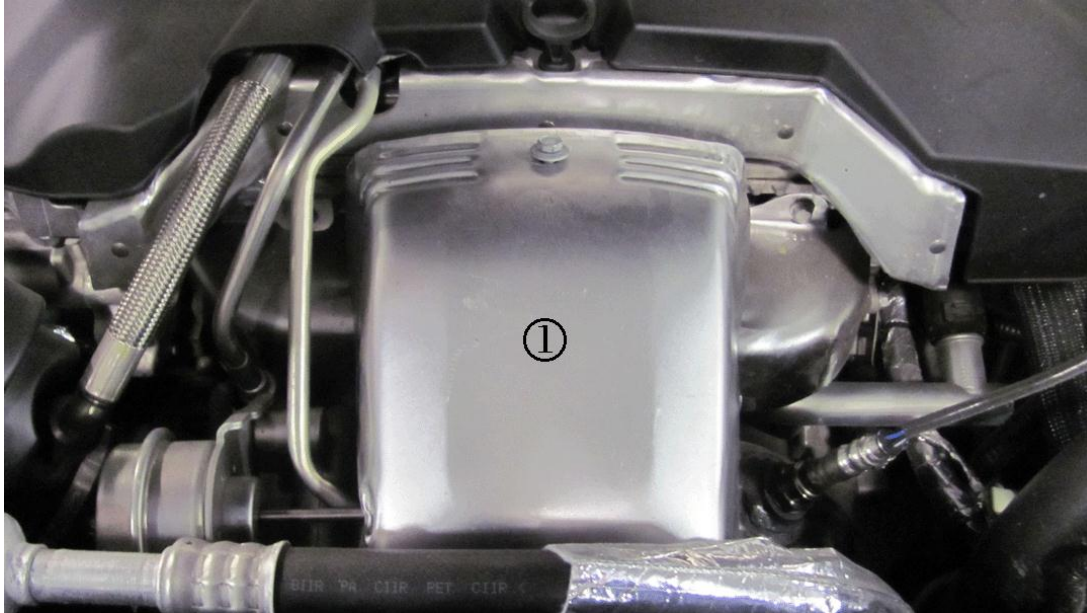
3268362

**Chevrolet Malibu shown for illustration purposes, Cadillac ATS similar.**

2. Locate the turbocharger exhaust heat shield (1).

3. Remove the turbocharger exhaust heat shield. Refer to *Exhaust Manifold Heat Shield Replacement (LTG)* in SI.

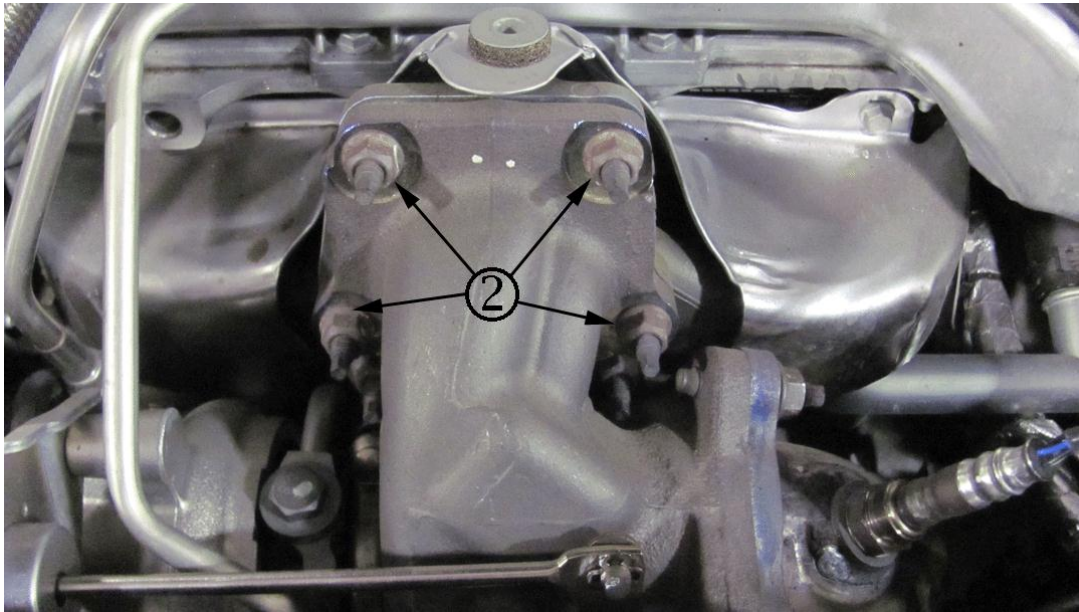
3268366

**Chevrolet Malibu shown for illustration purposes, Cadillac ATS similar.**

4. Tighten the four turbocharger-to-exhaust manifold nuts (2) to **30 Nm (22 lb-ft) + 90 degrees**.
5. Re-install the turbocharger exhaust heat shield. Refer to *Exhaust Manifold Heat Shield Replacement (LTG)* in SI.
6. Tighten turbocharger exhaust manifold heat shield fasteners to **9 Nm (80 lb-in)**.
7. Close the hood of the vehicle.
