SERVICE CAMPAIGN BULLETIN

NTB13-022a

VOLUNTARY SERVICE CAMPAIGN 2013 SENTRA COLD IDLE ECM AND TCM REPROGRAM

CAMPAIGN ID #: P3212

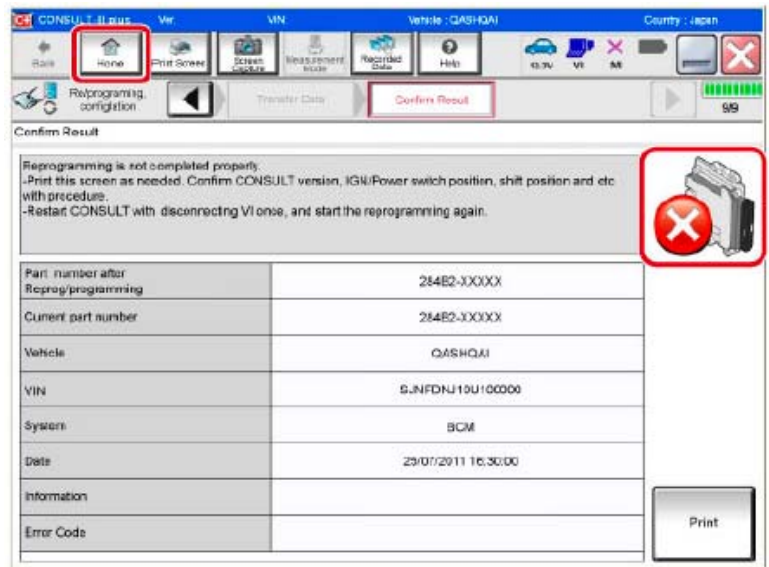
Figure 6

If reprogramming does not complete and the “X” icon displays as shown in Figure 6:

- Check battery voltage (12.0 – 15.5 V).
- CONSULT A/C adapter is plugged in.
- Ignition is ON, engine OFF.
- Transmission is in Park.
- All C-III plus / plus VI cables are securely connected.
- All C-III plus updates are installed.
- **Select Home, and restart the reprogram procedure from the beginning.**
