SERVICE CAMPAIGN BULLETIN

NTB13-022

VOLUNTARY SERVICE CAMPAIGN 2013 SENTRA COLD IDLE ECM AND TCM REPROGRAM

CAMPAIGN ID #: P3212

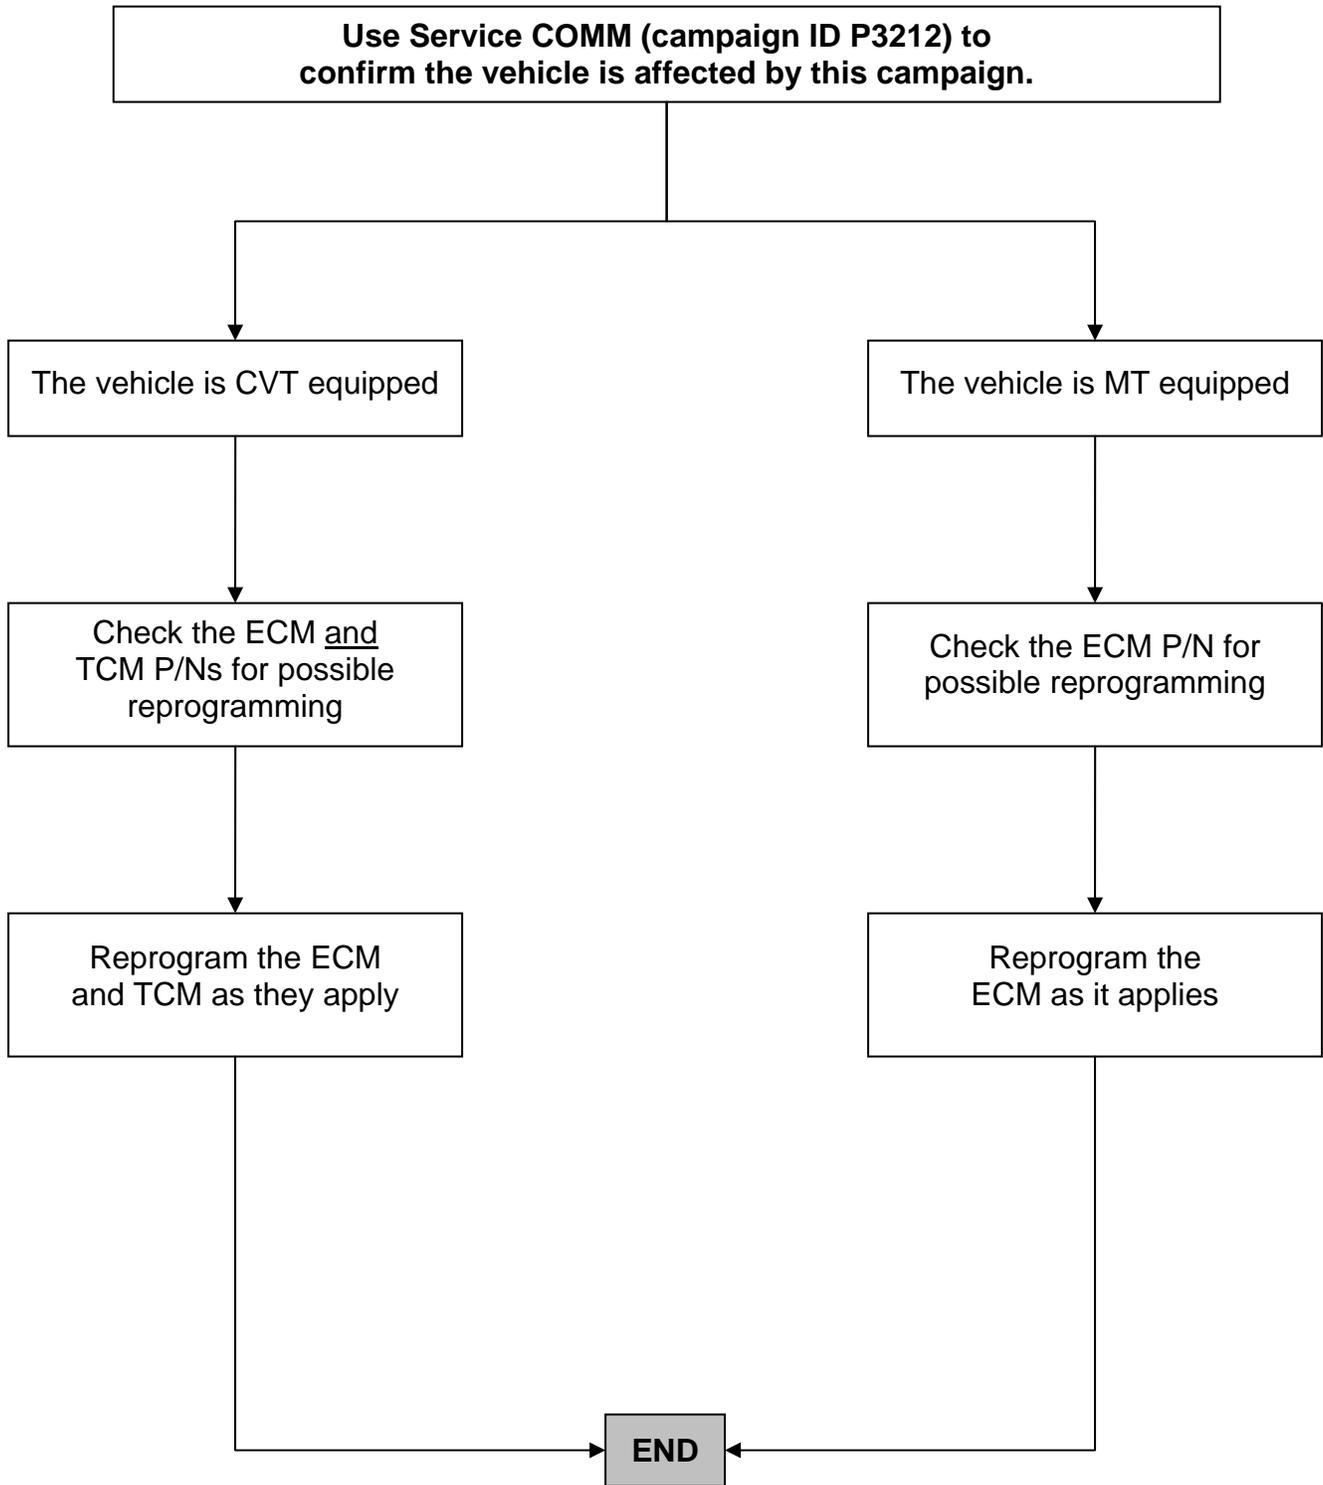
REPAIR OVERVIEW

Nissan is conducting a voluntary service campaign to reprogram the Engine Control Module (ECM), and if necessary, the Transmission Control Module (TCM) on certain specific 2013 Nissan Sentra vehicles at no charge to the customer for parts or labor. The reprogramming will prevent a condition in which the vehicle's engine may stop running under certain unique conditions at cold start. The vehicle still meets and exceeds applicable safety standards and there is no unreasonable risk to motor vehicle safety.

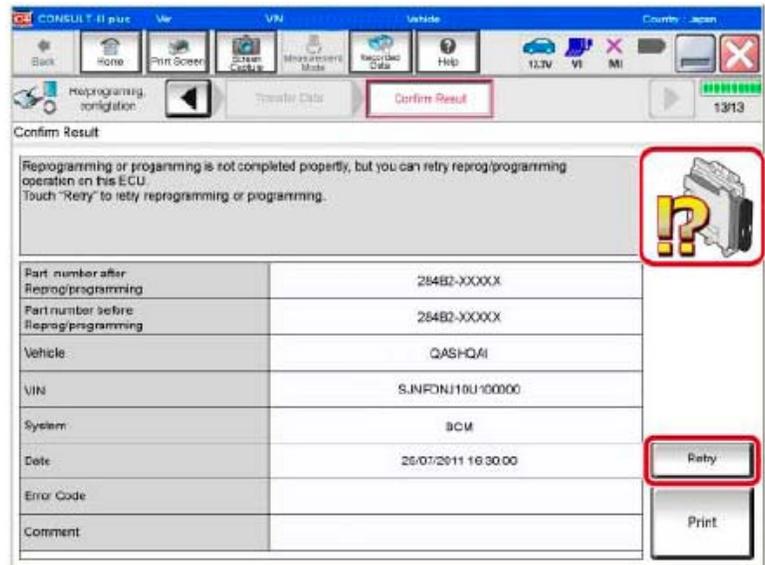
Figure 5

If reprogramming does not complete and the “!?” icon displays as shown in Figure 5:

- Check battery voltage (12.0–15.5 V).
- Ignition is ON, engine OFF.
- External Bluetooth® devices are OFF.
- All electrical loads are OFF.
- **Select retry and follow the on screen instructions.**
- “Retry” may not go through on first attempt and can be selected more than once.

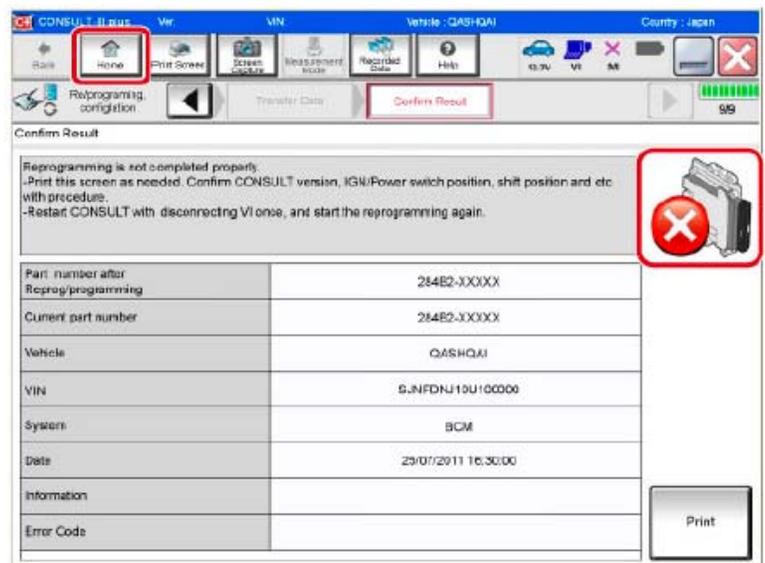
Figure 6

If reprogramming does not complete and the “X” icon displays as shown in Figure 6:

- Check battery voltage (12.0 – 15.5 V).
- CONSULT A/C adapter is plugged in.
- Ignition is ON, engine OFF.
- Transmission is in Park.
- All C-III plus / plus VI cables are securely connected.
- All C-III plus updates are installed.
- **Select Home, and restart the reprogram procedure from the beginning.**
