Technical Service Bulletin

00 - Engine shuts off and/or EPB activates when driver door is opened

00 13 44 2031850/2 January 17, 2013. Supersedes Technical Service Bulletin Group 46 number 12-27 dated November 20, 2012 for reasons listed below.

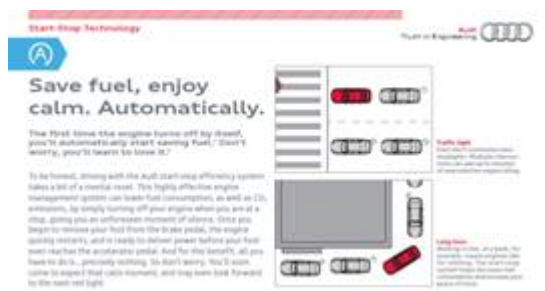
Figure 1. Old Start-Stop glovebox insert.

4. If available, replace the old Start-Stop glovebox insert (Figure 1), with the new glovebox insert **BR-12-631-US** (Figure 2). Additional inserts may be ordered from the Brand Store.

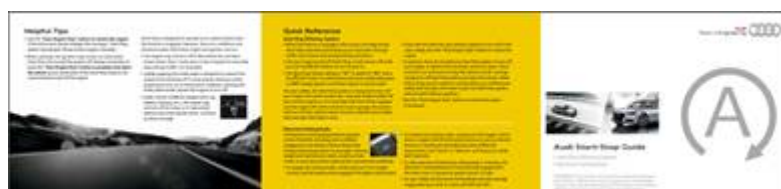
Figure 2. New Start-Stop glovebox insert.
