TECHNICAL BULLETIN

K161NAS1
11-JAN-13

SECTION: 211-02**Service Action: Steering Gear Pinion Bolt Torque****AFFECTED VEHICLE RANGE:**

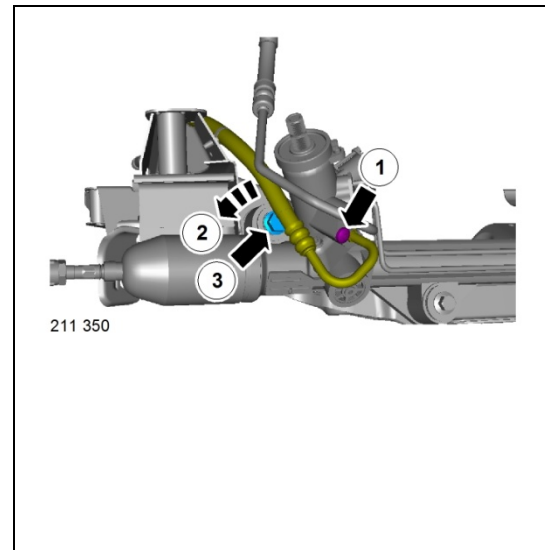
2. Remove the steering gear upper bolt.

- ① If required, loosen the Torx bolt.
- ② If required, carefully reposition the power steering pipe.
- ③ Remove the bolt.
