Service Bulletin

Bulletin No.: PIP5064B

Subject: Rough Running / Idle Surge / CEL On Or CMP Actuator Codes After Installation Of Reman HVV6

Models: 2007 Buick Rendezvous, Terraza
2007 Saturn VUE
2007 Chevrolet Monte Carlo
2007 Chevrolet Uplander
2007-2011 Chevrolet Impala
2007-2010 Chevrolet Malibu
2007-2009 Pontiac G6
2007-2008 Saturn Aura
2009-2011 Buick Lucerne
With 3.5L Engine (RPO LZE or LZ4)
or 3.9L Engine (RPO LZ8, LZ9, LZG or LGD)

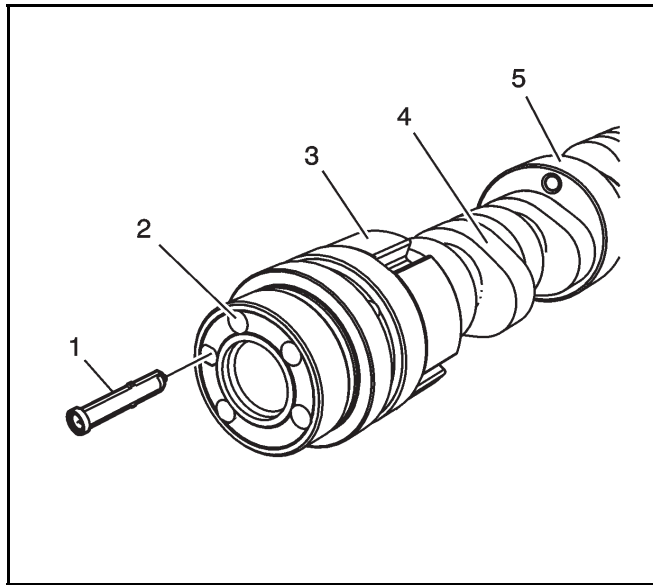
1608915

If oil pressure is within the specifications above, perform all testing listed in PIP4345A including a visual inspection of the camshaft position actuator filter (see picture below) and repair or replace as necessary.

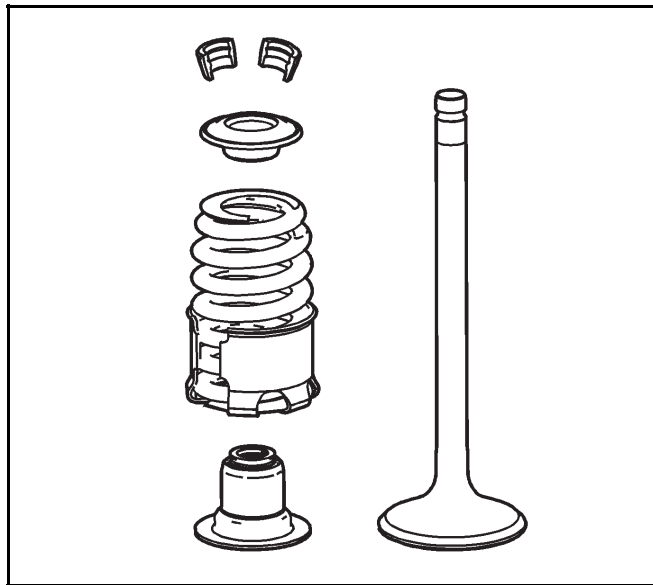
1665094

If single bank misfires are found, then remove the valve cover of the affected bank and check the valve springs for missing harmonic stabilizers (see picture below.) Replace the valve spring assemblies if the stabilizers are not present and retest for the misfires.
