# Technical Service Bulletin

## 94F6 UPDATE – Tail Lamp Seal (NVLW)

January 18, 2013

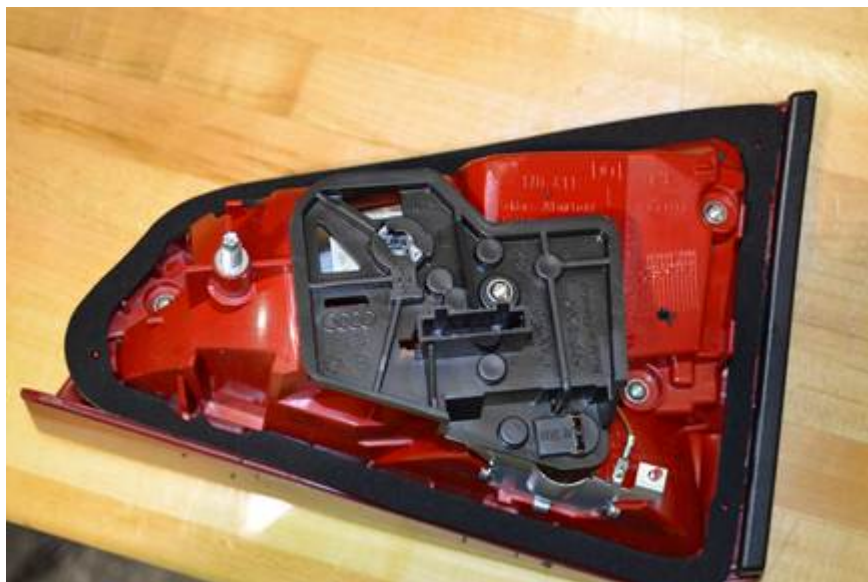
*Figure 1. Tail light.*

The contacts of the inner LED tail lights may develop oxidation which may cause malfunctions of the inner LED tail light. The outer tail lights are not affected and still function properly.

On Audi A4 vehicles with LED tail lights manufactured within a specific period, it is possible that oxidation can occur on the contacts of the inner LED tail lights due to environmental factors. This can lead to malfunctions. The outer tail lights are not affected and still function properly.

1. Replace seals for inner tail light assemblies (left and right sides).

**Tip:** To remove the old seals, warm gently with a hot air blower. Use the lowest setting, as excessive heat causes the tail light assemblies to deform.
