Service Bulletin

Bulletin No.: PI0891

Subject: Starter Positive Battery Cable Terminal Contact Repair

Models: 2012-2013 Chevrolet Sonic
Equipped with 1.4L Turbo Engine (RPO LUV)
Built Prior to October 29, 2012

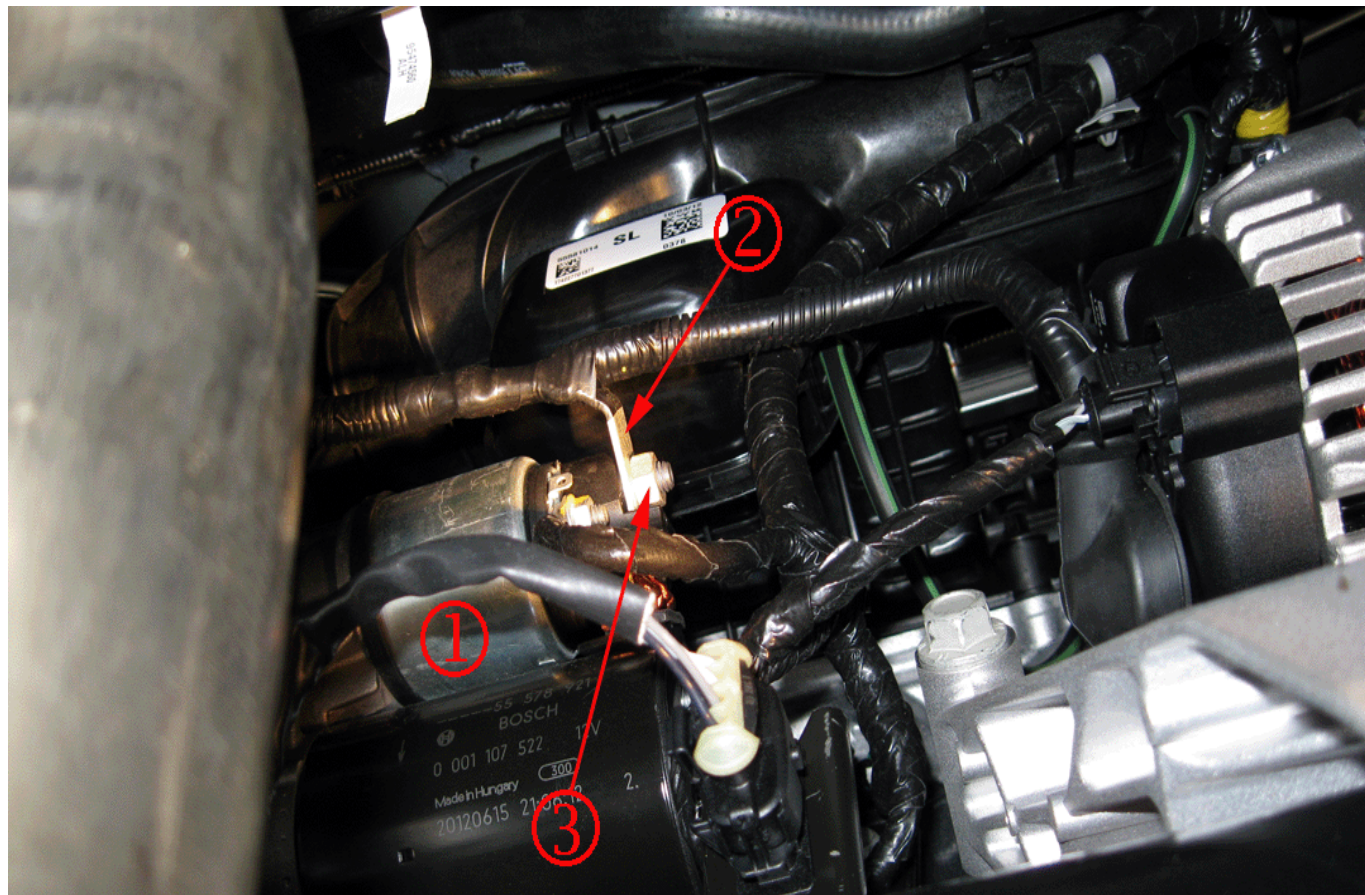
3136612

3. Locate the starter solenoid (1), positive battery cable terminal (2) and the positive battery cable fastener (3).

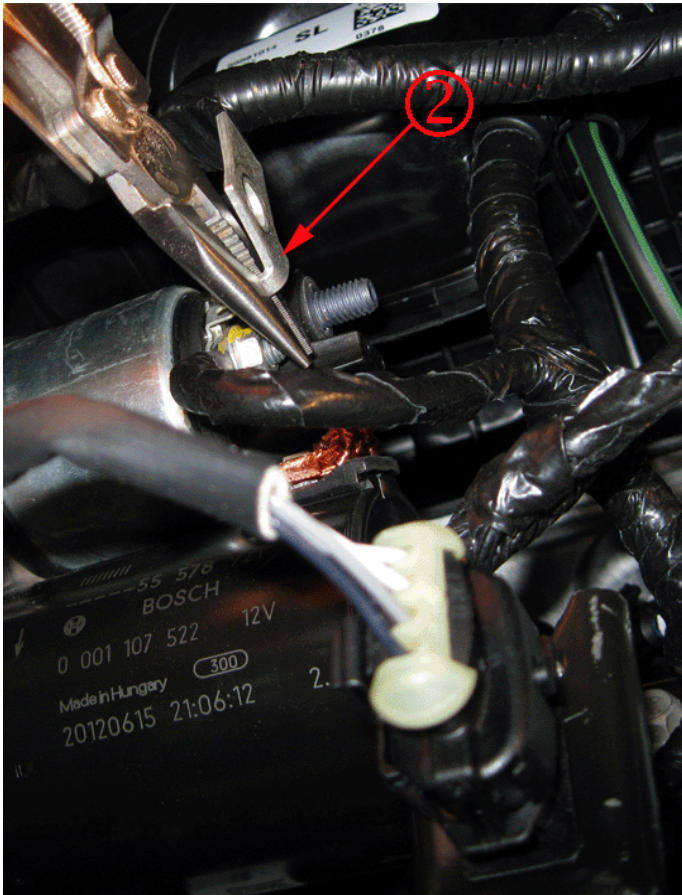
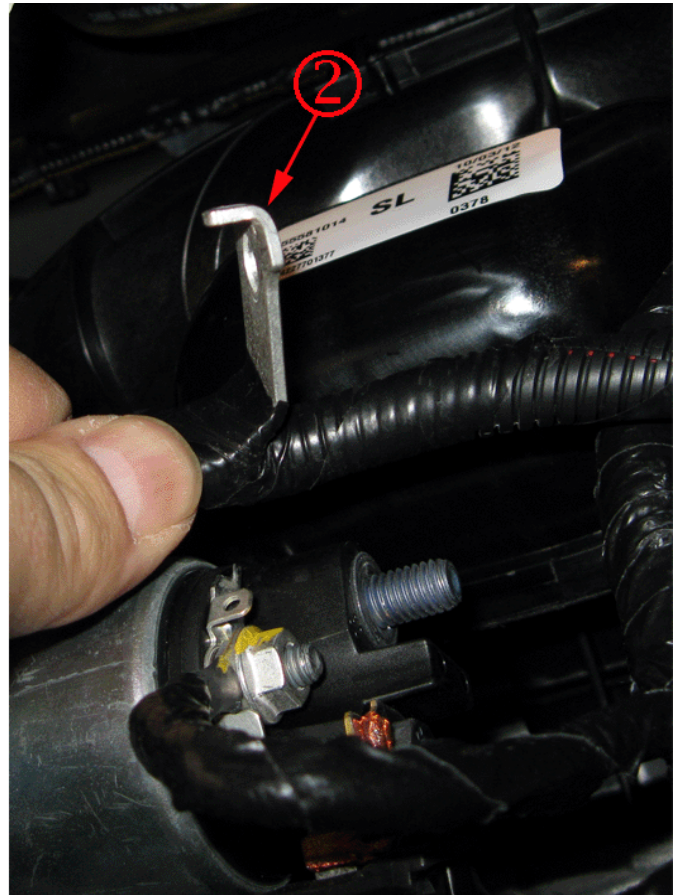
3136868

The purpose of this PI is to inform the technician that when replacing starter P/N 55576954, the tab on the starter cable needs to be bent 90 degrees inward.

5. Using pliers, bend the positive battery cable terminal tab (2) 90 degrees inward as shown in the illustration above.

Note: **DO NOT** allow the battery positive cable terminal tab to rotate clockwise on the starter solenoid while tightening the battery positive cable terminal faster. Hold the positive battery cable terminal tab down (counterclockwise) while tightening the positive battery cable terminal fastener.
