SB-10051782-8753

01 MIL on (P1545, P0121, P0123, P0221 or P0222 stored in ECM)

01 13 70 2018260/6 February 22, 2013. Supersedes Technical Service Bulletin Group 97 number 10-06 dated June 4, 2010 for reasons listed below.

Model(s)	Year	VIN Range	Vehicle-Specific Equipment
A6	2005-2008	All	3.2 FSI
A4	2005-2008	All	2.0 and 3.2 FSI
A4 Cabrio	2007-2008	All	2.0T
TT	2008	All	2.0
A3	2006-2009	All	2.0
Q7	2007-2009	All	3.6

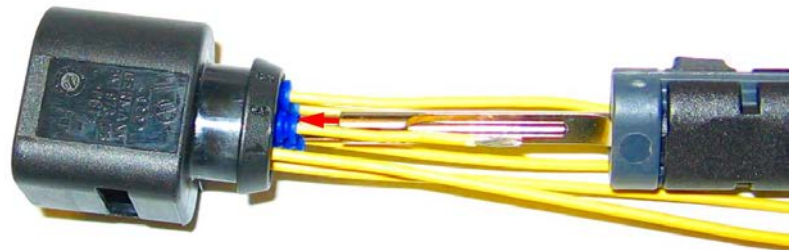
Figure 3. The single wire seal, slid as far as the stop.

5. Insert all terminals into housing until they audibly click.
6. Reinstall pink lock.
7. Using the appropriate assembly tool, slide the single wire seal up the repair wire until it contacts the housing. Continue to slide the single wire seal into the housing as far as the stop (Figure 3).
