Technical Service Bulletin

94 Headlight Flickering or Warning On in Cluster (All Xenon Headlights)

94 13 03 2029194/3 February 1, 2013. Supersedes Technical Service Bulletin Group 94 number 12-99 dated November 30, 2012 for reasons listed below.

Model(s)	Year	VIN Range	Vehicle-Specific Equipment
Q7	2010	All	Premium Plus and Prestige
	2011	All	
	2012	All	
	2013	All	
	2014	All

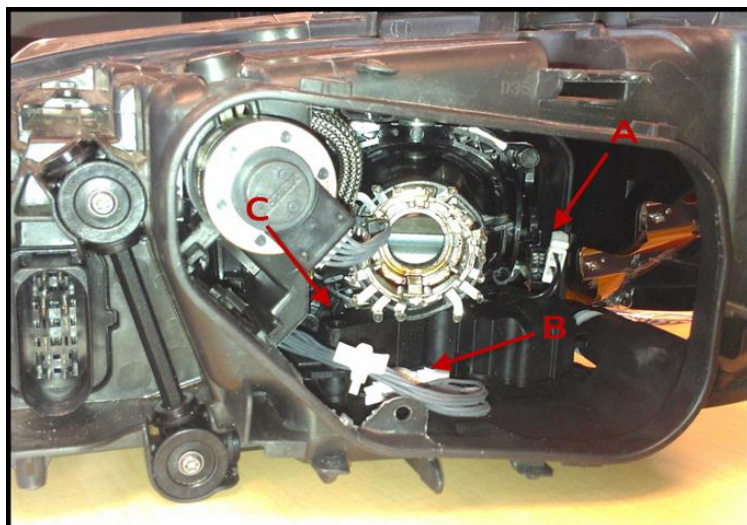
Figure 1. Back of Tri-Xenon Headlight showing three connectors, “A”, “B”, “C”. Bi-Xenon Headlight will only have a single “A” connector.
