# Technical Service Bulletin

## 94 Headlight Flickering or Warning On in Cluster (All Xenon Headlights)

94 13 10 2029194/4 March 4, 2013. Supersedes Technical Service Bulletin Group 94 number 13-03 dated February 1, 2013 for reasons listed below.

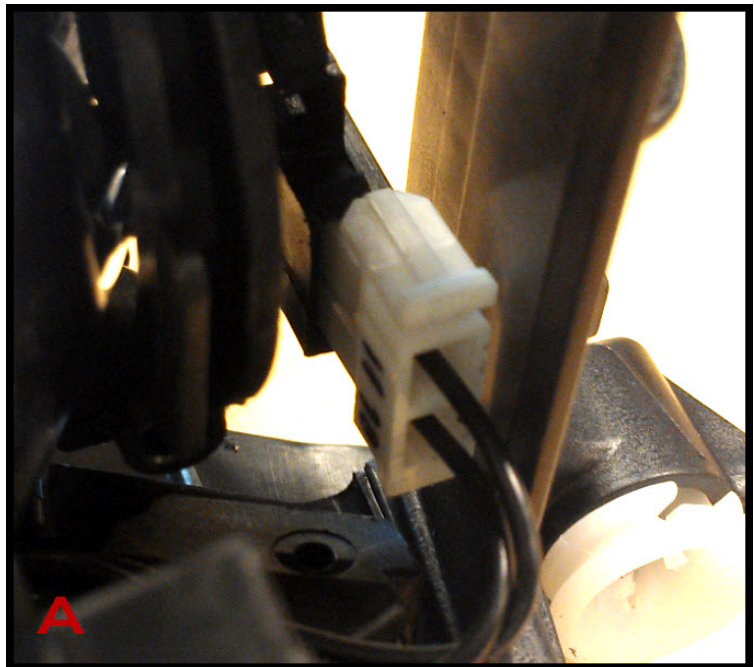
Connector “A” (Figure 2, A) can be seated but not fully engaged. When pushing on this connector the projector will swivel, so it is important to hold the projector housing when applying pressure to the connector.

*Figure 2. Connector “A” shown not fully seated.*

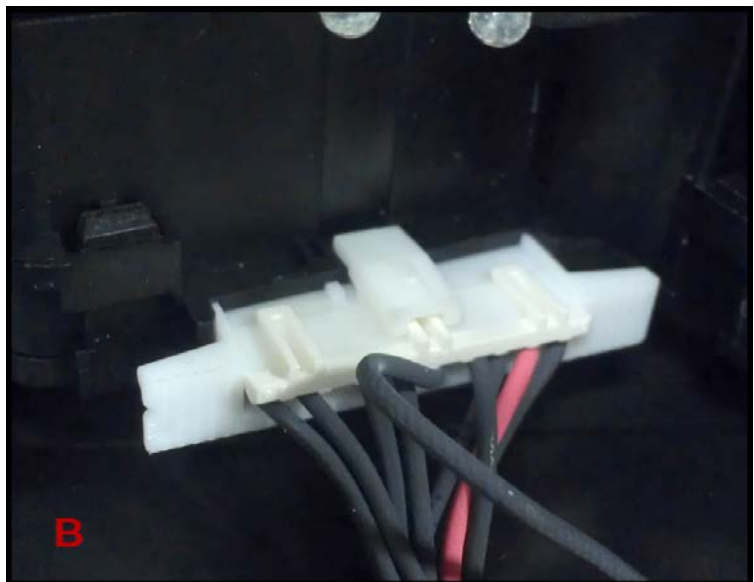
Connector “B” (Figure 3, B) can be fully locked into place but it can be rotated 5-10 degrees off center. Therefore, it is important to ensure that the harness connector is seated parallel to the connector housing on the headlamp.

*Figure 3. Connector “B” shown off center.*

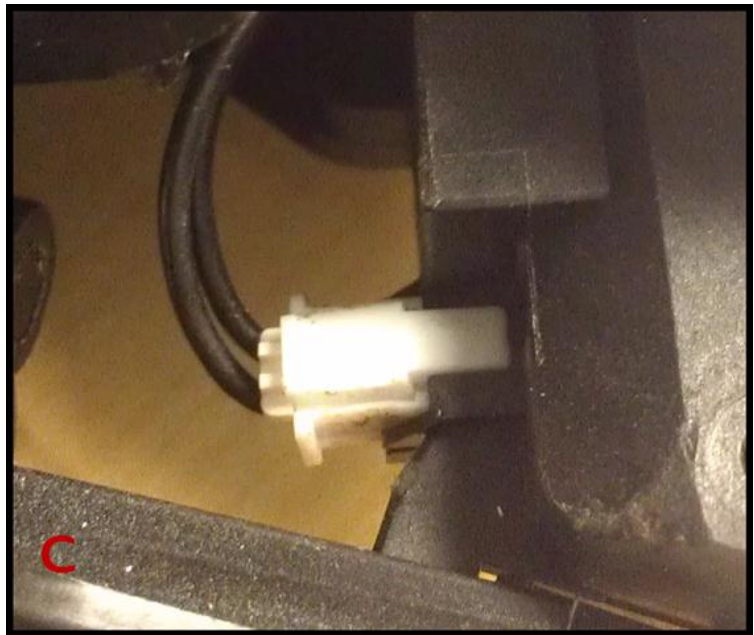
Connector “C” (Figure 4, C) is located behind the motor mechanism, which rests below the projector lens. This is a very small two-pin connector. Use caution when wiggling this connector because if it becomes fully disconnected, it is almost impossible to reconnect without using special tools. Place your finger, or a set of small bent pliers, on this connector and pull towards yourself to fully seat the connector.

*Figure 4. Connector “C” shown in the locked position.*
