Service Action Campaign

Subject: 2009 - 2011 Model Year Audi A6 Vehicles Equipped with

3.0L TFSI Engine Radiator Mountings

Code: 19i4

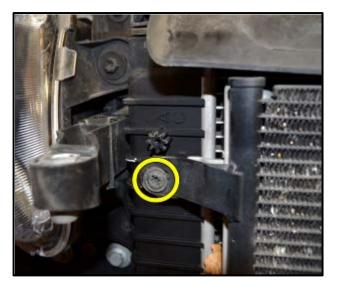
Remove the upper and lower mounting screws from the passenger side of the charge air cooler <circle> and discard them (upper screw shown).

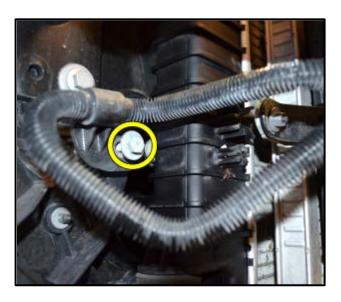
Loosen the mounting bolt for the power steering fluid cooler <circle>.
