# Ferrari North America

## Technical Information

| Bulletin #: | 2089 |

**Model Type:** 458 Challenge (F142CHP)  
**Model Year:** All Applicable  
**Subject:** Replacing the DCT Gearbox Differential Flanges

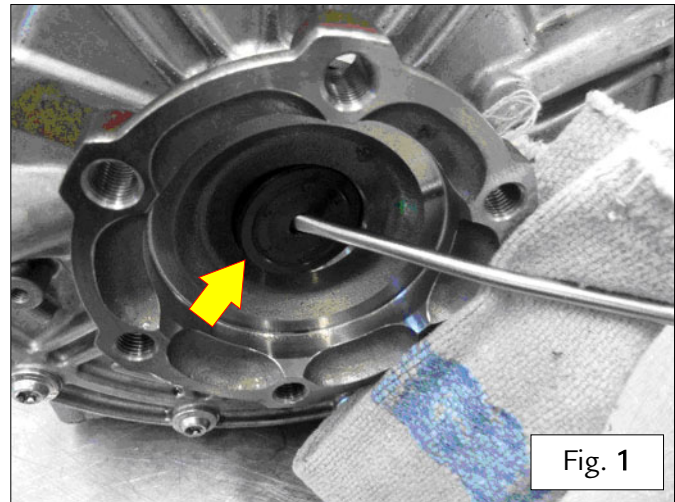
- Using a sharp implement, pierce the centre of the rubber cap indicated on the right hand differential flange, then pry it out of its seat – Fig. 1.

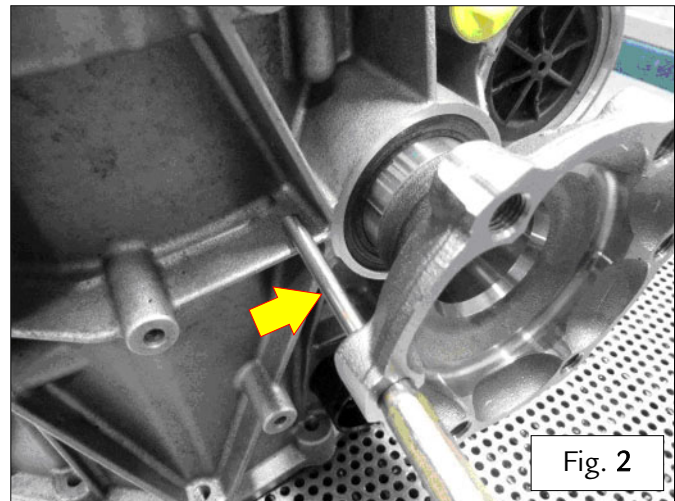
- Immobilise the differential by inserting a punch as shown through the left hand differential flange – Fig. 2.

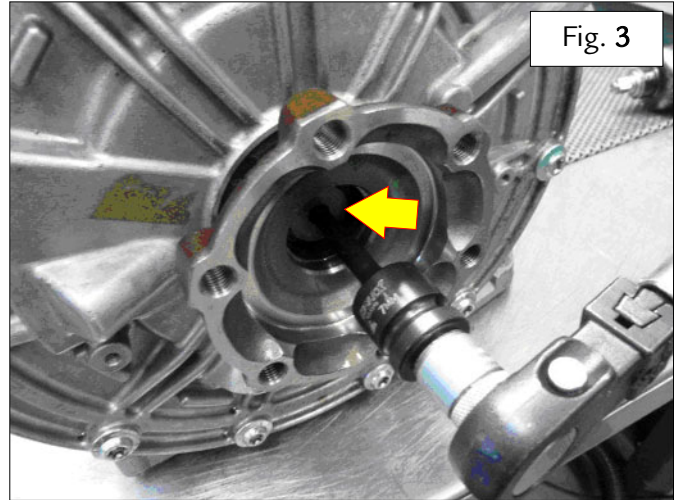
Fig. 3

- Using a 7 mm hexagonal socket wrench bit, undo the indicated screw on the right hand differential flange – Fig. 3.

**Note:** Do NOT use an air powered tool to undo the indicated screw.

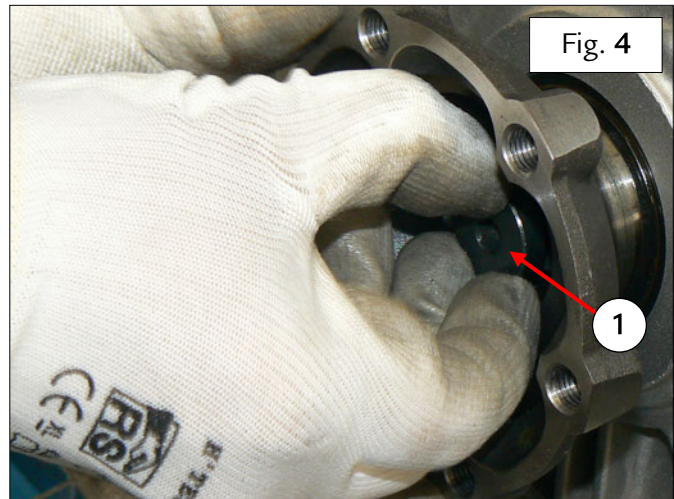
Fig. 4

- Remove the screw (1) from the right hand differential flange – Fig. 4.

**Note:** A small quantity of oil may escape; take all necessary precautions to limit and collect the spillage.

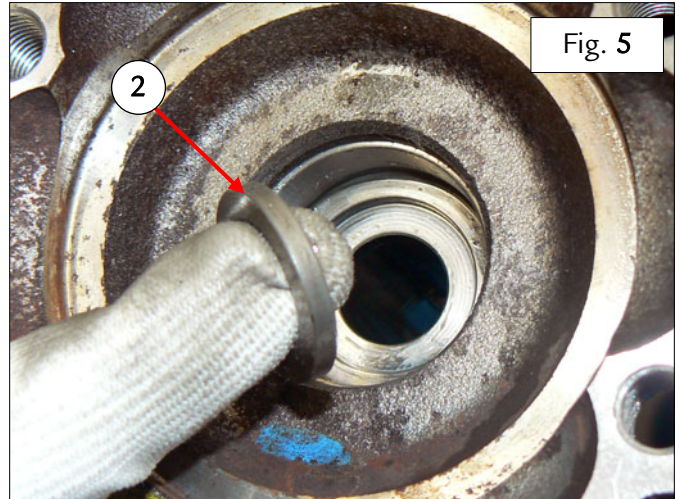
- Retrieve the washer (2) from the RH differential flange – Fig. 5.

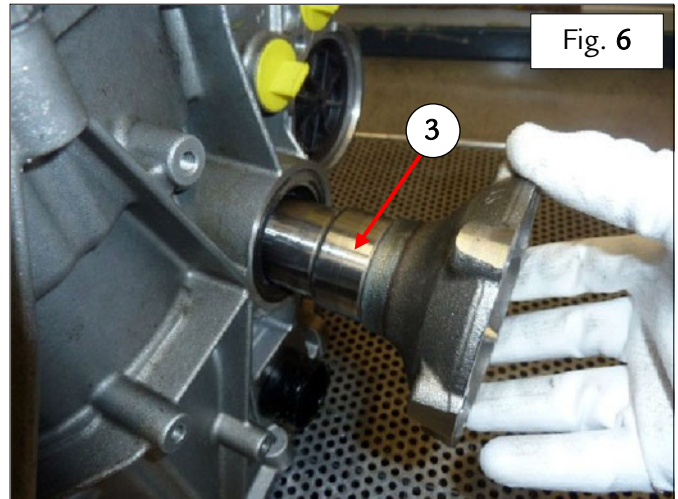
- Remove the LH differential flange (3) and replace – Fig. 6.

Note: Take care not to damage the lip of the Corteco seal.

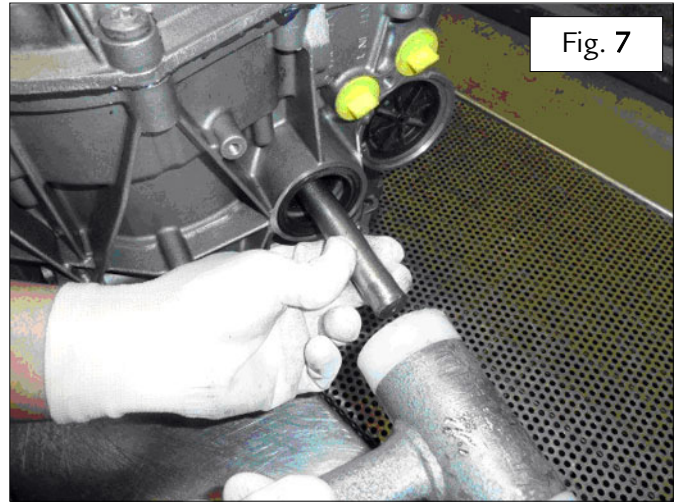
- From the left hand side of the gearbox and using a suitable punch and plastic mallet, push out and remove the right hand differential flange – Fig. 7.

**Note:** Take care not to damage the lip of the Corteco seal.

**Note:** Tap gently with the mallet to prevent damage to the components.

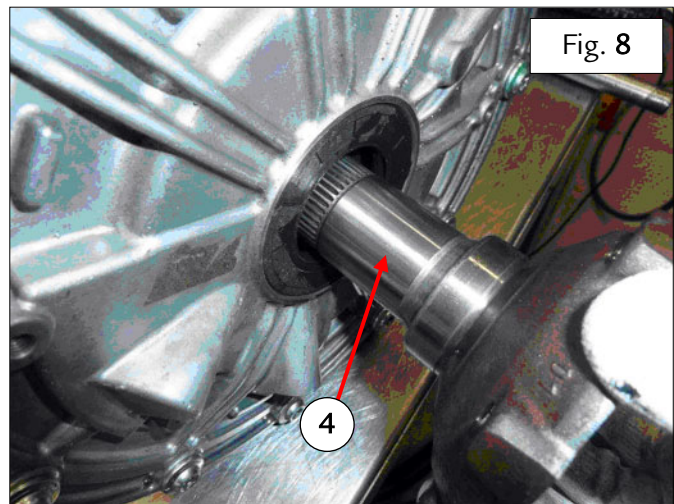
- Remove the RH differential flange (4) and replace – Fig. 8.

**Note:** take care not to damage the lip of the Corteco seal.

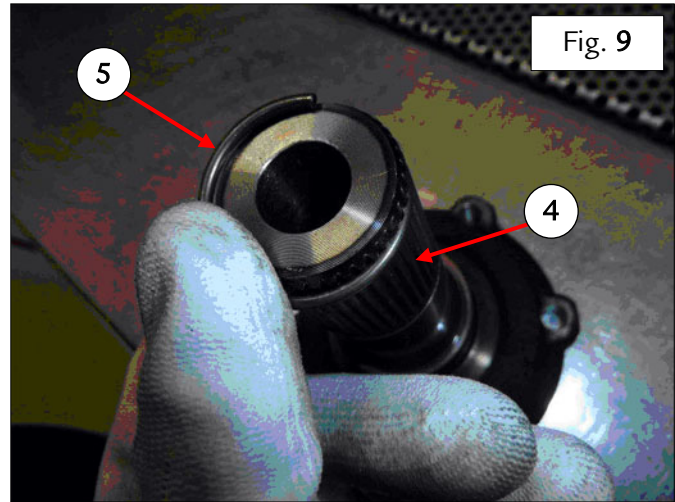
- If not already installed on the flange, fit the retainer ring (5) on the new RH differential flange (4) – Fig. 9.

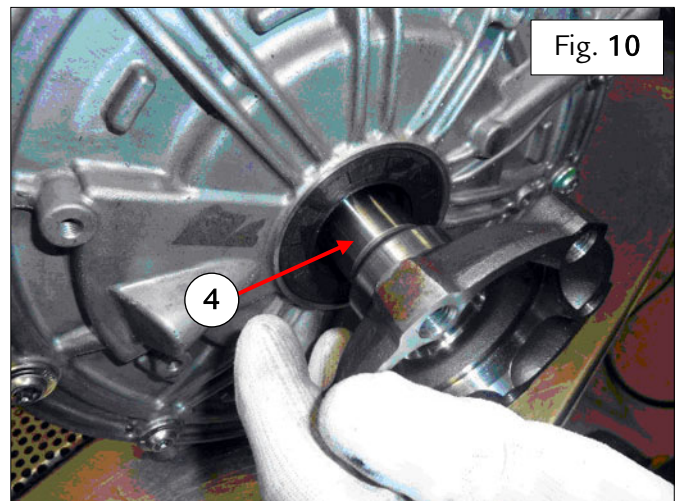
- Fit the new RH differential flange (4) in the relative seat on the DCT gearbox – Fig. 10.

**Note:** take care not to damage the lip of the Corteco seal.

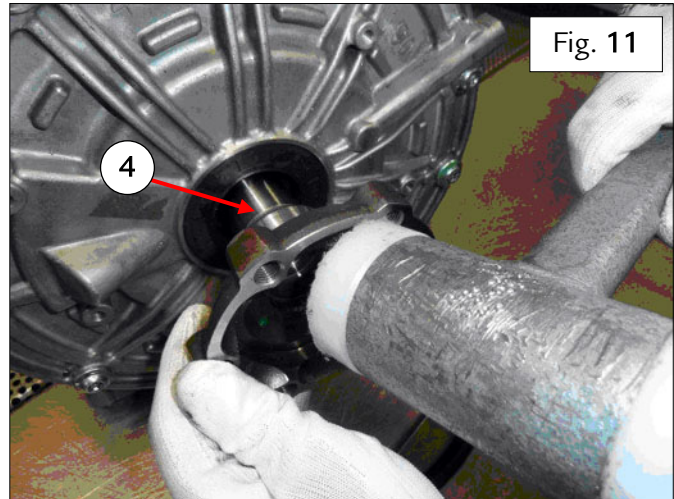
Fig. 11

- Use a plastic mallet to push the RH differential flange (4) the remaining distance into the relative seat on the gearbox – Fig. 11.

**Note:** tap gently with the mallet to prevent damage to the components.

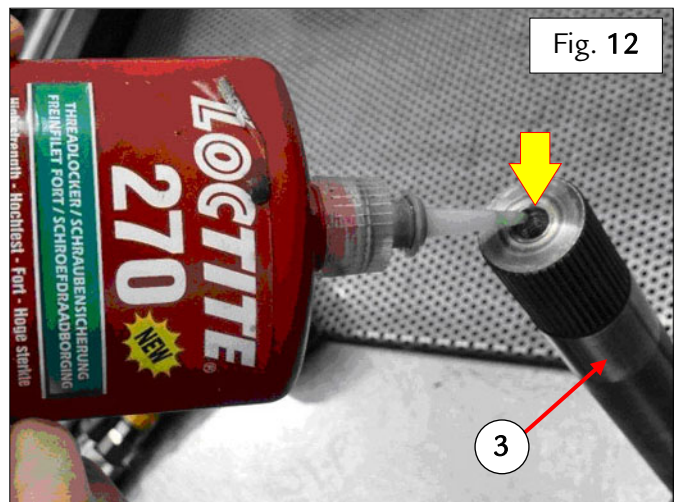
Fig. 12

- Apply **Loctite 270** to the indicated thread of the new LH differential flange (3) – Fig. 12.

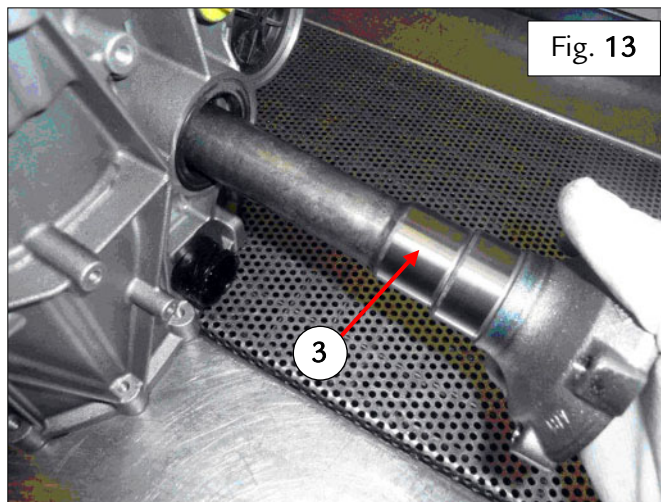
- Fit the new LH differential flange (3) in the relative seat on the DCT gearbox – Fig. 13.

**Note:** take care not to damage the lip of the Corteco seal.

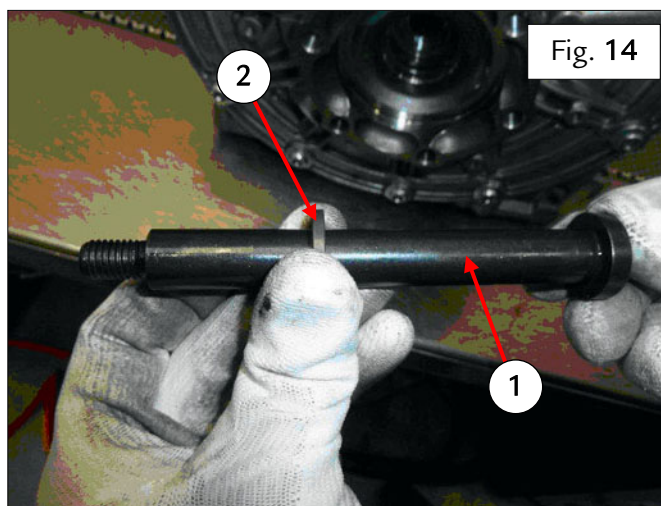
- Lubricate the contact surfaces of the new washer (2), then fit the washer on the new flange fastener screw (1) – Fig. 14.

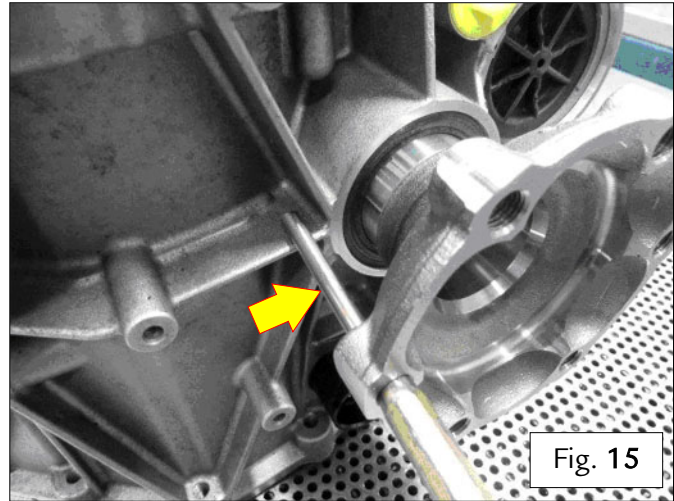
- Immobilise the differential by inserting a punch as shown through the left hand differential flange – Fig. 15.

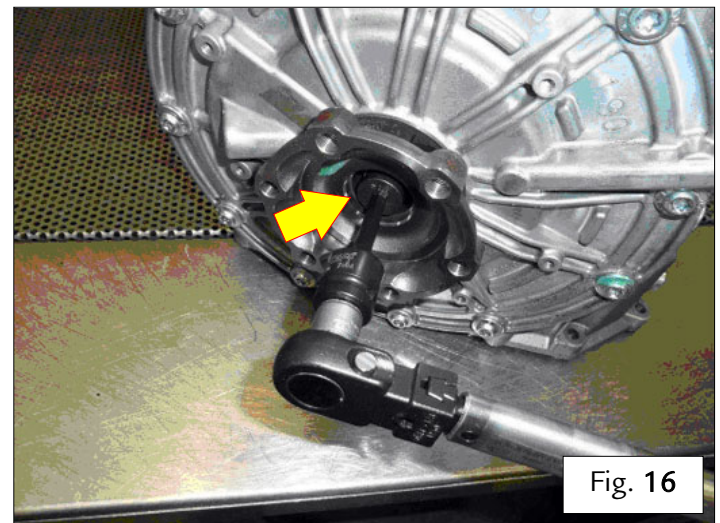
- Using a calibrated and certified torque wrench tighten the new screw indicated to a torque of **40 Nm** – Fig. 16.

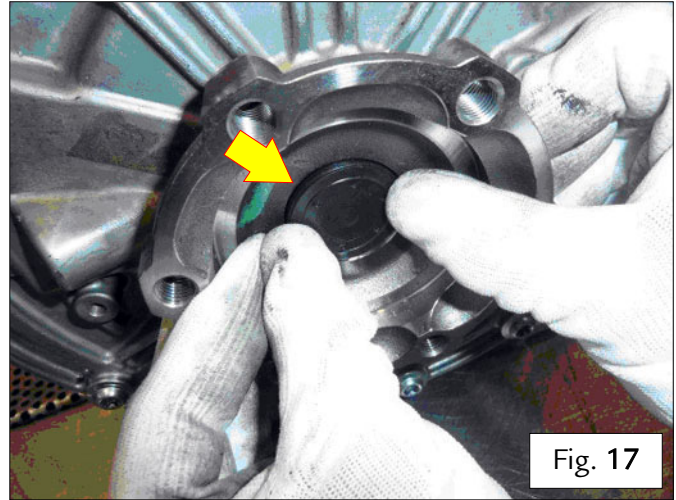
- Manually fit a new plug as indicated in the relative seat of the RH differential flange – Fig. 17.

**Note: DO NOT USE A MALLET or HAMMER**
