March 27, 2013

Horn Sounds By Itself; Driver's Airbag Rattles

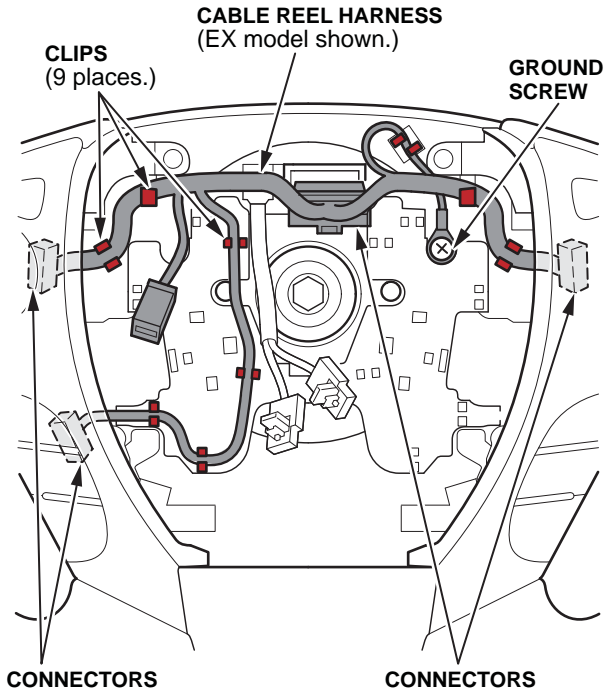
> Cable Reel Sub-harness

There are three possible causes. The cable reel harness is not routed correctly, the horn harness has shorted against the SRS module retainer, or the airbag module is not centered.

10. Install the new cable reel sub-harness, and route it as shown.
