# Technical Service Bulletin

## 00 - Engine shuts off and/or EPB activates when driver door is opened

00 13 46 2031850/3 March 13, 2013. Supersedes Technical Service Bulletin Group 00 number 13-44 dated January 17, 2013 for reasons listed below.

Model(s)	Year	VIN Range	Vehicle-Specific Equipment
A6/A7	2013	All	Not Applicable
A8	2013	All	Start-Stop
Q5	2013

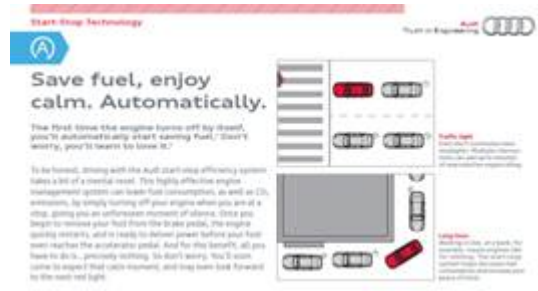
**Figure 1.** Old Start-Stop glovebox insert.

4. If available, replace the old Start-Stop glovebox insert (Figure 1), with the new glovebox insert **BR-12-631-US** (Figure 2). Additional inserts may be ordered from the Brand Store.

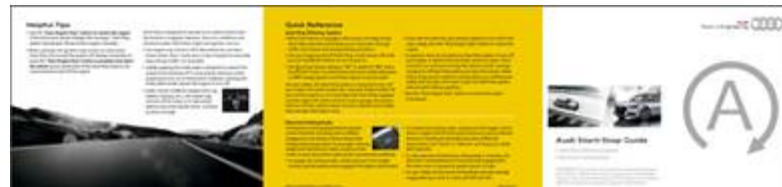
**Figure 2.** New Start-Stop glovebox insert.
