Service Bulletin

Bulletin No.: PIT5198

Subject: Power Door Locks and/or Windows Inoperative (Inspect Connectors X500, X501, X600)

Models: 2013 Chevrolet Silverado
2013 GMC Sierra
Without Memory Seats (RPO AN3) or Power Folding Mirrors (RPO DL3)

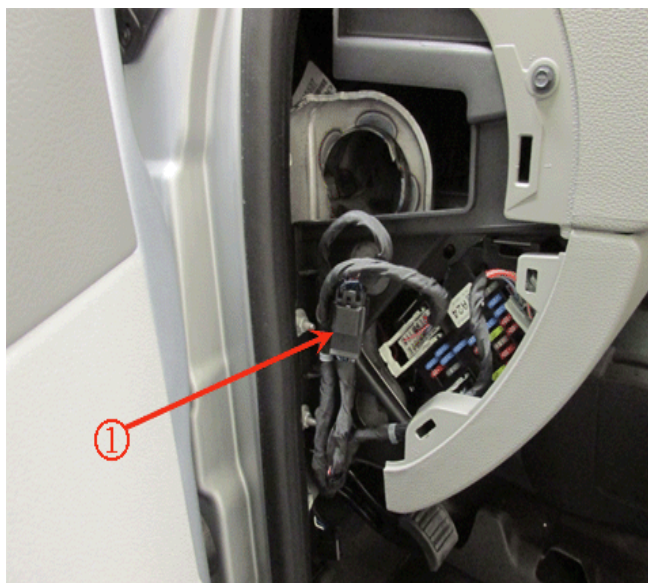
3274701

Some owners may comment that the power door locks and/or windows may be inoperative. This concern may be caused by poor terminal tension at connectors X500 (1), X501 (2), and/or X600 (3), shown below.

Using the Gray Diagnostic Test Probe J-35616-2A, test each of the terminals for proper tension and repair/replace as necessary.
