S-SB-0002-13

January 16, 2013

Moisture in Rear Combination Light / Water Intrusion Into Vehicle

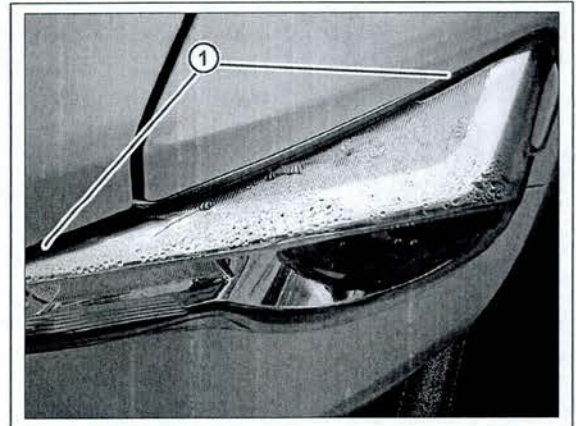
Figure 1.

1. Prior to making any repairs or replacing parts, locate the source of water entry.
2. See Figure 1 for an example of moisture inside the Rear Combination Light.

1	Interior Moisture
---	-------------------

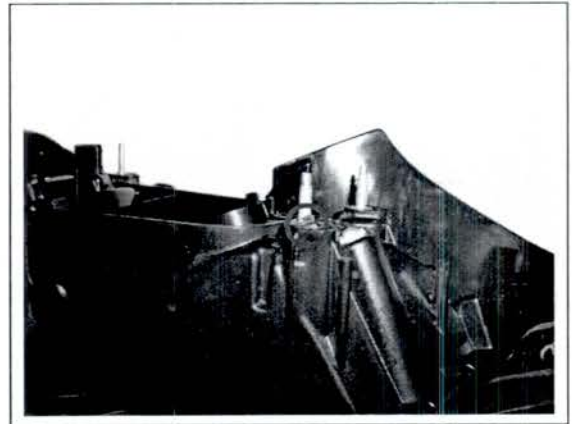
Figure 3.

6. Remove one or both lights that show evidence of moisture intrusion.
7. Inspect the back side of the combination lights for evidence of plastic cracking around the mounting studs. If cracking is present, replace the housing and the gasket.

The sealing gasket is a "ONE USE ONLY" type gasket and **MUST** be replaced every time a combination light housing is removed from the vehicle.

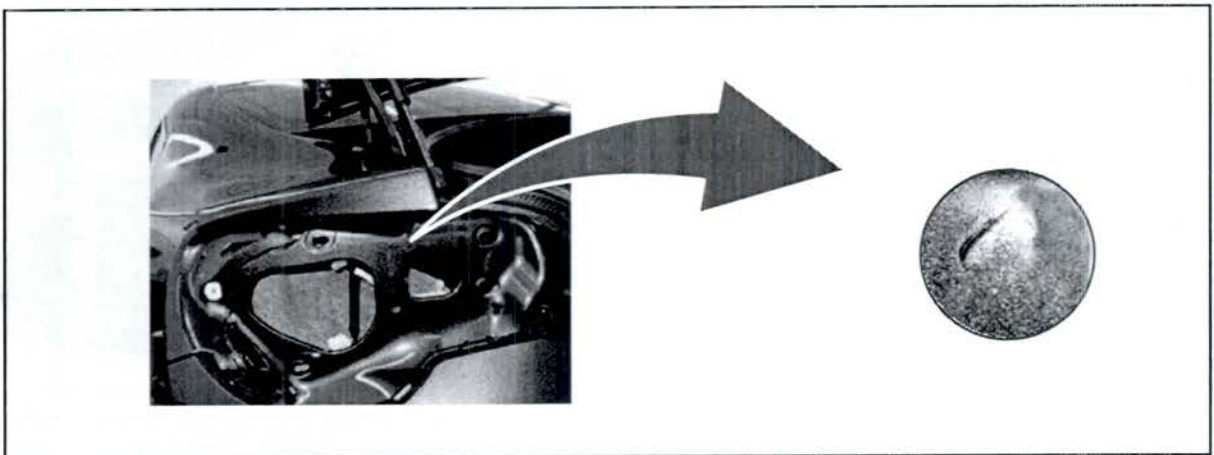
Figure 4.

1. Inspect the sheet metal body panel adjacent to the back side of the light housing for evidence of misplaced body seam sealer.

Remove any misplaced seam sealer with the sharp end of the plastic pry tool (SST# 00002-06002-01) being careful **NOT** to damage the painted body surface. If bare metal should appear during the sealer removal process, use touch-up paint to cover any bare metal areas before proceeding.

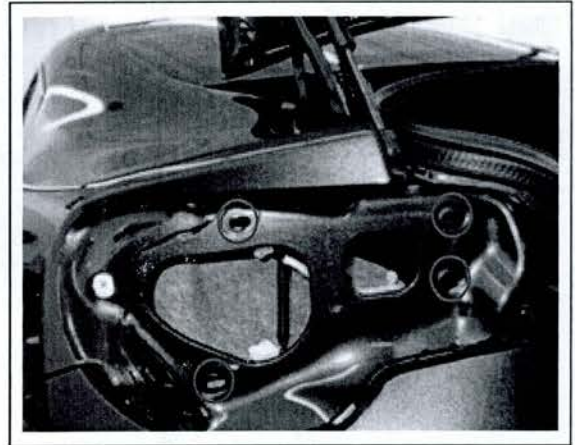
Figure 5.

2. Inspect the body sheet metal for evidence of deformed (cone shape) sheet metal around the 4 through-holes in the body.

Use a Body Hammer and Body Dolly to flatten the sheet metal around the 4 through-holes in the body (see circled areas for through-hole locations). Use touch-up paint on any bare metal areas.

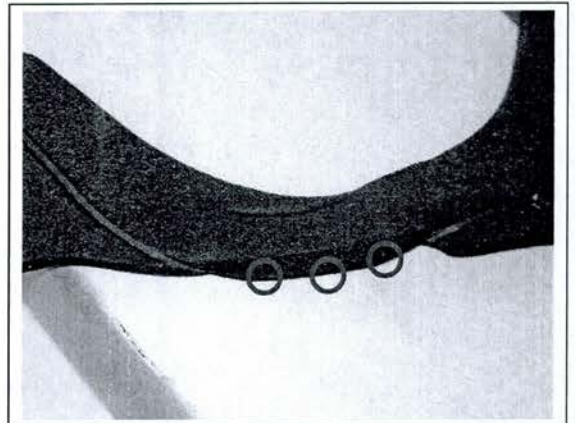
Figure 6.

3. Inspect the rear combination light sealing gasket for evidence of misplacement.

A misplaced gasket may allow water to enter the combination light housing or possibly the interior of the vehicle.
