S-SB-0032-12 Rev1 November 19, 2012

MIL "ON" DTC P0017 or P0019

YEAR(S)	MODEL(S)	ADDITIONAL INFORMATION
2013	FR-S

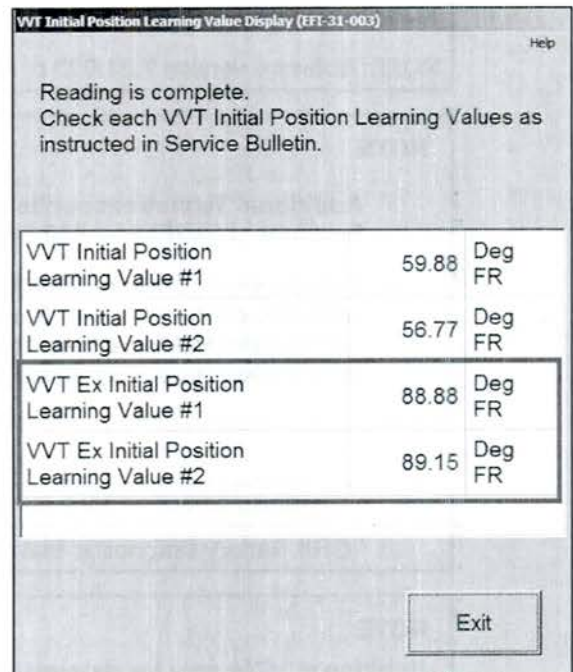
Figure 1.

1. Confirm DTC P0017 or P0019 is set.
2. Using the Techstream Utility "VVT Initial Position Learning Value Display", confirm the VVT Ex Initial Position Learning Value #1 and #2 are within the range.

3. Is the value within range?

RANGE (IN DEGREES)	
	MINIMUM	MAXIMUM
VVT Ex Initial Position Learning Value	85.0	95.0

- **YES** — Proceed to step 4 (Reprogram the ECM).
- **NO** — Proceed to step 5 (Replace the ECM).
