# Technical Service Bulletin

## 91 Front Park Aid and/or ACC inop

91 13 79 2033406/1 March 21, 2013.

Model(s)	Year	VIN Range	Vehicle-Specific Equipment
A6	2012-2013	All	Audi Parking System Plus

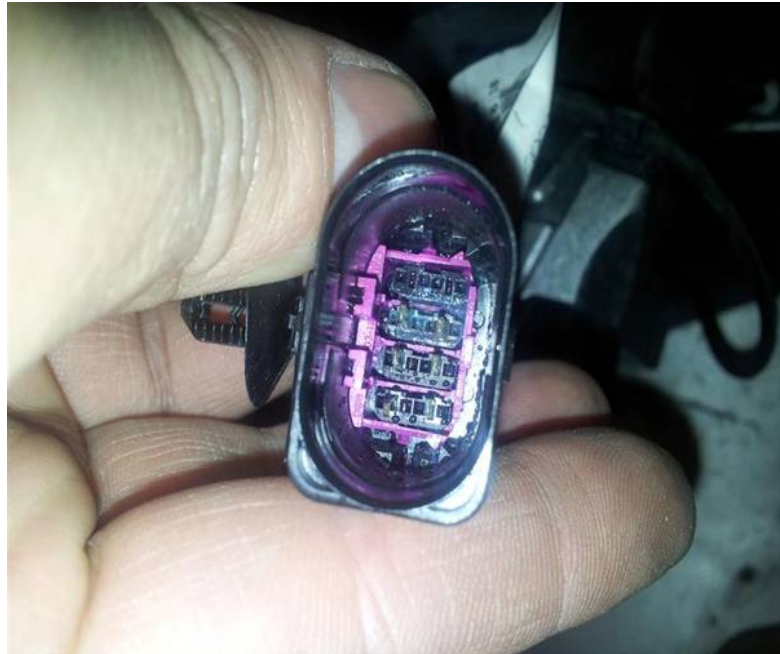
Water can get into the 8-pin connector between the central wiring harness and the front bumper harness.

**Figure 1.** Water ingress on front bumper harness connector.

1. Inspect the connector between the front bumper harness and the central wiring harness for water ingress (Figure 1, Figure 2). If no water ingress is found, this bulletin does not apply.
2. If water ingress is discovered at the connector, replace the front bumper harness. Repair the central wiring harness by cutting the wires back until the corrosion is no longer present, and repair the contacts using the VAS 1978B wiring repair kit.

**Tip:** Replace the seals around each contact that is repaired to prevent water from entering the plug again.

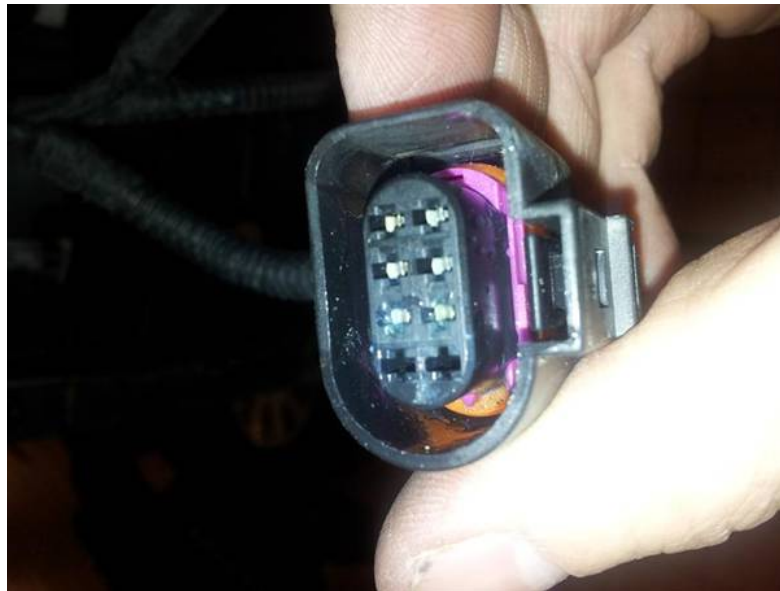
**Figure 2.** Water ingress on central wiring harness connector.
