SB-10051857-5051

94 Moisture accumulation in headlamps

94 13 28 2028277/9 August 13, 2013. Supersedes Technical Service Bulletin Group 94 number 13-24 dated July 18, 2013 for reasons listed below.

Model(s)	Year	VIN Range	Vehicle-Specific Equipment
Q7	2010 - 2014	All	Not Applicable

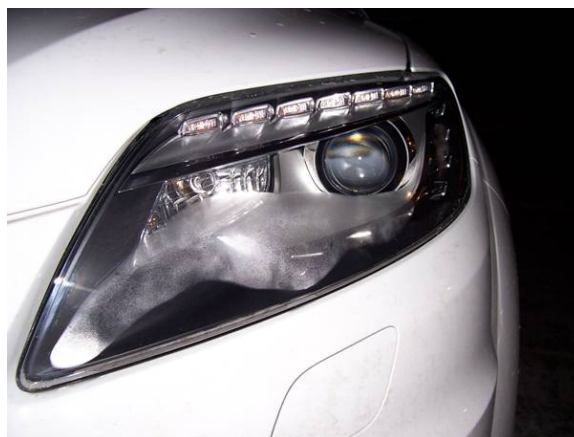
- There is considerable moisture present in the headlamp (Figure 1).
- The moisture disappears only after extended drives (greater than 10 minutes).
- There is no external damage to the headlamp which could introduce moisture.

Figure 1. Moisture in headlamp.

Humid air settles on the inside of the glass, causing moisture to appear on the inside of the headlamp lens.

When high air humidity and temperature differences exist between the inside of the headlamps and the outside, condensation can form on the inside of the lens, especially in cold and wet weather. This moisture buildup can happen, for example, after a car wash, after steam cleaning of the engine or the front end, or after overnight temperature changes.

1. Remove the headlamps and dry the inside using compressed air or a hot air blower. Check for any loose caps, loose or unsealed control modules, or cracks in the headlamp housing(s) as the culprit of moisture exposure.
2. If the vehicle’s build is prior to VIN # *CD004736 and the updated ventilation hoses are not currently installed, replace the headlamp ventilation hose for each headlamp with the new part number to help reduce any further humidity ingress into the headlamps (see *Required Parts and Tools*, below). Proceed to step 3.

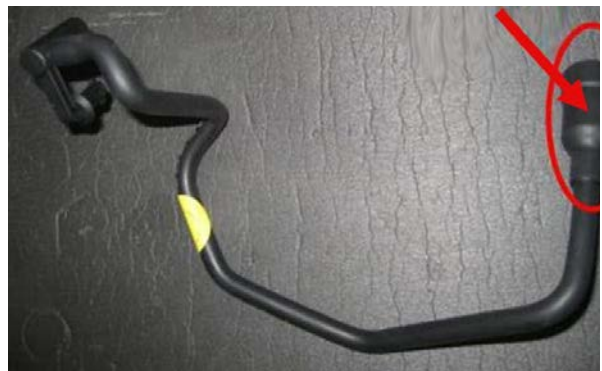
Tip: The updated ventilation hose can be recognized by the integrated filter (Figure 2, arrow).

Figure 2. Updated ventilation hose with integrated filter.

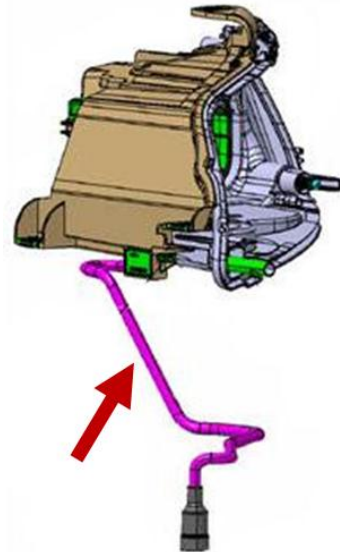
i Tip: The updated ventilation hose is not connected directly to the headlamp housing. The hose routes downward from the headlamp carrier and between the radiator and bumper (Figure 3, arrow).

Figure 3. Mounting of updated ventilation hose.

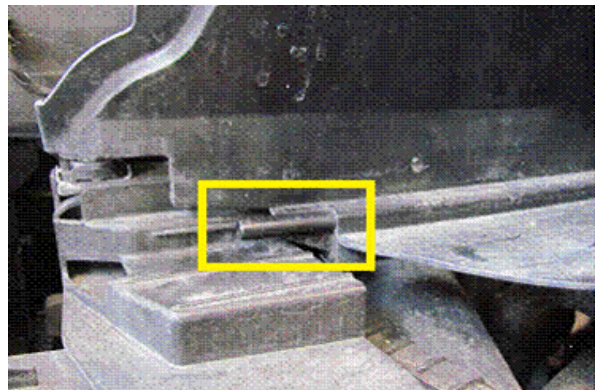
Figure 4. Headlamp ventilation guide tube.

3. Each headlamp air ventilation tube must be sealed to protect against further moisture ingress (Figure 4).

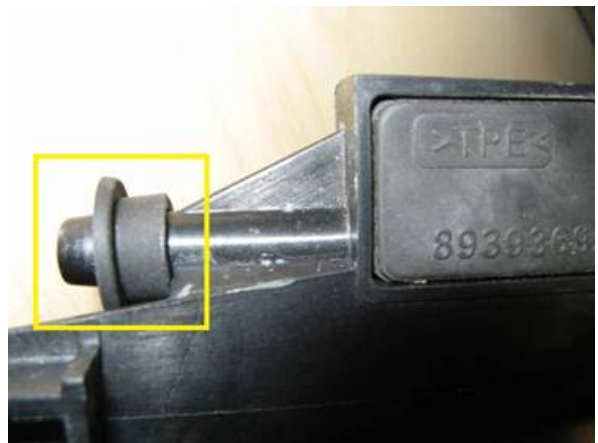
Figure 5. Ring seal installed on headlamp air tube.

4. Install ring seal on headlamp air ventilation tube (Figure 5). The larger diameter of the seal faces the headlamp.

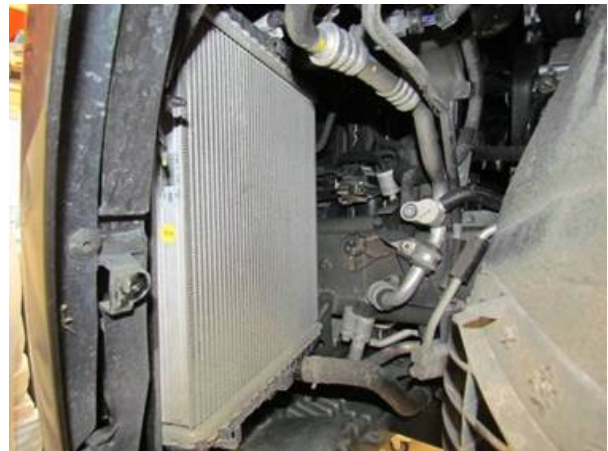
Figure 6. View of charge air cooler with wheel well liner removed.

6. Check vehicle for left and right air ducting for exiting air behind charge coolers. Vehicles built from June 2010 will not have these exit air ducts installed. Check vehicle regardless of build date. If air ducts are not installed, continue with steps 7 – 11. Otherwise, proceed to step 12.
7. Remove front wheels and wheel housing liners. The rear of the charge air coolers will be exposed (Figure 6).

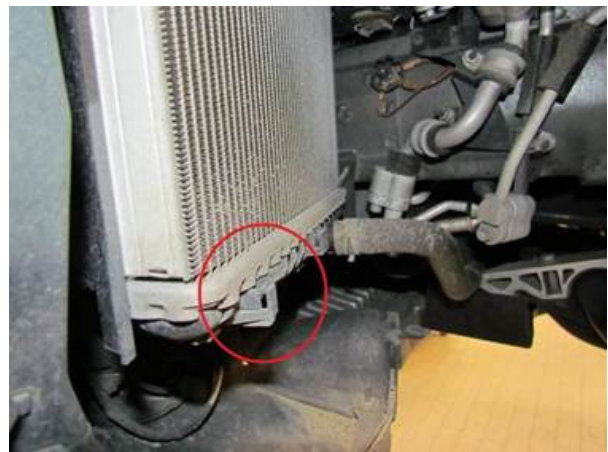
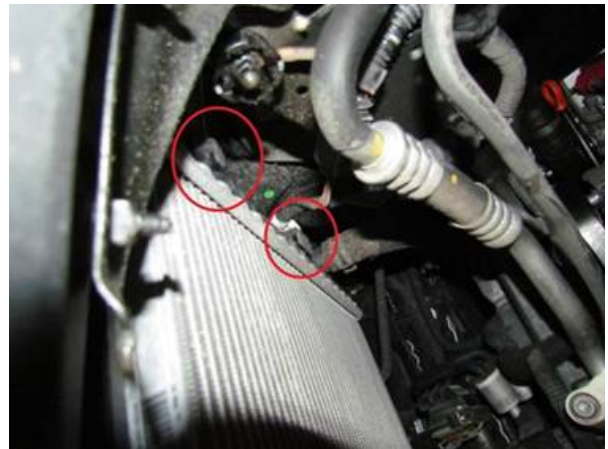
Figure 7. Lower exit air duct attachment point to charge air cooler.

Figure 8. Upper exit air duct attachment points to charge a cooler.

8. Locate exit air duct attachment hooks on the left and right air charge coolers (Figures 7 and 8).

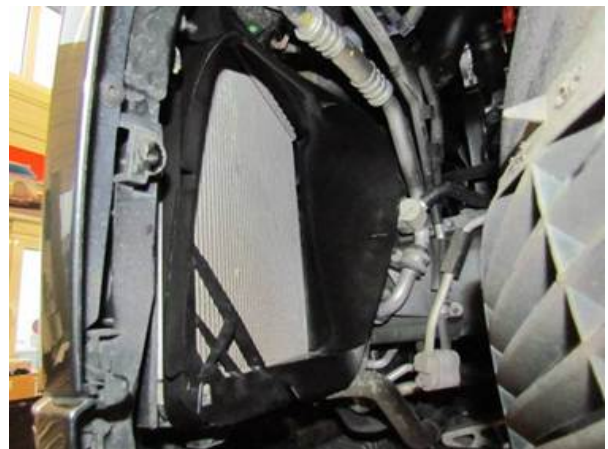
Figure 9. Charge air cooler exit air duct installed.

9. Affix left and right exit air ducts over the rear of the charge air coolers (Figure 9).

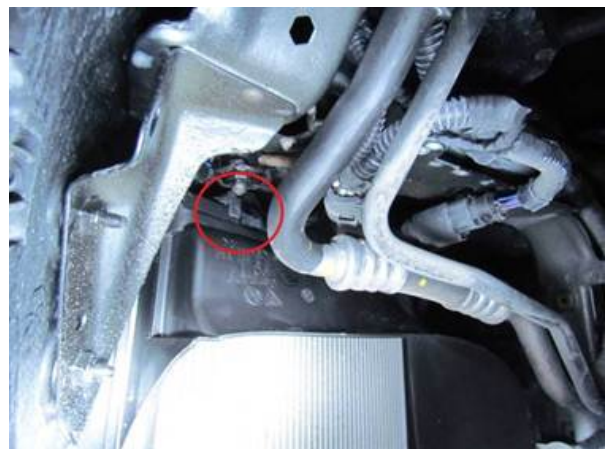
Figure 10. View of exit air duct affixed to mounting hook.

10. Inspect exit air duct attachment points to be sure that ducts are engaged properly over charge air cooler hooks (Figure 10).
