Technical Service Bulletin

94 Moisture accumulation in headlights

94 13 11 2028277/6 March 6, 2013. Supersedes Technical Service Bulletin Group 94 number 13-01 dated January 2, 2013 for reasons listed below.

Model(s)	Year	VIN Range	Vehicle-Specific Equipment
Q7	2010	All	Not Applicable
	2011	All	
	2012	All	
	2013	All	
	2014	All

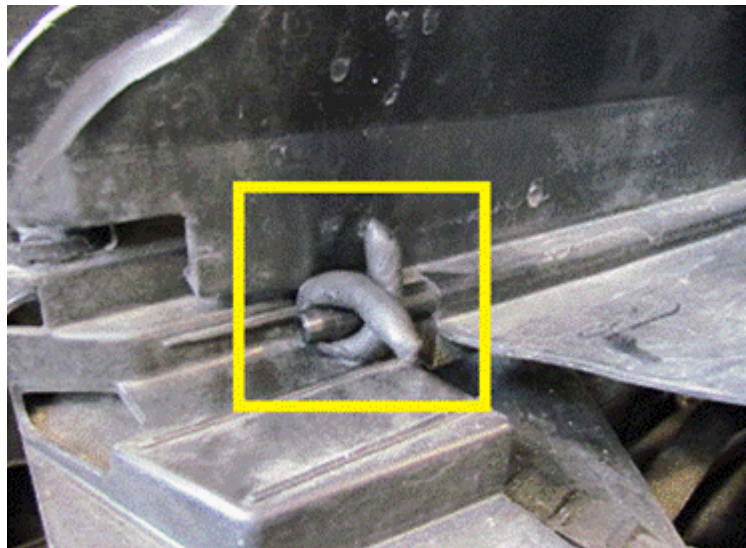
Figure 6. Initial butyl cord shown on guide tube.

5. Wrap butyl cord sealant around the left and right ventilation tubes, taking care not to block the air passage tube (Figure 6).

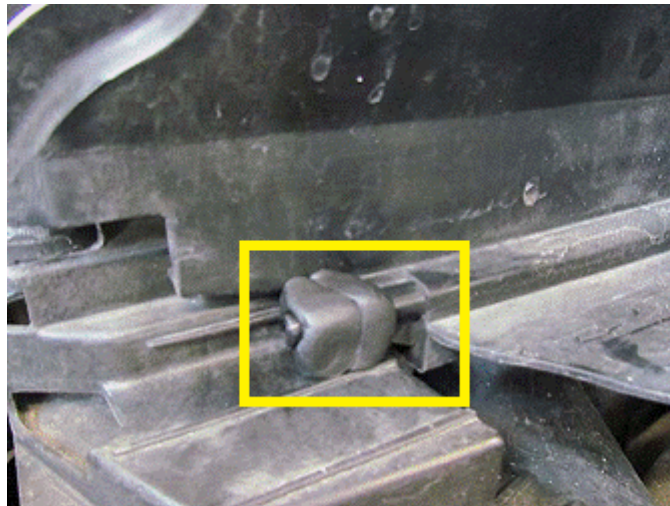
Figure 7. Butyl cord kneaded in place.

6. Knead the butyl cord sealant in place. The butyl sealant must be excessive enough so that the headlamp housing squeezes it and creates a robust seal at the housing (Figure 7).

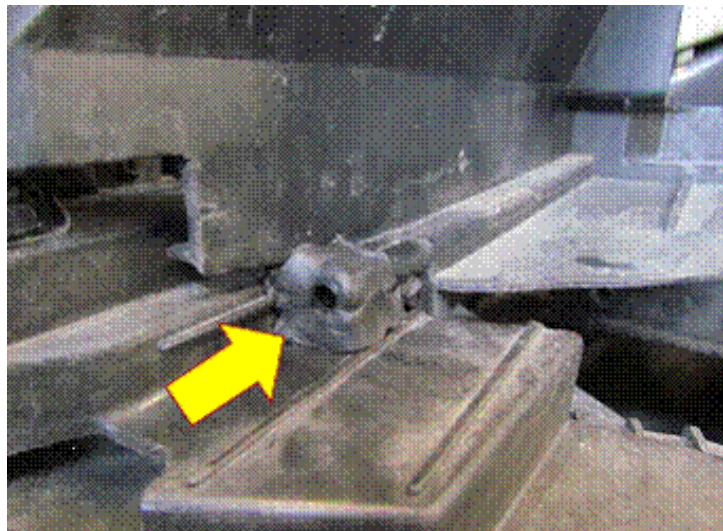
Figure 8. View of direction of headlamp engagement, with appropriate butyl cord application.

7. Leave an uncovered section of the air tube so that there is no chance the sealant will clog the air passage tube (Figure 8).

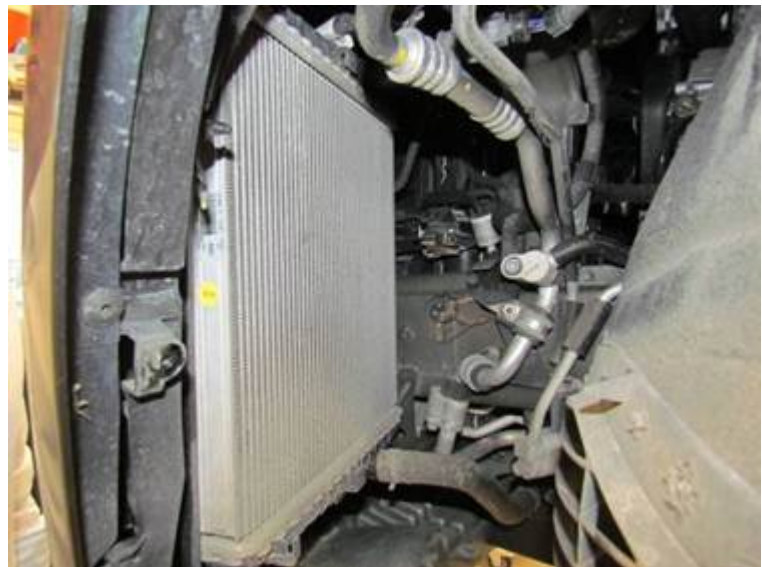
Figure 9. View of charge air cooler with wheel well liner removed.

10. Remove front wheels and wheel housing liners. The rear of the charge air coolers will be exposed (Figure 9).

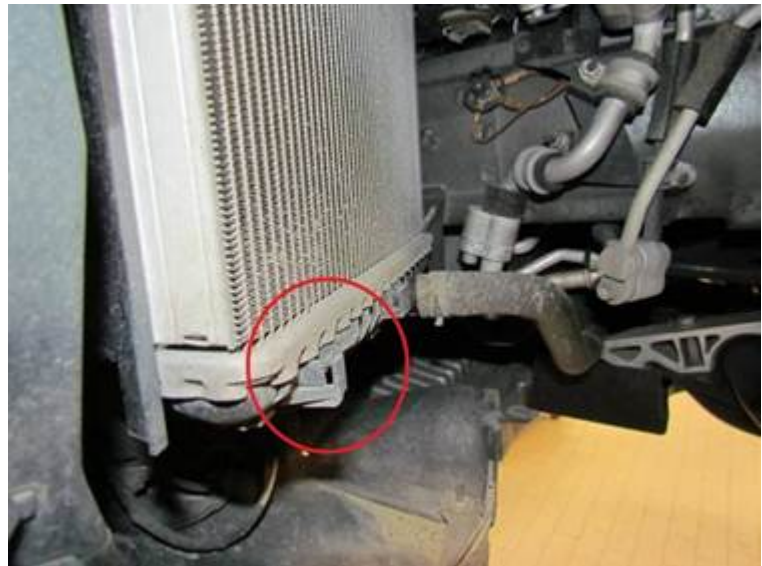
Figure 10. Lower exit air duct attachment point to charge air cooler.

11. Locate exit air duct attachment hooks on the left and right air charge coolers (Figures 10 and 11).

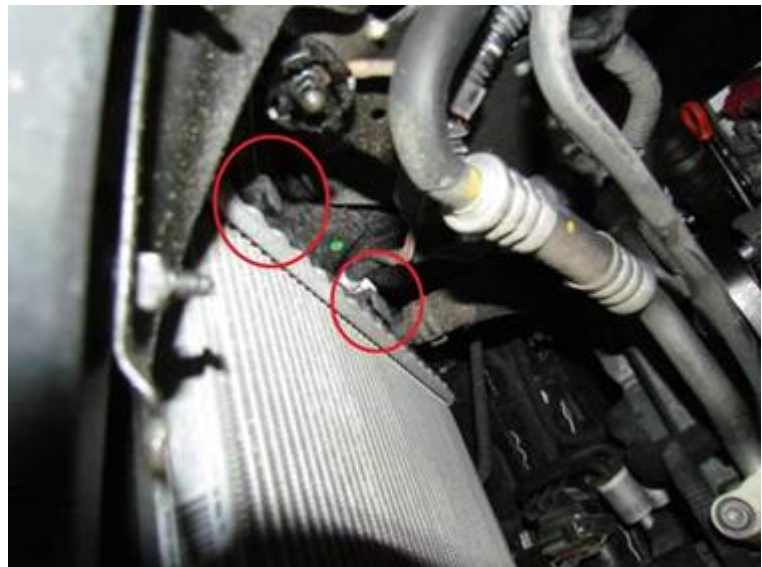
Figure 11. Upper exit air duct attachment points to charge a cooler.

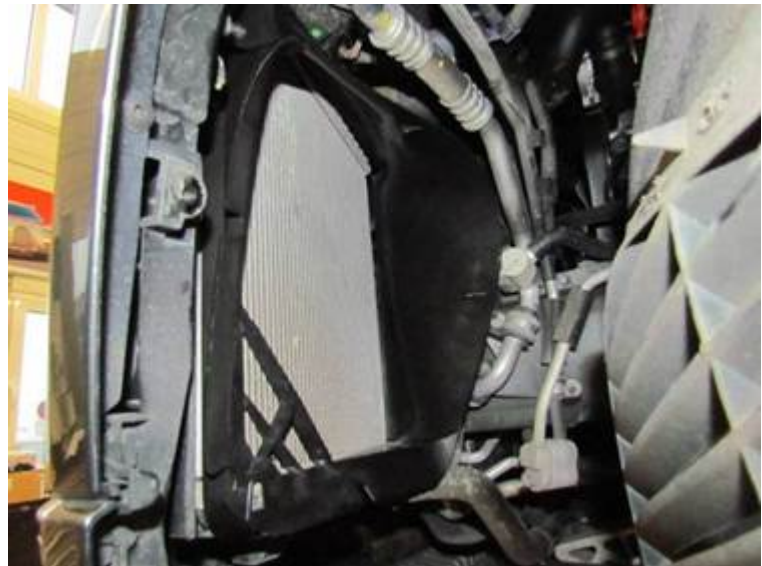
Figure 12. Charge air cooler exit air duct installed.

12. Affix left and right exit air ducts over the rear of the charge air coolers (Figure 12).
