# Technical Service Bulletin

## 94 Moisture accumulation in headlamps

94 13 20 2028277/7 July 3, 2013. Supersedes Technical Service Bulletin Group 94 number 13-11 dated March 6, 2013 for reasons listed below.

Model(s)	Year	VIN Range	Vehicle-Specific Equipment
Q7	2010 - 2014	All	Not Applicable

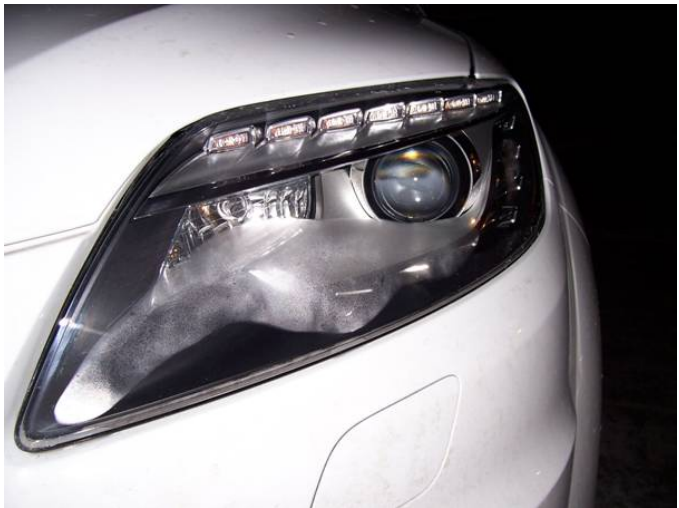
- There is considerable moisture present in the headlamp (Figure 1).
- The moisture disappears only after extended drives (greater than 10 minutes).
- There is no external damage to the headlamp which could introduce moisture.

*Figure 1. Moisture in headlamp.*

Humid air settles on the inside of the glass, causing moisture to appear on the inside of the headlamp lens.

When high air humidity and temperature differences exist between the inside of the headlamps and the outside, condensation can form on the inside of the lens, especially in cold and wet weather. This moisture buildup can happen, for example, after a car wash, after steam cleaning of the engine or the front end, or after overnight temperature changes.

1. Remove the headlamps and dry the inside using compressed air or a hot air blower. Check for any loose caps, loose or unsealed control modules, or cracks in the headlamp housing(s) as the culprit of moisture exposure.
2. If the vehicle's build is prior to VIN # \*CD004736 and the updated ventilation hoses are not currently installed, replace the headlamp ventilation hose for each headlamp with the new part number to help reduce any further humidity ingress into the headlamps (see *Required Parts and Tools*, below). Proceed to step 3.

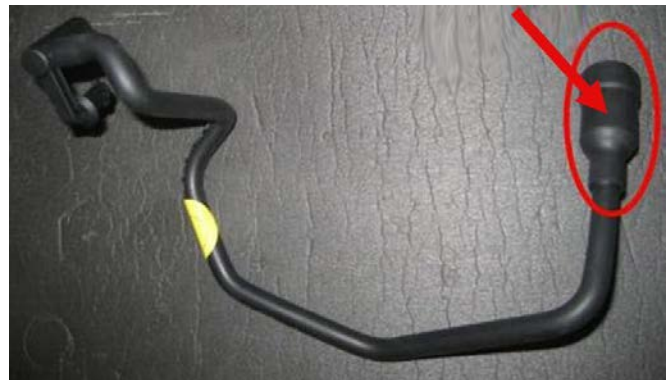
**Tip:** The updated ventilation hose can be recognized by the integrated filter (Figure 2, arrow).

*Figure 2. Updated ventilation hose with integrated filter.*

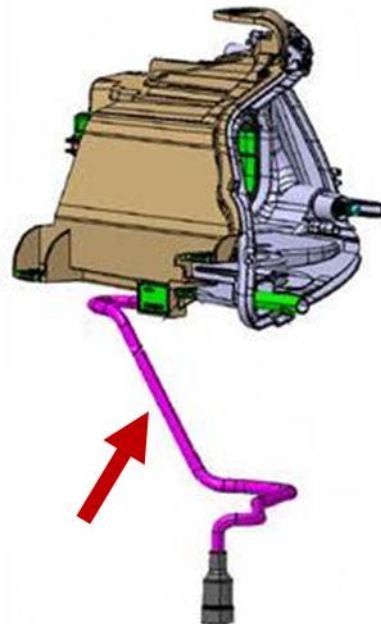
**Tip:** The updated ventilation hose is not connected directly to the headlamp housing. The hose routes downward from the headlamp carrier and between the radiator and bumper (Figure 3, arrow).

*Figure 3. Mounting of updated ventilation hose.*

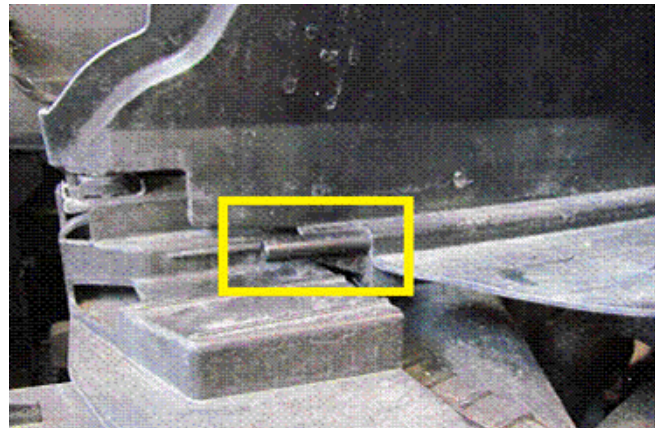
*Figure 4. Headlamp ventilation guide tube.*

- Each headlamp air ventilation tube must be sealed to protect against further moisture ingress (Figure 4).

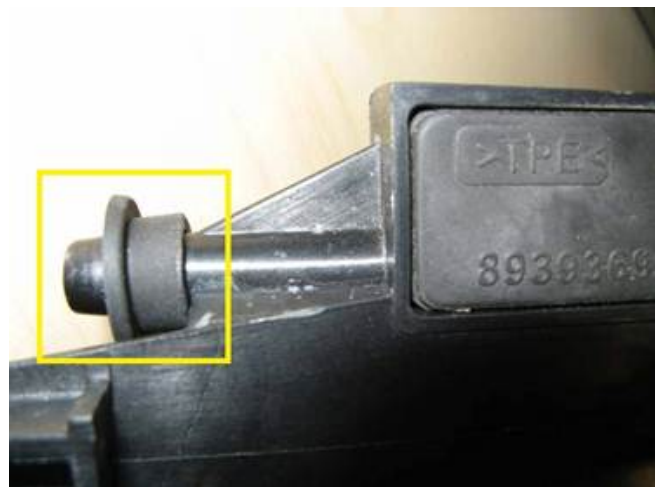
*Figure 5. Ring seal installed on headlamp air tube.*

- Install ring seal on headlamp air ventilation tube (Figure 5). The larger diameter of the seal faces the headlamp.

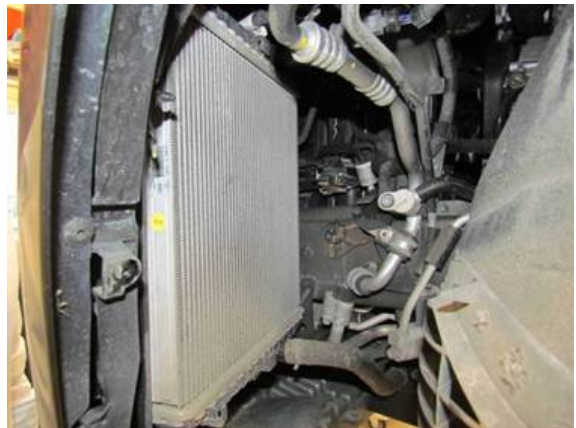
**Figure 6.** View of charge air cooler with wheel well liner removed.

7. Remove front wheels and wheel housing liners. The rear of the charge air coolers will be exposed (Figure 6).

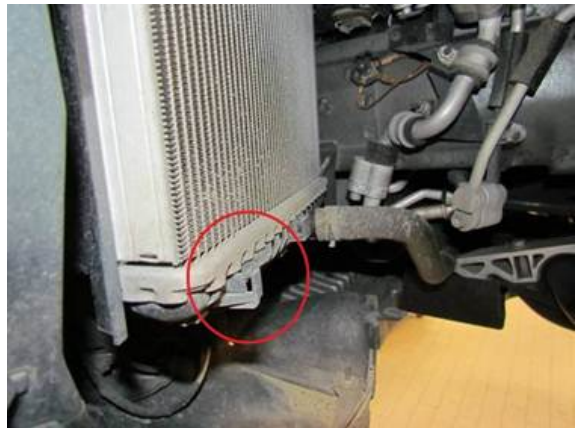
**Figure 7.** Lower exit air duct attachment point to charge air cooler.

8. Locate exit air duct attachment hooks on the left and right air charge coolers (Figures 7 and 8).

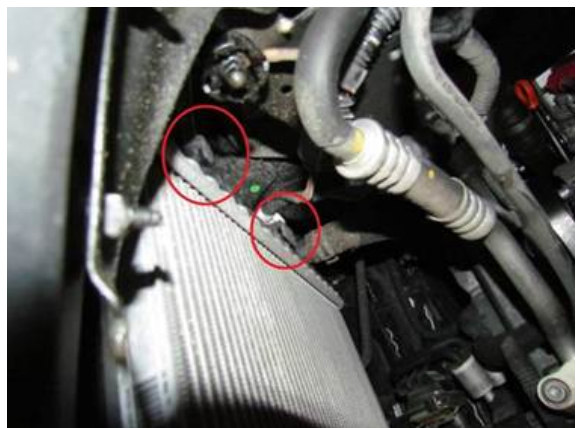
**Figure 8.** Upper exit air duct attachment points to charge a cooler.

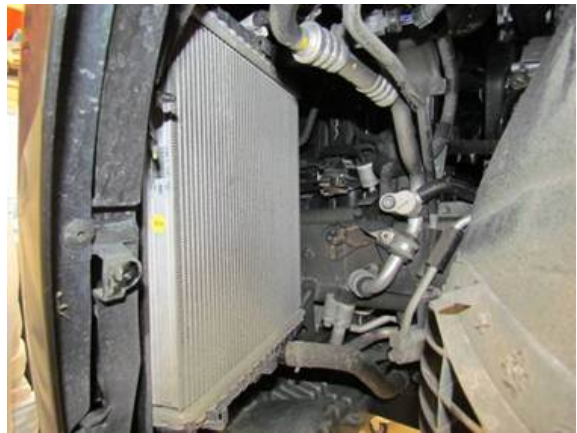
**Figure 9.** Charge air cooler exit air duct installed.

9. Affix left and right exit air ducts over the rear of the charge air coolers (Figure 9).

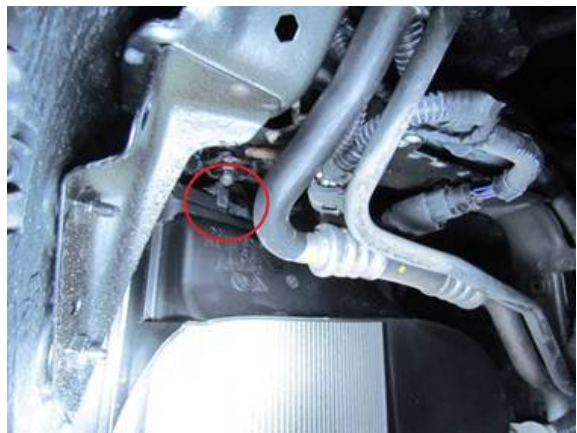
**Figure 10.** View of exit air duct affixed to mounting hook.

10. Inspect exit air duct attachment points to be sure that ducts are engaged properly over charge air cooler hooks (Figure 10).
