Technical Service Bulletin

94 Moisture accumulation in headlamps

94 13 24 2028277/8 July 18, 2013. Supersedes Technical Service Bulletin Group 94 number 13-20 dated July 3, 2013 for reasons listed below.

Model(s)	Year	VIN Range	Vehicle-Specific Equipment
Q7	2010 - 2014	All	Not Applicable

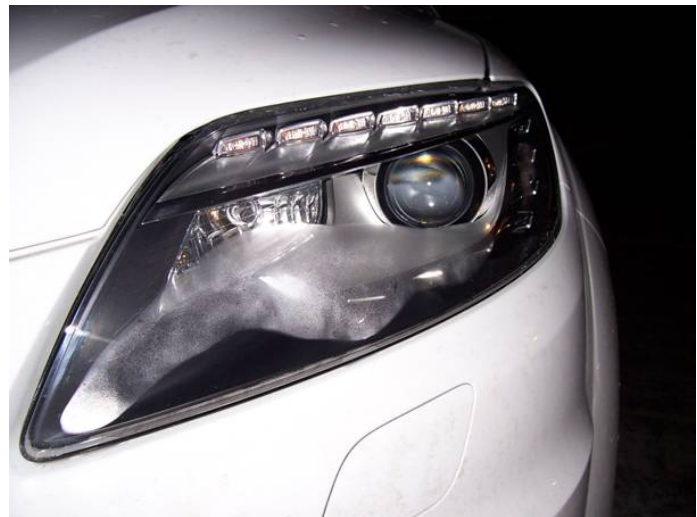
- There is considerable moisture present in the headlamp (Figure 1).
- The moisture disappears only after extended drives (greater than 10 minutes).
- There is no external damage to the headlamp which could introduce moisture.

Figure 1. Moisture in headlamp.

Humid air settles on the inside of the glass, causing moisture to appear on the inside of the headlamp lens.

Because of the headlamp circulation system, outside air is allowed to flow through the headlamps. The open, water-protected ventilation system (needed for pressure compensation) creates different “ climate zones” inside the headlamp, where the lens is either warmed up by the light or cooled down by passing air.

When high air humidity and temperature differences exist between the inside of the headlamps and the outside, condensation can form on the inside of the lens, especially in cold and wet weather. This moisture buildup can happen, for example, after a car wash, after steam cleaning of the engine or the front end, or after overnight temperature changes.

1. Remove the headlamps and dry the inside using compressed air or a hot air blower. Check for any loose caps, loose or unsealed control modules, or cracks in the headlamp housing(s) as the culprit of moisture exposure.
2. If the vehicle's build is prior to VIN # *CD004736 and the updated ventilation hoses are not currently installed, replace the headlamp ventilation hose for each headlamp with the new part number to help reduce any further humidity ingress into the headlamps (see *Required Parts and Tools*, below). Proceed to step 3.

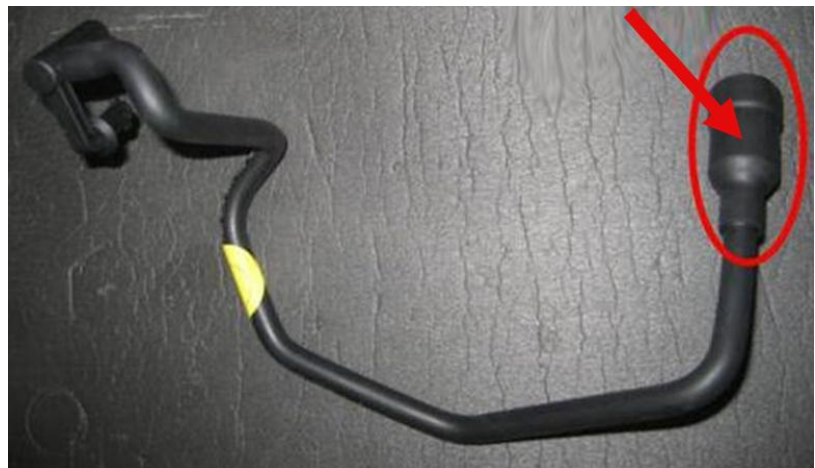
Tip: The updated ventilation hose can be recognized by the integrated filter (Figure 2, arrow).

Figure 2. Updated ventilation hose with integrated filter.

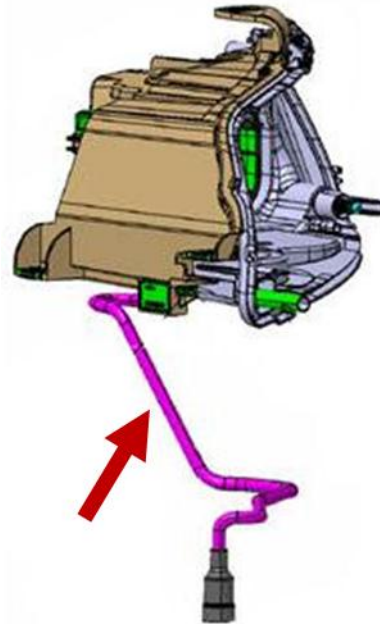
i **Tip:** The updated ventilation hose is not connected directly to the headlamp housing. The hose routes downward from the headlamp carrier and between the radiator and bumper (Figure 3, arrow).

Figure 3. Mounting of updated ventilation hose.

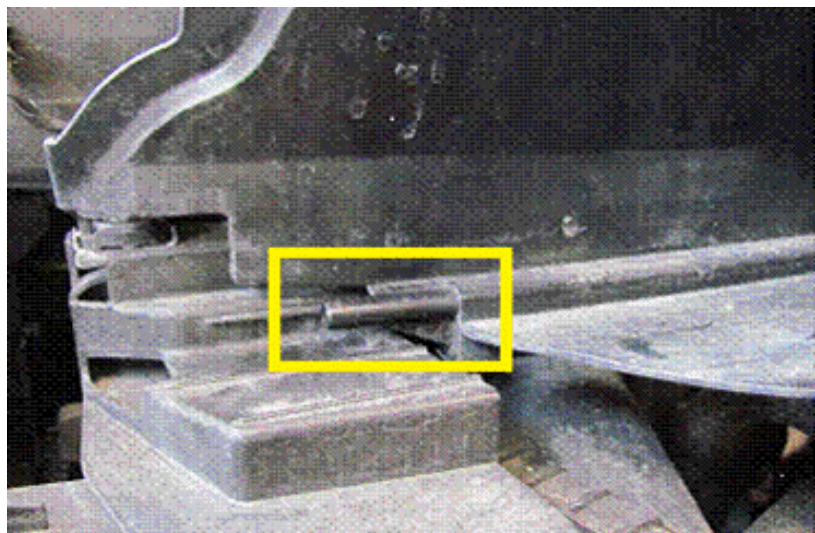
Figure 4. Headlamp ventilation guide tube.

3. Each headlamp air ventilation tube must be sealed to protect against further moisture ingress (Figure 4).

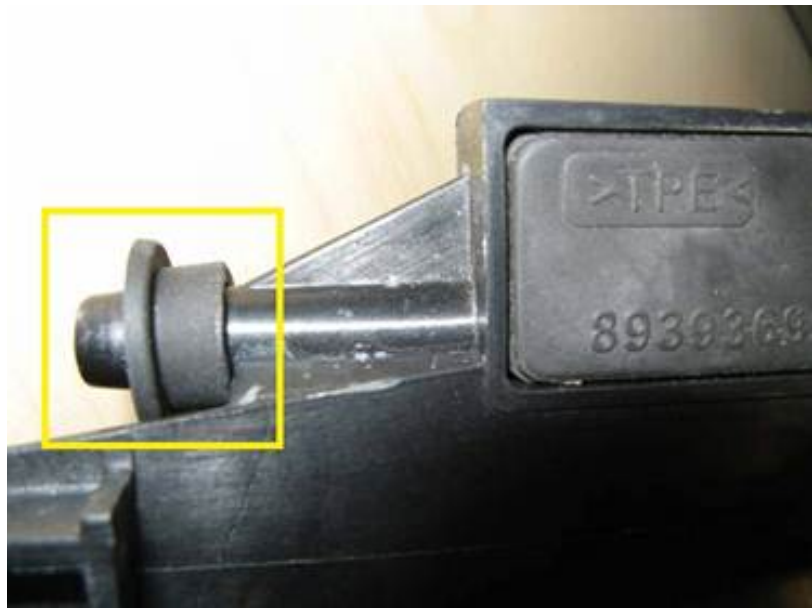
Figure 5. Ring seal installed on headlamp air tube.

4. Install ring seal on headlamp air ventilation tube (Figure 5). The larger diameter of the seal faces the headlamp.

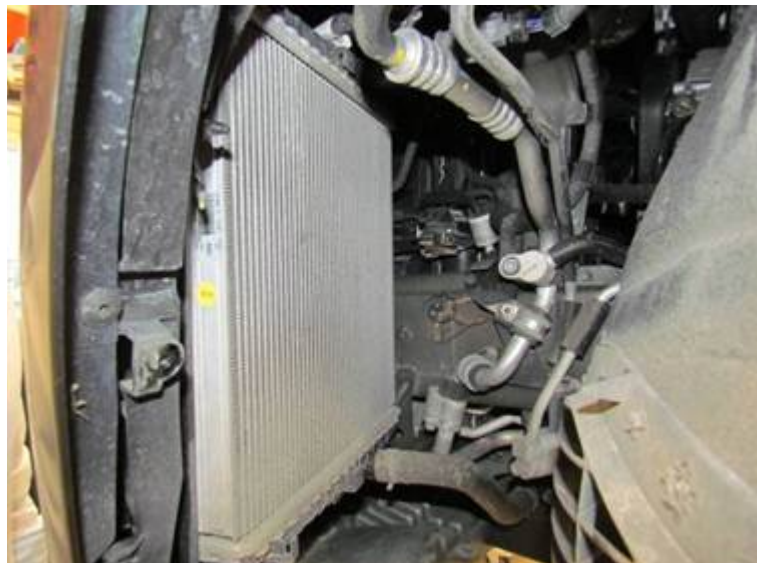
Figure 6. View of charge air cooler with wheel well liner removed.

6. Check vehicle for left and right air ducting for exiting air behind charge coolers. Vehicles built from June 2010 will not have these exit air ducts installed. Check vehicle regardless of build date. If air ducts are not installed, continue with steps 7 – 11. Otherwise, proceed to step 12.
7. Remove front wheels and wheel housing liners. The rear of the charge air coolers will be exposed (Figure 6).

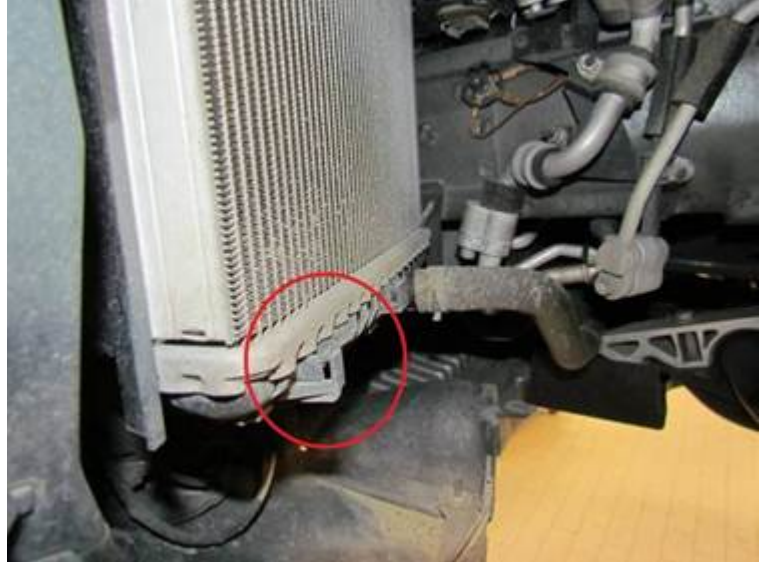
Figure 7. Lower exit air duct attachment point to charge air cooler.

8. Locate exit air duct attachment hooks on the left and right air charge coolers (Figures 7 and 8).

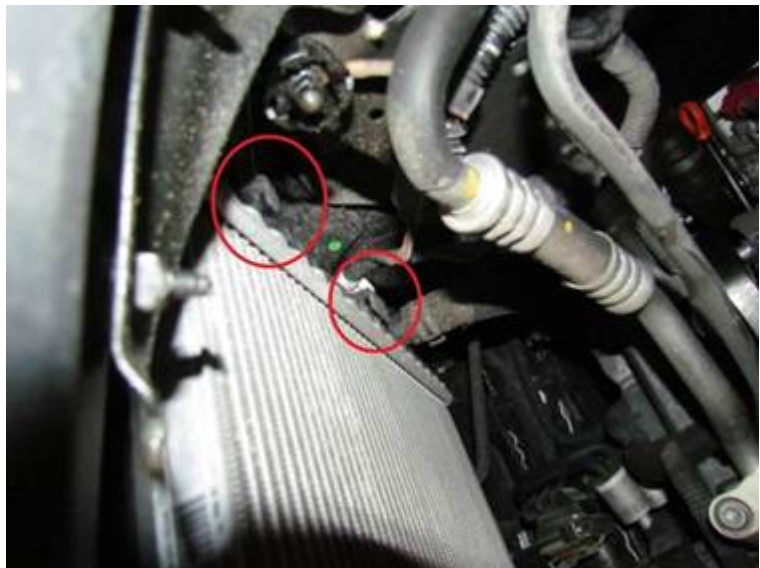
Figure 8. Upper exit air duct attachment points to charge a cooler.

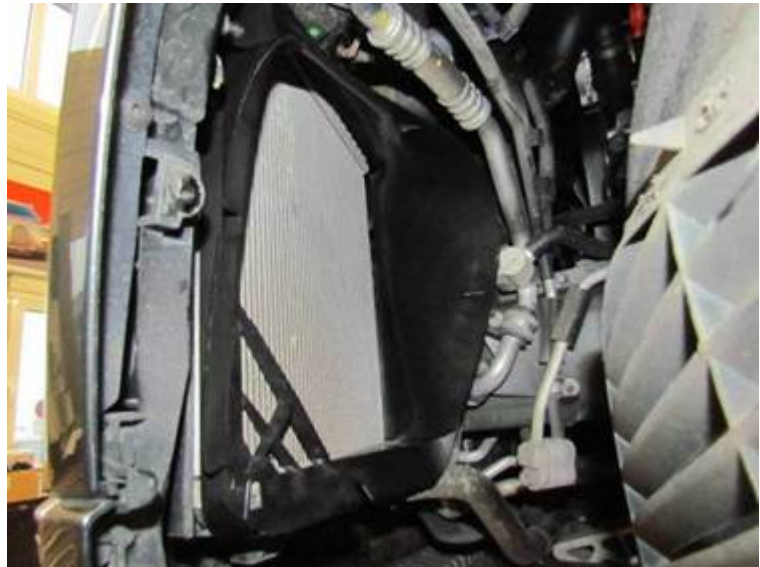
Figure 9. Charge air cooler exit air duct installed.

9. Affix left and right exit air ducts over the rear of the charge air coolers (Figure 9).

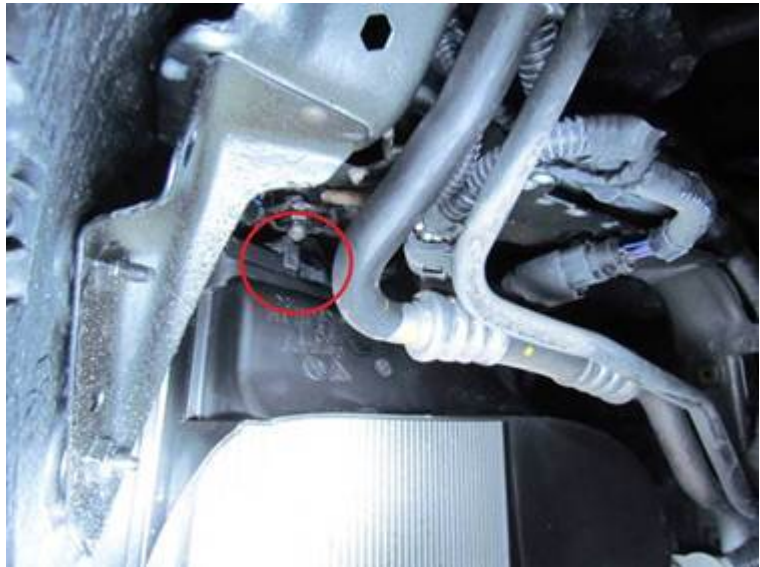
Figure 10. View of exit air duct affixed to mounting hook.

10. Inspect exit air duct attachment points to be sure that ducts are engaged properly over charge air cooler hooks (Figure 10).
