**NUMBER:** 16-001-13**GROUP:** Prop Shaft / U-joint**DATE:** January 17, 2013

Driveline Vibration

2012 DP Ram 4500/5500 Cab Chassis

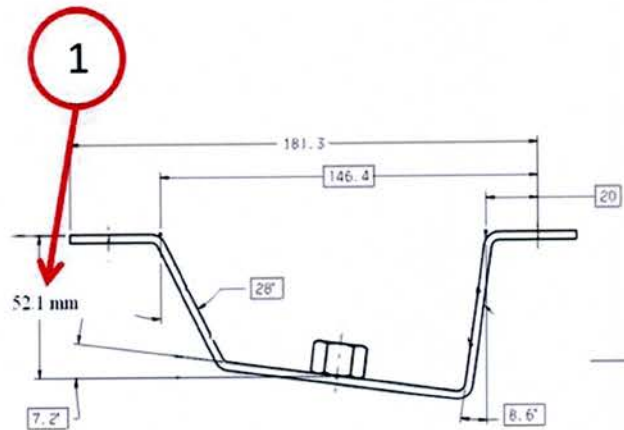
Fig. 1 Drive Shaft Center Support Bearing Bracket

A small number of vehicles were built with an incorrect drive shaft center support bearing bracket. The bracket on these vehicles may have an incorrect height which could allow the drive shaft to operate at an angle that could cause the driveline to vibrate while the vehicle is in motion.

2. Measure the height of the drive shaft center support bearing bracket from the attaching fastener to the frame rail (Fig. 1). The distance should be 52.1 mm (2 inches). Incorrect drive shaft center support bearing brackets will be 82 mm (3.25 inches).

8. Install new drive shaft center support bearing bracket (p/n 52123065AB) securing it with the attaching fasteners. Tighten the bolts to 54 N·m (40 ft. lbs.).

9. Align center bearing with reference marks on center bearing bracket and tighten bolts to 54 N·m (40 ft. lbs.).
10. Lower the vehicle.
