**SB-10051861-4798**

TECHNICAL BULLETIN  
LTB00384NAS3  
22 JAN 2013

Headlamp 'Blooming'

**Range Rover (LM) - All with Adaptive Xenon Lamps**

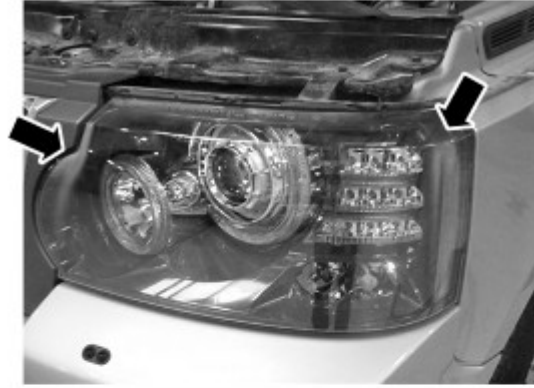
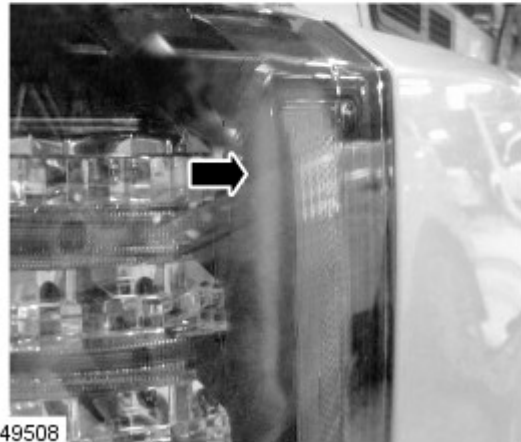
**Situation:** A visible discoloration on the inside of the headlamp lens may be evident.

**Cause:** This may be caused by silicon discharge within the headlamp assembly.

- NOTE: Example of the locations of the headlamp blooming issue.**

**NOTE: Only replace the headlamp that has the fault condition. Do not automatically replace as a pair.**

Replace affected headlamp assembly / assemblies (TOPIx Workshop Manual section 417-01).
