## Wrong SRS Replacement Parts Can Cause SRS DTCs 41-xx thru 46-xx

Currently Applies To: '12 Civic Sedan, '12 Civic Sedan Si, and '11 CR-V

EDITOR'S NOTE: This article revises the one issued in July 2012. Changes are highlighted in red.

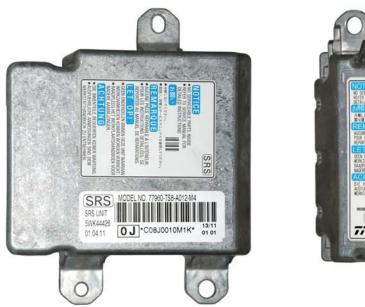
#### SRS Unit

Continental units have a smooth housing. The barcode label doesn't have a logo and it's separate from the notice.

- TRW units are scalloped around the outside of the housing. The barcode label has the TRW logo and it's combined with the notice.
- The replacement part number for either unit is the **first 11 characters** of the 14-character model number on the barcode label.

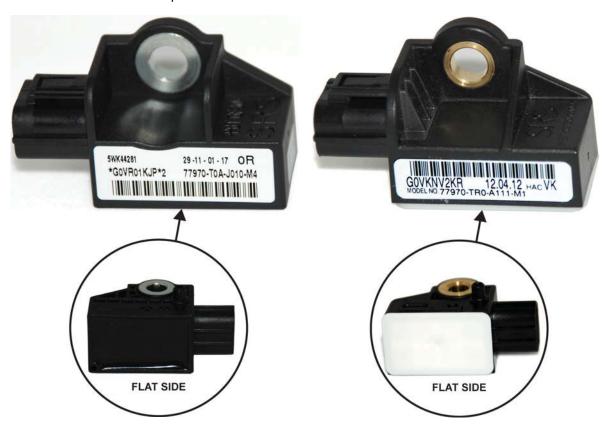
### Front and Side Impact Sensors

• The flat side of a Continental impact sensor is black.

- The flat side of a TRW impact sensor is white.
- Neither sensor has a logo.
- TRW impact sensors have three angular braces next to the mounting bolt hole.
- The replacement part number for either sensor is the **first 11 characters** of the 14-character model number on the barcode label.
