SB-10051884-1956

Title: Dual Throttle Pedal Harness Troubleshooting

Applies To: 7000 4000 Models with Dual Throttle Harness and Switch Installed.

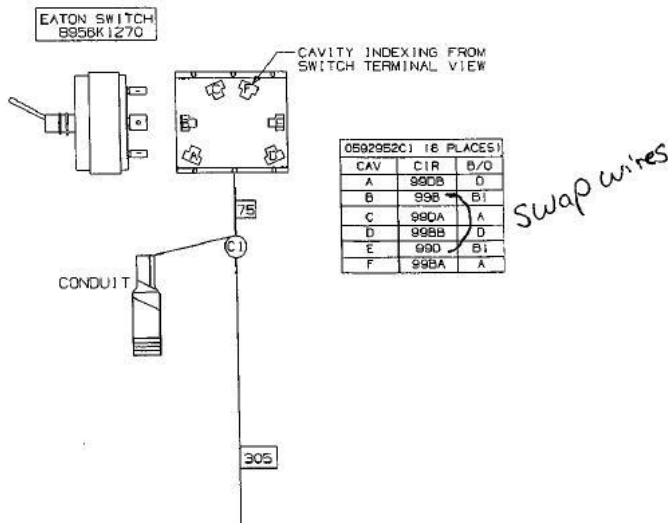
CIRCUIT DIAGRAM

Dual throttle pedals are inoperative.

- Will not accelerate
- Check engine light on

DTC	MODULE	DESCRIPTION
134	Engine	APS/IVS conflict

1. Check the wires on the back of the selector switch
2. Verify that wire 99B is in cavity B
3. Verify that wire 99D is in cavity E
4. If these are incorrect please swap the two wires.
5. If these wires are in the correct locations please follow the correct Iknow article for the aps troubleshooting.
