**SERVICE BULLETIN**

**APPLICABILITY:** 2013 MY BRZ

**NUMBER:** 12-145-13R

**SUBJECT:** Condensation in Rear Combination Lamps, Retaining Nut and Sealing Gasket Change

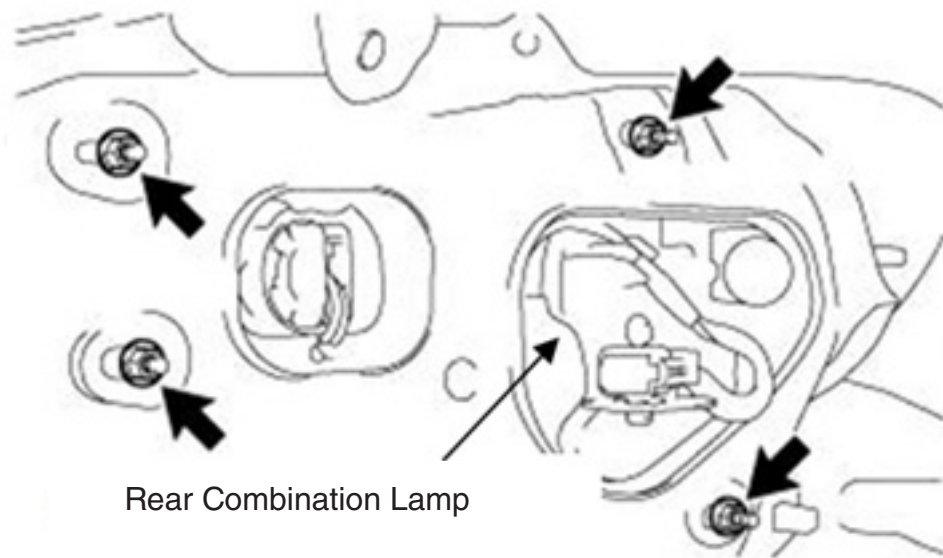
### Retaining Nut Locations (4)

Due to a smaller diameter flange surface, the original retaining nuts may distort the rear body panel mounting and sealing surfaces for the combination lamps enough to allow moisture seepage past the seals into the combination lamps and possibly the trunk area. In addition, the thickness of the sealing gasket (packing) for the rear combination lamp has been increased from 5mm to 8mm.

Remove the trunk floor mat, rear floor finish plate, inner trunk trim and the affected rear combination lamp assembly(s) following the instructions in the applicable Service Manual.

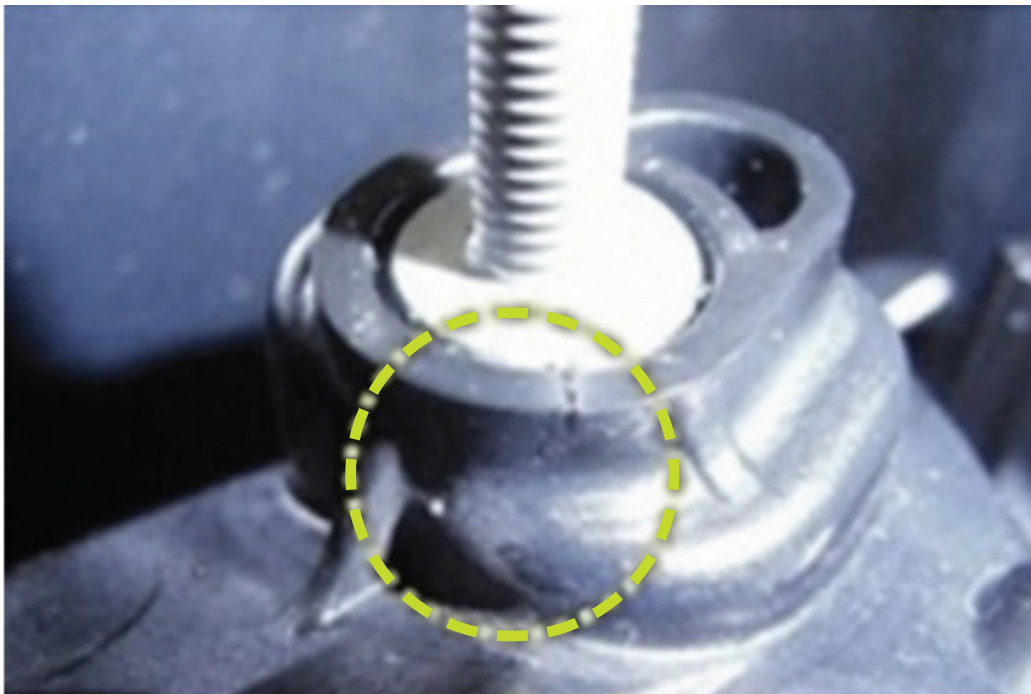
### Example of crack

Once the combination lamps are removed, inspect their mounting stud boss areas carefully for any cracking as shown in the photo example below. Any damaged combination lamps must be replaced.

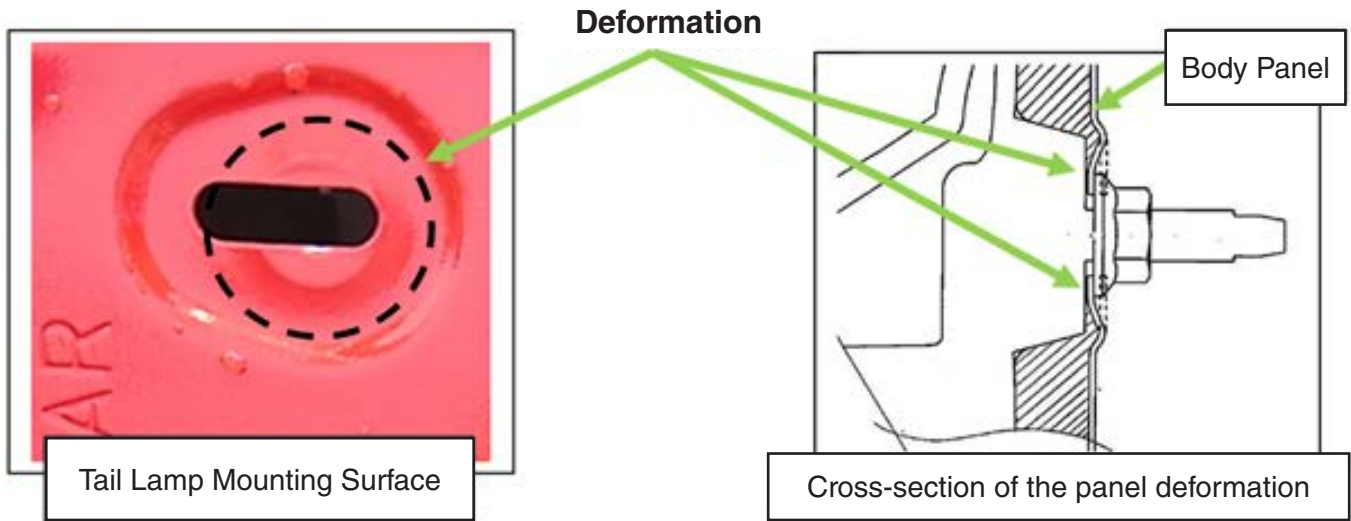
Inspect the rear body panel in the retaining nut areas for any deformation of the metal as shown in the illustrations below.

If any deformation is found, CAREFULLY straighten the affected mounting area using a small body hammer and dolly.
